<b>VOLUME</b>  <b>3</b>	GROUP Climate Control	MODEL 2006-2008 Sedona
		NUMBER 010 (revised)	DATE August 2008
<b>TECHNICAL SERVICE BULLETIN</b>			
<b>SUBJECT:</b>  <b>A/C COMPRESSOR NOISE CONCERN</b>

## A/C COMPRESSOR NOISE CONCERN

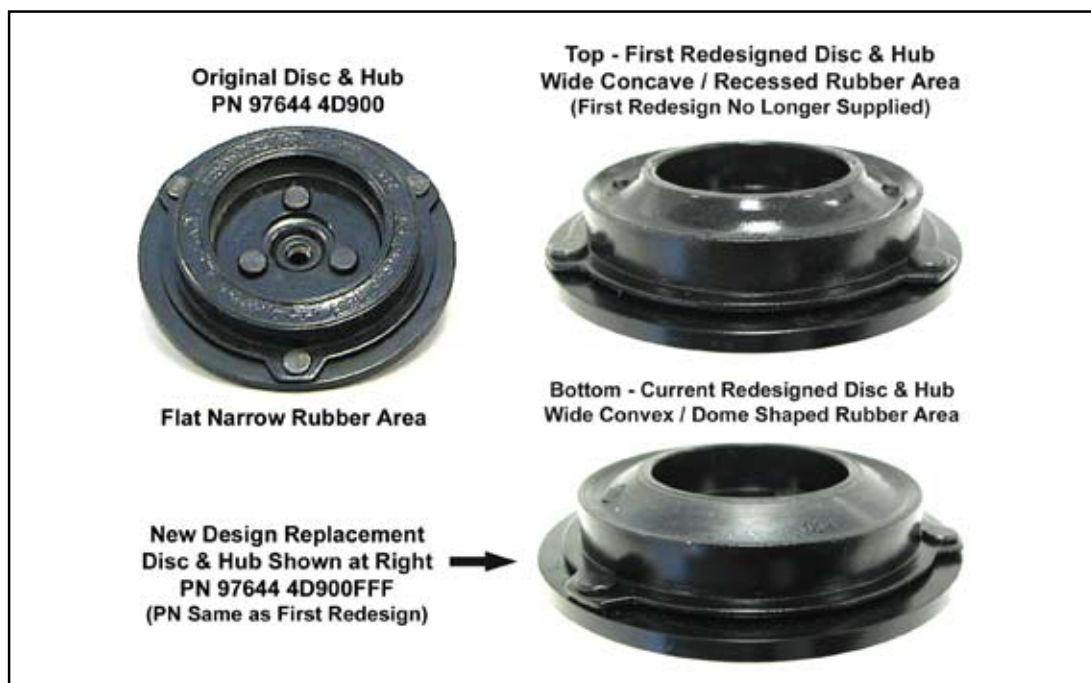
This revised bulletin replaces information published on 5/23/2007, Climate Control – 010. It readdresses some 2006 – 2008 Sedona (VQ) that may exhibit a knocking noise (mainly at idle) during A/C operation. A new redesigned A/C compressor Disc & Hub with better dampening characteristics can be retrofitted to these vehicles A/C compressors to eliminate the concern. This new design Disc & Hub assembly can be applied to any 2006 – 2008 Sedona (VQ) manufactured before January 16, 2008 that exhibits this concern and hasn't had the current new redesigned Disc & Hub installed.

Please note that there are two (2) redesigned Disc & Hub assemblies, the first of which is no longer supplied. In some cases KMA has found that the first redesign did not effectively address all customer concerns. The current redesigned Disc & Hub should be used in these cases, even if the first redesigned Disc & Hub had been tried.

As of 7/17/2008, only the current redesigned Disc & Hub is being shipped from all Parts Distribution Centers. The part number has not changed between the first and current redesigned Disc & Hub. To order the current redesign Disc & Hub, use PN 97644 4D900FFF.
