MODEL
Optima
(TF/QF/HEV)
2011/13MY

NUMBER
039

TECHNICAL SERVICE BULLETIN

CAUTION DURING REAR UPPER ARM SERVICE

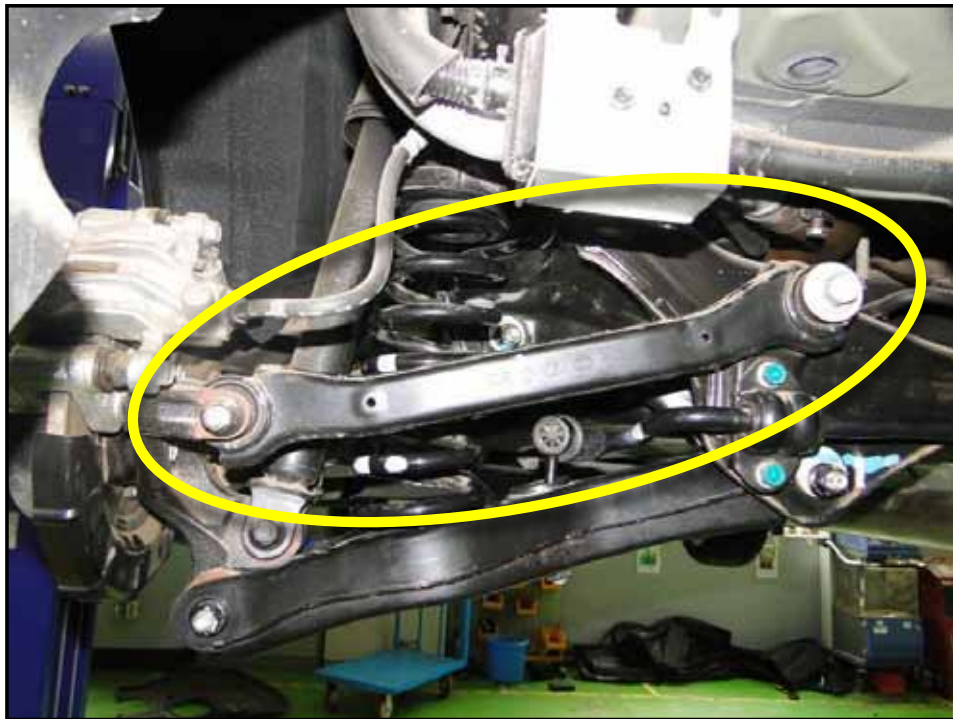
This bulletin provides cautionary information relating to the Optima when installing the rear upper arm to the subframe to prevent potential quality concerns regarding rear upper arm bolt. Without properly aligning the bolt holes of rear upper arm and subframe (horizontally), the bolt securing the rear upper arm to the subframe may become loose, and as a result, rust and noise concerns may occur later on.
