GROUP Electrical	MODEL 2014MY Sorento (XMa) w/IMS Seats
	NUMBER ELE 069	DATE September 2014

TECHNICAL SERVICE BULLETIN

SUBJECT: DRIVER'S SIDE POWER WINDOW SWITCH REPLACEMENT

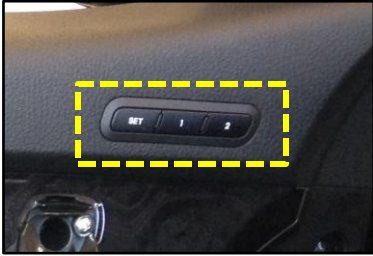
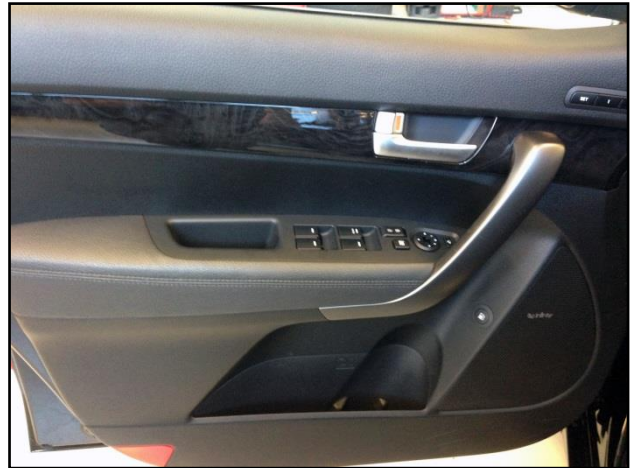
Verify the vehicle is equipped with an IMS switch.

2. Remove the quadrant inner cover using a non-marring plastic remover.
