BTB 00477 (1411)

## Buzzing or Static on Receiving End During HFL Call

### AFFECTED VEHICLES

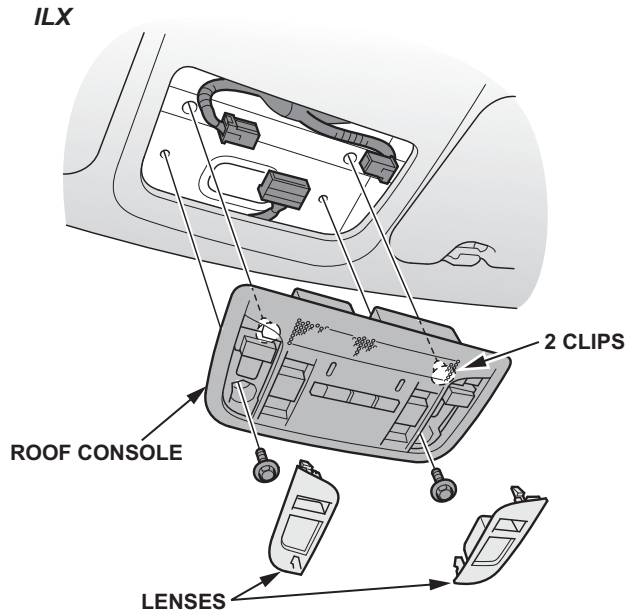
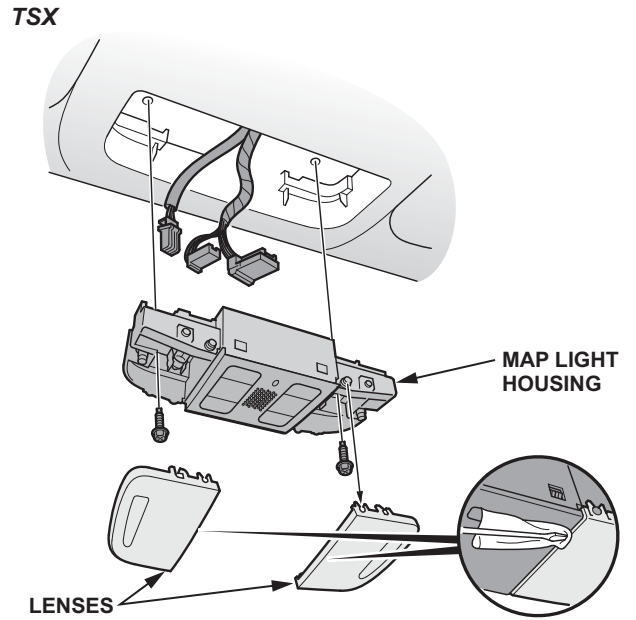
1. Turn off the front individual map light switch.
2. Carefully pry off the lenses with a flat-tip screwdriver.

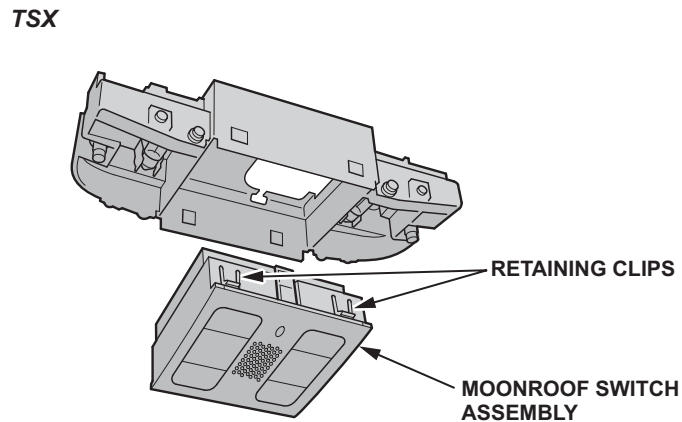
3. Remove the two mounting bolts
4. Disconnect the connectors, then remove the roof console (ILX) or map light housing (TSX).
5. *TSX only:* Carefully pry off the moonroof switch assembly from the map light housing while pressing in on the retaining tabs.
