L624-
A.05.15

AC System software update

All Lamborghini Huracán 2015 Right Hand drive starting from VIN 00163 to FLA01968

As a result of continuous product monitoring, Automobili Lamborghini Spa has introduced a new software enhance the air recycle functionality.

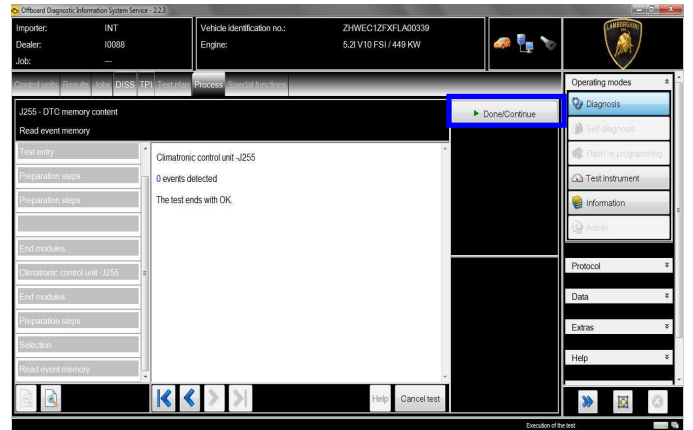
62. Check that all errors are erased on the Air Conditioning control unit. In the case still remain some sporadic errors, erase again.

In the case still remain static errors at the end of the Air Conditioning software update, and even after having performed the basic settings, restart the procedure from step 38.

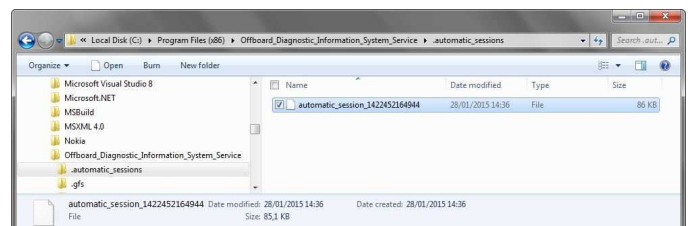
If the same error was present during the application test, try following procedure:

- quit ODIS;
- Enter the folder C:\Program Files (x86)\Offboard_Diagnostic_Information_System_Service\automatic_sessions on your diagnosis laptop

- delete the only file present in that folder
- re-Start ODIS Service under following conditions:
 1. Network connection available;
 2. ODIS connection set on “Internet”;
- Retry the application test and the SVM with your GeKO Token.

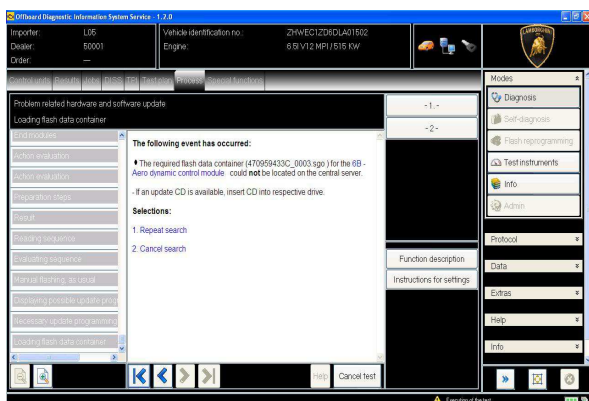
F. In the case the flash container is not detected (see figure):

- Make sure to be recently synchronized with Mirrorserver by checking the last date of Sync under:
<http://mirrorserver/welcome>
 or under
http://IP_address/welcome
 if you don't have previously defined the “mirrorserver” IP address alias.
- Make sure to be correctly connected with Mirrorserver.
