L624-
A.10.15

To: Official After Sales Network
Subject: Software Update Of Headlight Alignment Adjustment Control Unit (AFS)
Date: 02/20/2015
Pages: 16

Software update of headlight alignment adjustment control unit (AFS).

All Lamborghini Huracán 2015 From VIN FLA00163 to FLA02206

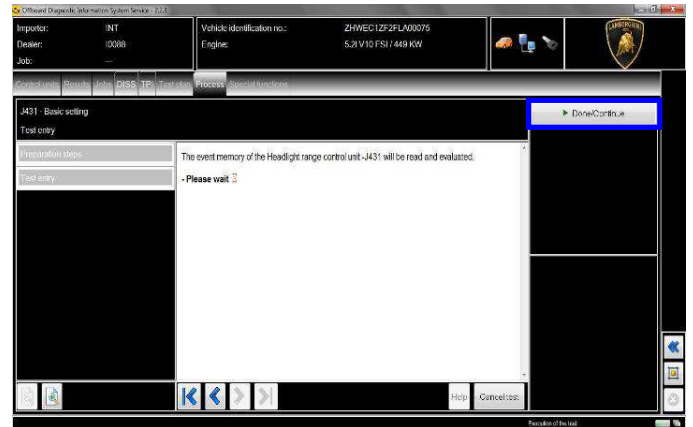
45. Click "Done/Continue" to perform a memory DTC reading on AFS ECU.

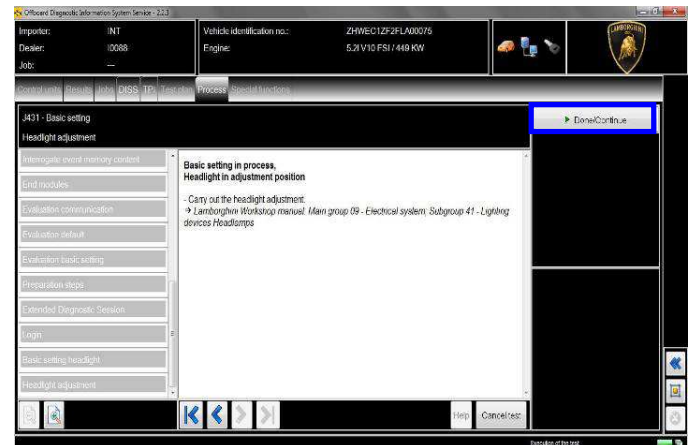
46. Basic setting in progress: adjust now manually the headlight regulation following the Workshop Manual indications, only if needed.

The AFS software update doesn't change the headlight regulation, therefore no manual operation is needed in this step.

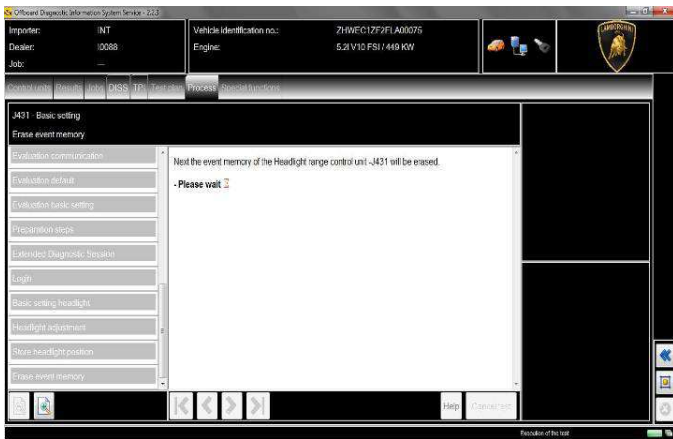
48. Wait the erase of all errors in AFS control unit.

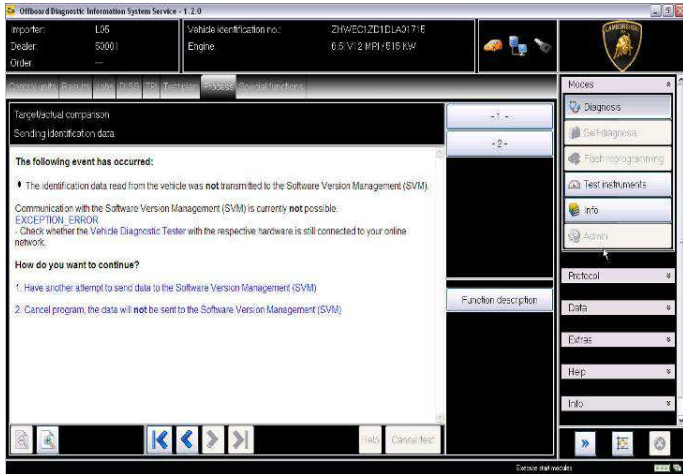
C. If the loss of connection happens during the target/actual comparison.

- It is not possible to connect to central server, check the working connection of internet and retry by clicking “1”.

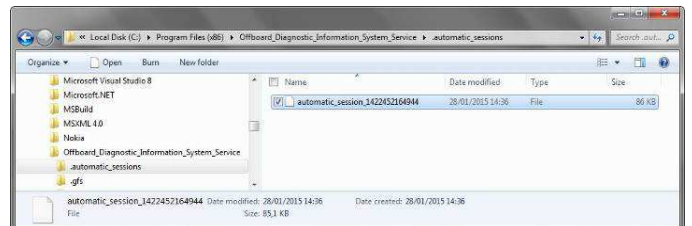
If the same error was present during the application test, try following procedure:

- quit ODIS;
- Enter the folder C:\Program Files (x86)\Offboard_Diagnostic_Information_System_Service\automatic_sessions on your diagnosis laptop

- delete the only file present in that folder
- re-Start ODIS Service under following conditions:
 1. Network connection available;
 2. ODIS connection set on “Internet”;
- Retry the application test and the SVM with your GeKO Token.
