L625-
A.06.16

To: Official After Sales Network
Subject: Soft top latch update
Pages: 21

L625-A.06.16

Soft top latch update

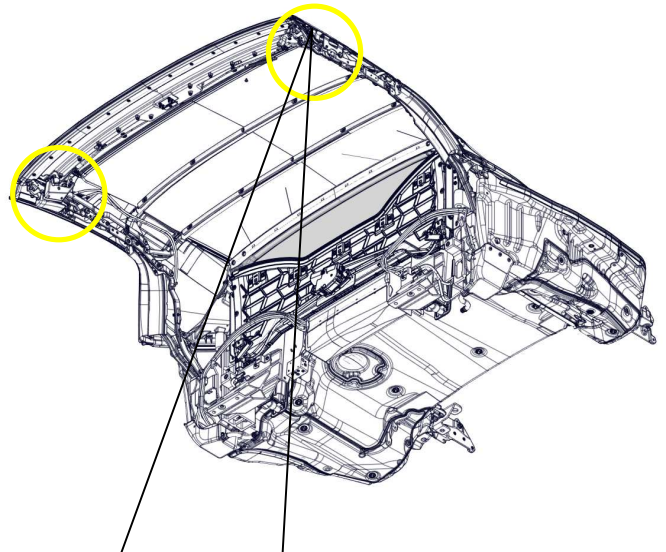
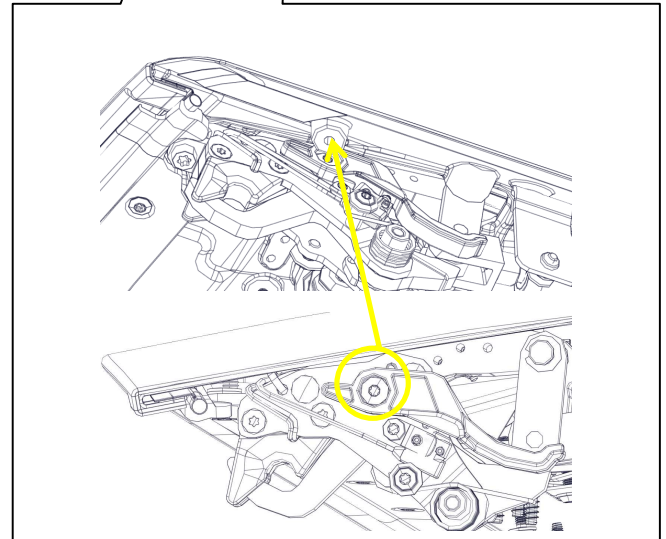
1. Area where you will be working.

1. front latch cover locking screw;
2. latch cover;
3. front seal mounting screw;
4. rear seal mounting screw;
5. front latch mounting screw (replace during re-assembly) and 2 washers;
6. lever mounting screw (replace during re-assembly).

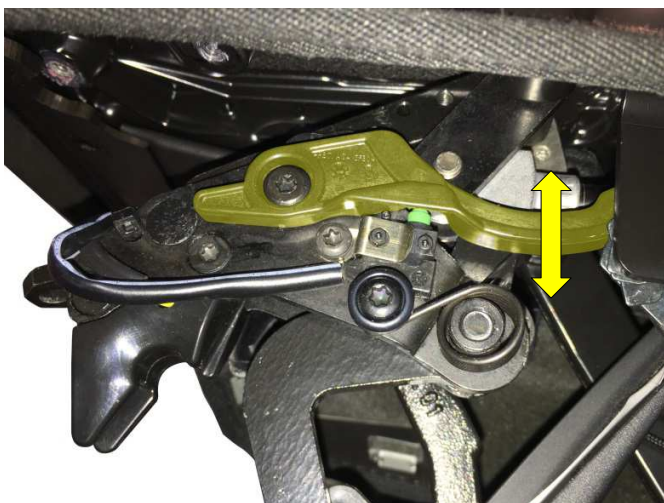
17. Make sure the lever moves up and down freely without any friction on the switch.

Before checking the play, make sure the lever does not touch any parts of the soft top. If this is the case, slightly rotate the latch assembly until it reaches a position where it can move freely.

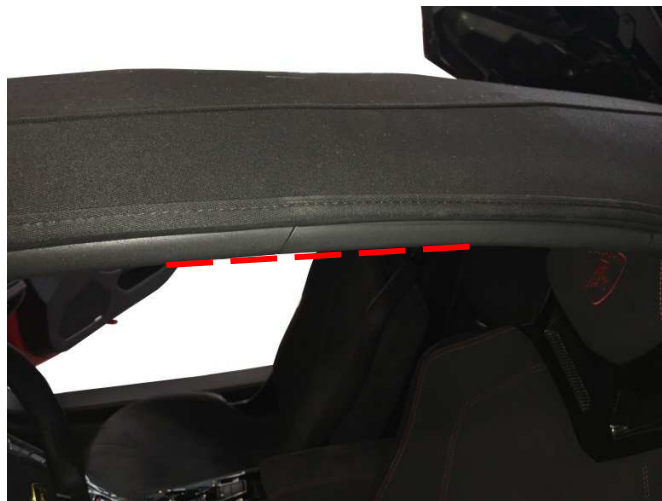
23. Close the soft top and make sure the 2 seals lock together properly. The seals must be perfectly aligned and there must not be any gaps in between.

If the seals are not aligned as regards height:

- loosen the rear screw (4);
- adjust the seal until it is aligned correctly;
- install the screw but do not tighten;
- re-close the soft top and check the alignment.

If the 2 seals are not correctly aligned with each other:

- loosen both the screws on the seal (front (3) and rear (4));
- adjust the seal until it is aligned correctly;
- install the screws but do not tighten;
- re-close the soft top and re-check.
