L83X-
A.11.14

To: Official After Sales Network
Subject: Kombi s.w. update.
Date: 01st/08/2014
Pages: 15

Kombi s.w. update.

All Lamborghini Aventador Coupé and Roadster MY 14 starting from VIN ELA02757.

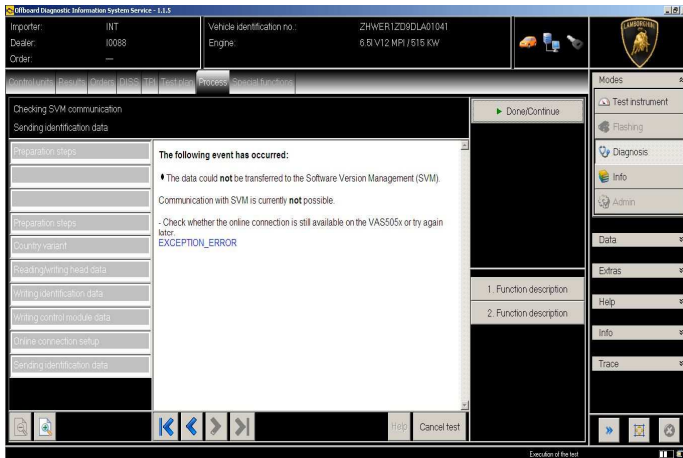
C. If the loss of connection happens during the target/actual comparison.

- It is not possible to connect to central server, check the working connection of internet and retry by clicking “1”.
