L83X-
A.14.14

To: Official After Sales Network
Subject: Drivability enhancement
Date: 03rd/10/2014
Pages: 25

Drivability enhancement

All Lamborghini Aventador MY 12.

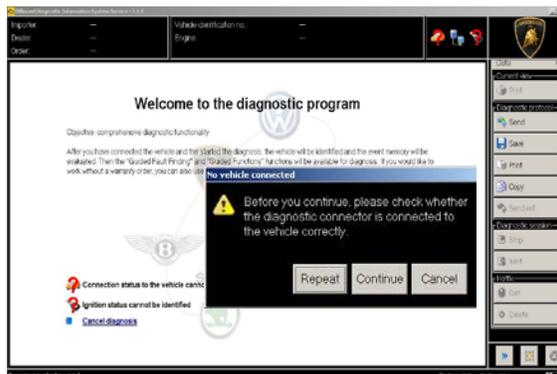
- A. If the error message regarding the VAS5054 interface and the 2 icons for status of on board connection and key on are shown as in the picture below:
 - Click “Cancel”;
 - Repeat the VAS5054 HW interface installation following the procedure (*) “VCI Manager v2.0”, by entering in the menu “Extras” on the right side and clicking on “Diagnostic interface”.

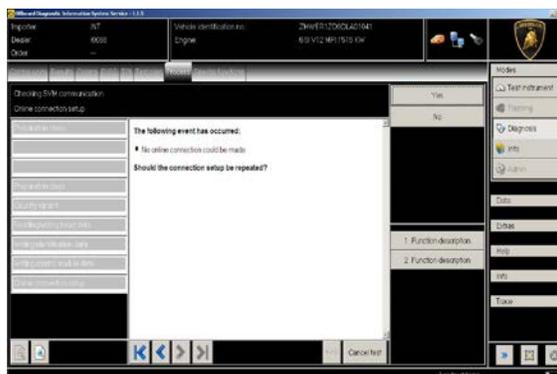
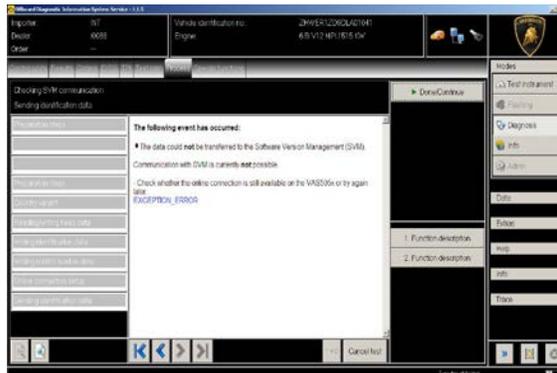
B. If one of the connection errors screens is shown as in the pictures below:

- it is not possible to establish a connection with the central server. Please check carefully that the diagnosis laptop is properly connected to the internet network and retry clicking “Yes” or “Done/Continue”.

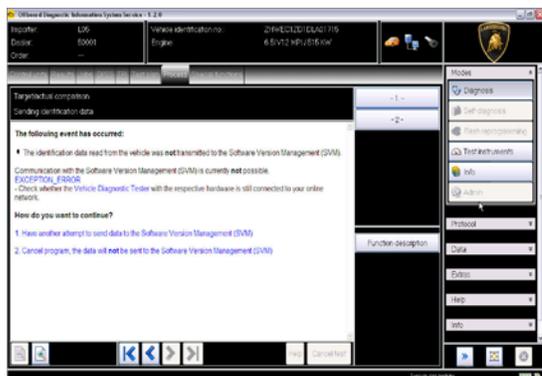
C. If the loss of connection happens during the target/actual comparison.

- It is not possible to connect to central server, check the working connection of internet and retry by clicking “1”.

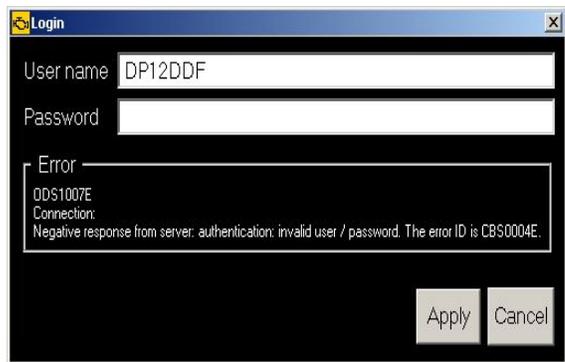
D. If the incorrect identification message is shown as in the picture below (error code: ODS1007E):

- be sure that your Geko account is valid;
- be sure that the label “Geko” is written on the token that you are using for the authentication;
- be sure the Password inserted is correct;
- click on Cancel and perform the application test (see document “ODIS_Checking_ConnectionServer_SVM_2.0” (*)).
