Service Bulletin

Subject: Information on Vibration Analysis and Diagnostic

Models: 2014 Chevrolet Silverado 1500
 2015 Chevrolet Silverado
 2014 GMC Sierra 1500
 2015 GMC Sierra

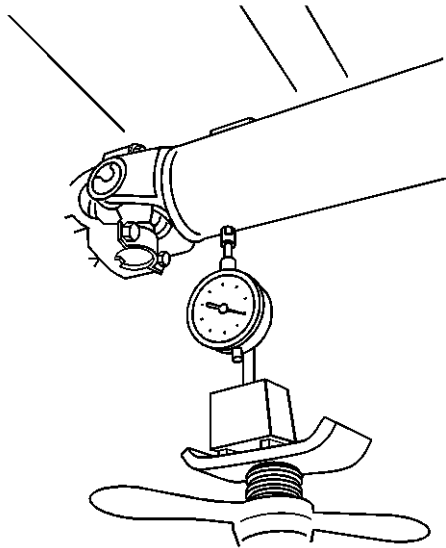
- This measurement procedure is intended to measure propeller shaft runout for prop shaft systems with 2 or 3 U-joints only. This is not for prop systems with only 1 U-joint, or with only constant velocity (CV) joints, and/or coupler assemblies.
 - When measuring runout of propeller shafts, do not include fluctuations on the dial indicator due to welds or surface irregularities.
1. Raise and support the vehicle with the wheels free to rotate. Refer to the Lifting and Jacking the Vehicle in SI.
 2. Place the transmission in NEUTRAL.
 3. Clean the circumference of the propeller shaft of any debris and/or undercoating along the rear of the shaft, where contact of the dial indicator will make to the propeller shaft.
 4. Inspect the propeller shaft for dents, damage, and/or missing weights. Any propeller shaft this is dented or damaged requires replacement.

5. Mount the GE-7872 Magnetic Base Dial Indicator Set, or equivalent, or the GE-8001 Dial Indicator Set, or equivalent, to the vehicle underbody or to a service stand positioned just clear of the U-joint yoke weld on the prop shaft.

6. Rotate the drive pinion axle flange, torque tube input flange, transmission output, or transfer case output flange by hand while take runout measurements of the prop shaft. The prop shaft will rotate more easily in one direction than in the other. If necessary, the tire and wheel assemblies and even the brake caliper assemblies can be positioned and supported aside, or the brake drums can be removed from the drive axle to provide axle to provide easier rotation of the prop shaft.

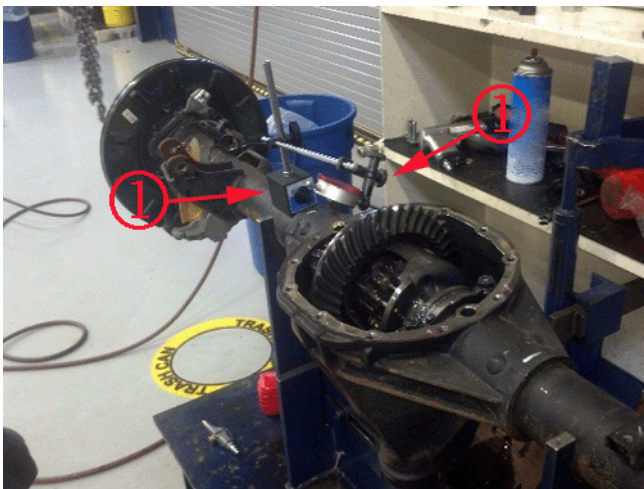
Note: The illustration above is for reference only. The differential does NOT need to be removed from the vehicle.

3. Set the J-8001-3 indicator (1) so that the stem is aligned with the gear rotation (1) and square to the tooth angle.
4. Hold the drive pinion stationary and move the ring gear back and forth.
5. Repeat the measuring procedure at **each tooth** around the ring gear.
6. The difference between the backlash at all of the measuring points should not vary by more than 0.05mm (0.002 in).
7. If the difference between the backlash at all of the measuring points varies by more than 0.05 mm (0.002 in), inspect for burrs, a distorted case flange or uneven bolting.
