## PIC6293 Installation of the GM Accessory Interior Spectrum Lighting Kit

Brand:	Model:	Model Years:	VIN:		Engine:	Transmissions:
			from	to		
Chevrolet	Camaro	2016 - 2018	All	All	All	All

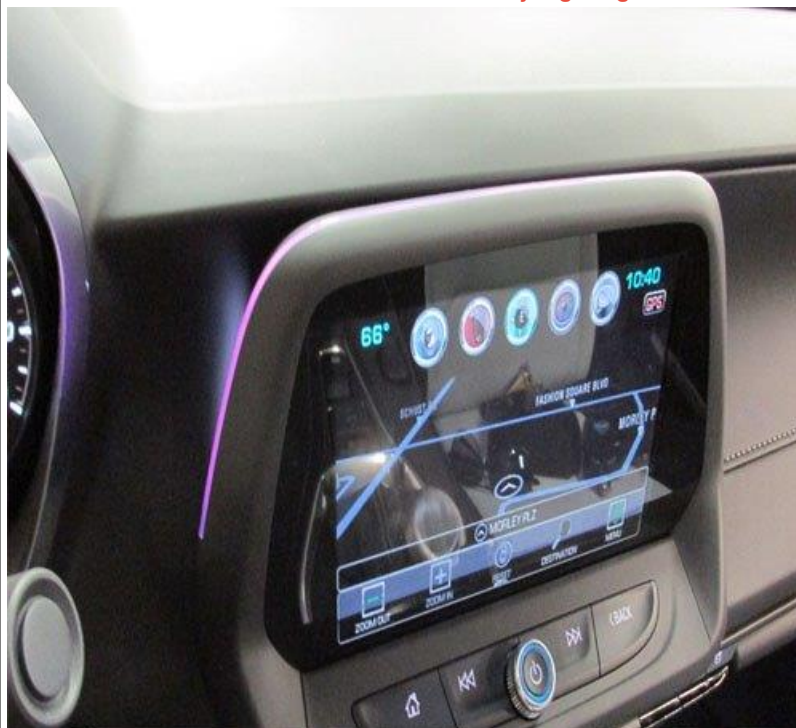
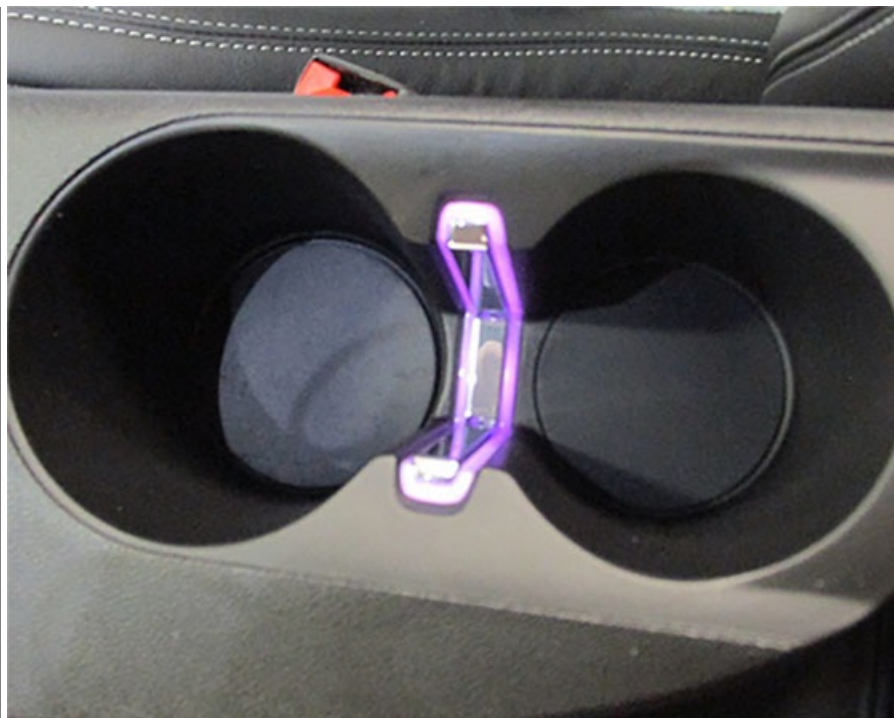
**IMPORTANT:** When installing a GM Accessory Lighting Kit, the light strips around the radio display and the center cupholders will NOT illuminate. The only way to get these two lights to operate is to purchase the vehicle with the factory C70 RPO. The radio display and the center cupholder will NOT illuminate with installation of the GM Accessory Lighting Kit.
