Service Bulletin

PRELIMINARY INFORMATION

Subject: Upper Steering Column Pop Click Tick Snap Itch Noise While Turning The Steering Wheel

Models: 2015 Cadillac Escalade Models
2015 Chevrolet Suburban, Tahoe
2015 GMC Yukon Models
With Power Tilt and Telescoping Steering Column (RPO N38)

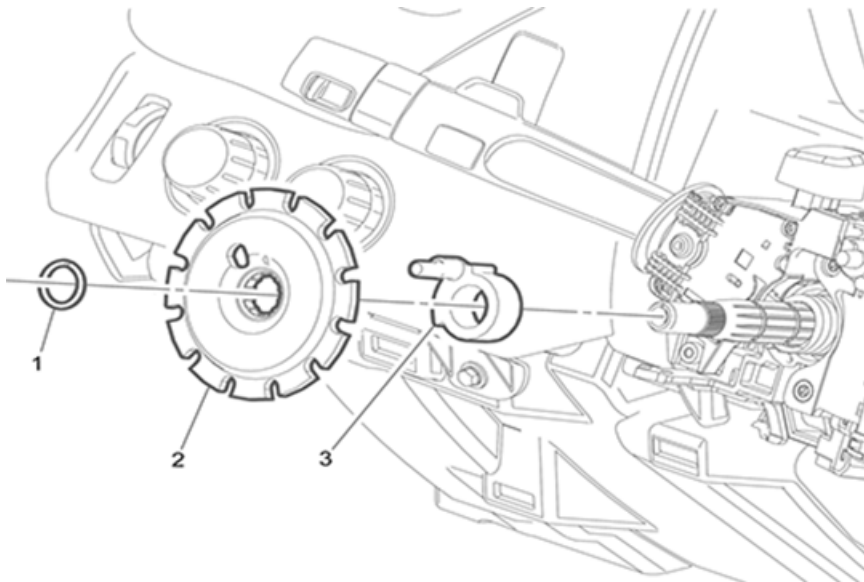
Some owners may comment on a pop, click, tick, snap, or itch type noise in the steering column when turning left or right during low speeds or parking maneuvers. Upon investigation, this concern may be similar to steering wheel to column trim contact, or similar to noise produced by a SIR coil with a damaged internal tape.

This noise could be caused by the upper column bearing race being slightly out of alignment.

1. Remove the steering column upper bearing inner race, spring seat, and spring from the column:

1.1 Remove the steering wheel from the column.

1.2 Remove the steering column lock plate ring (1), lock plate (2) and cancel cam (3) from the column.
