Customer Satisfaction Program

16147 Center High Mount Stop Lamp Water Leak

Reference Number: N162064340

Release Date: December 2016
Revision: 00

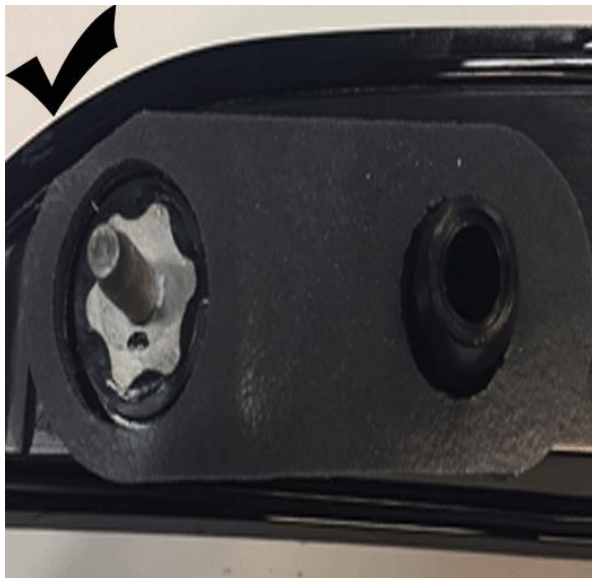
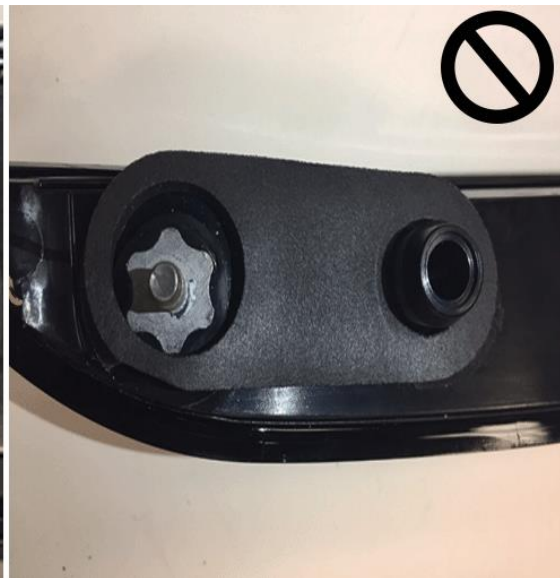
4641386

Caution: Make sure the gasket is centered and does NOT ride up the fastener joint. A water leak may occur if the gasket is not installed properly. Refer to the pictures above.

27. Remove the gaskets from the high mount stop lamp and DISCARD.
