# Service Bulletin

**Subject:** Convertible Top Difficult to Latch Closed

**Models:** 2013-2014 Chevrolet Camaro Convertible

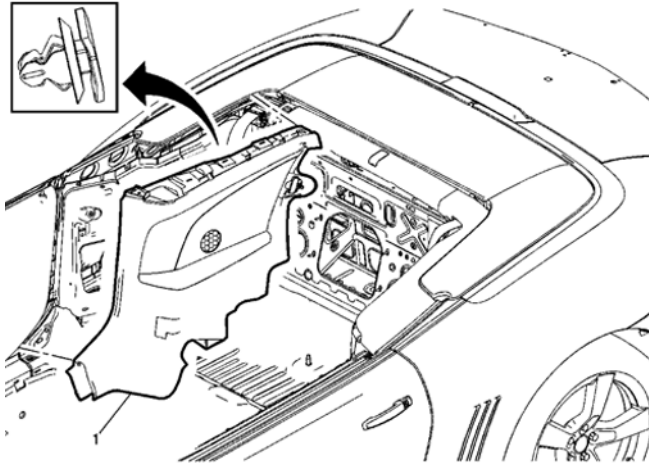
Adjust the body side folding top mounting brackets following the steps below:

1. Remove the rear seat cushion, the left/right quarter trim panels and related trim. Refer to Quarter Trim Panel Replacement (Convertible) in SI.
