# Service Bulletin

**Subject:** Information on Vibration Analysis and Diagnostic

**Models:** 2014 Chevrolet Silverado 1500  
 2015-2018 Chevrolet Silverado 1500  
 2014 GMC Sierra 1500  
 2015-2018 GMC Sierra 1500  
 EXCLUDES HD Trucks

*This PI has been revised to add 2018 Model Year. Please discard PI1354F.*

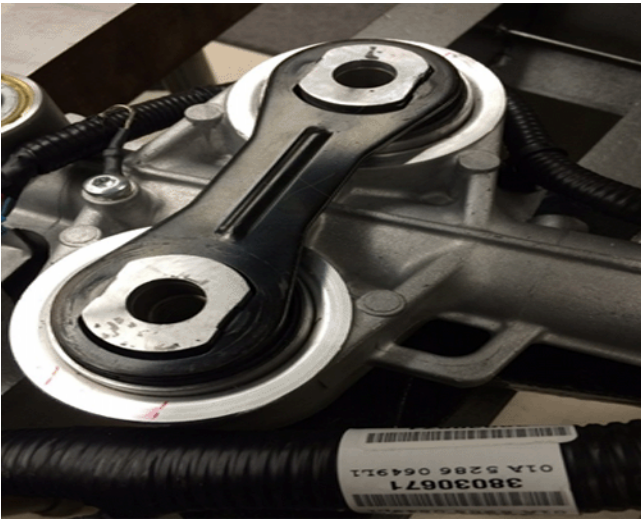
**Important:** *The following procedure should only be used after all tire issues have been corrected. Installation of revised steering bushing will have little to no effect on trucks that still have tire conditions. The T1 vibration must be reduced to under 20-25mg's for these bushings to be effective.*

*A revised steering bushing (2) has been released to address customer vibration concerns. After various testing and measurement of the T1 vibration, a vibration path from the tie rods =>steering rack=>steering bushings=>frame=>Body Mount=>Cabin Floor=>Seat has been identified. To help isolate the steering rack (1), a revised hydraulic bushing has been released and tuned to the T1 frequency. The new steering bushing dampens minor T1 vibrations. This is the reason that the causal part (normally the Tire/Wheel Assembly) must be corrected first. If the T1 vibration is over 20-25m/g's, the bushings will have little to no effect.*

For vehicles with T1 vibrations under 20-25m/g's, replace steering bushing per parts catalogue. Utilize SI procedure "Steering Gear Mount Bushing Replacement" for replacement of the steering bushings.

**Warning: Care must be taken to not damage the EPS Motor electrical connectors or gear replacement may be required.**

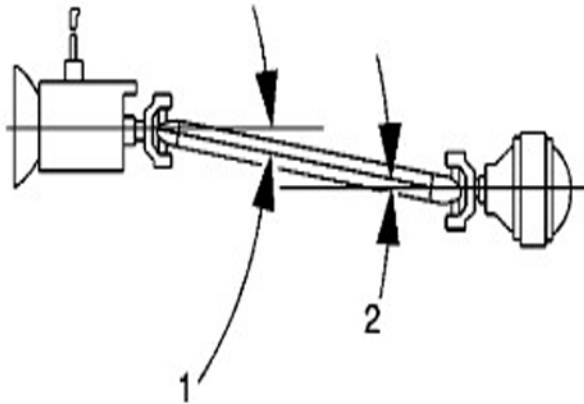
Measurement	Notes:
Yoke to Shaft		The first (forward most) U-joint action on a two piece driveshaft system is not canceled out by another U-joint. Because of this, the first U-joint working angle should be between 0.5 and 0.75 degrees.
Front Shaft to Center Support Bearing (if equip)		U-joint pairs cancel each other. Neither U-joint working angle should exceed 4 degrees, nor the allowable range of difference between cancelling U-joint working angles is 0.00 to 1.0 degrees.
Shaft to Diff Yoke

Propeller systems containing only 1 U-joint: The U-joint working angle should be between 1/2 and 3/4 degrees.

Allowable range of difference between cancelling U-joint working angles: 0.25 to 1.0 degrees.

1. Trucks were built prior to 1/1/2015 had a 14 mm spacers under the transfer case (4WD only). Starting with 1/1/2015. The shim was reduce to 7 mm shim which may correct the condition.
2. A 2 degree axle shim (P/N 23469809 – Qty 2) can be placed between the leaf spring pack and the axle perch. To rotate the pinion up to correct this; the “fat end” of the shim must face backwards, to the rear of the truck.

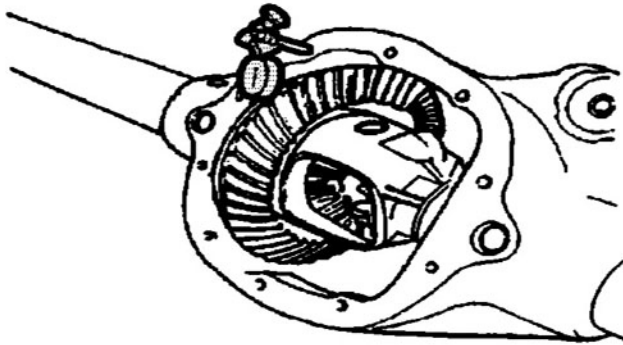
3. Pitchline runout – Pitchline runout will normally show as a 1st order tire vibration on the PicoScope. If after correcting tire(s) with excessive Road Force, a vibration exists, remove differential cover and check ring gear backlash. Every tooth should be checked for excessive backlash. If there is more than 0.0762 mm (0.003 in) of variation, the ring gear and/or differential should be replaced to correct the condition (SI Document ID# 3269088, 3620298) (PIP4148).

2. Install the J-25025 pins and the J-8001 indicator to the axle housing.

**Note:** Preload the dial of the J-8001-3 indicator approximately  $\frac{3}{4}$  of a turn and zero the gauge.
