Service Bulletin

Subject: Information on Vibration Analysis and Diagnostic

Models: 2014 Chevrolet Silverado 1500
 2015-2018 Chevrolet Silverado 1500
 2014 GMC Sierra 1500
 2015-2018 GMC Sierra 1500
 EXCLUDES HD Trucks

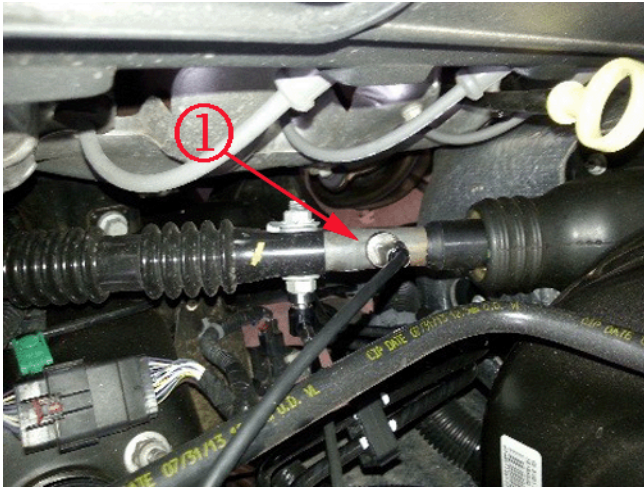
- Steering Wheel Vibration – mount the sensor to the steering wheel bracket (2) under dash.

Note: In some cases, moving the sensor from a vertical position to a horizontal position may indicate higher amplitude and may be beneficial to help in diagnosis.

4. This step should be only be used if the vibration can be felt while running the vehicle on the rack. Mount the sensor on the steering shaft (under the hood as illustrated above.
5. Measure the vibration. Typically trucks should be driven in M5 for 6 speed applications and M7 for 8 speed applications to keep the engine from switching in and out of active fuel management (AFM).

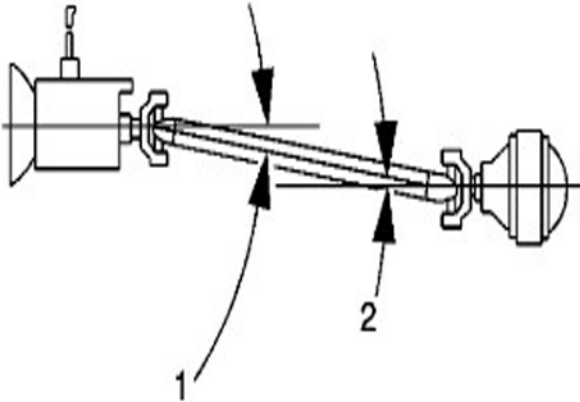
Measurement	Notes:
Yoke to Shaft		The first (forward most) U-joint action on a two piece driveshaft system is not canceled out by another U-joint. Because of this, the first U-joint working angle should be between 0.5 and 0.75 degrees.
Front Shaft to Center Support Bearing (if equip)		U-joint pairs cancel each other. Neither U-joint working angle should exceed 4 degrees, nor the allowable range of difference between cancelling U-joint working angles is 0.00 to 1.0 degrees.
Shaft to Diff Yoke

Propeller systems containing only 1 U-joint: The U-joint working angle should be between 1/2 and 3/4 degrees.

Allowable range of difference between cancelling U-joint working angles: 0.25 to 1.0 degrees.

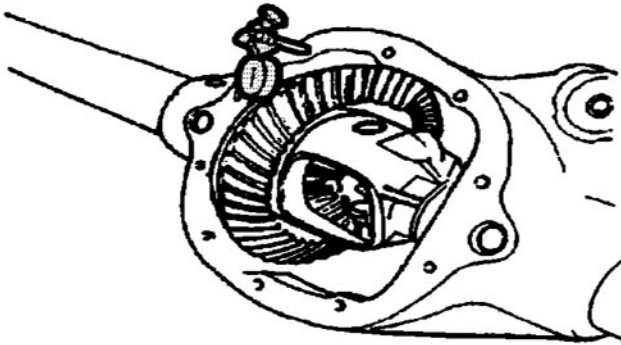
- Ensure that the side bearing surfaces in the axle housing are clean and free of burrs. If the original bearings are to be reused, the original bearing cups must also be used.
 - The differential side bearings must be initially preloaded in order to determine the backlash of the gear set. After the backlash is set, the final bearing preload is set.
 - Mark the bearing caps left or right sides.
1. Measure the rotating torque of the drive pinion and differential assembly. Refer to the Differential Drive Pinion Gear Bearing Replacement i SI.

2. Install the J-25025 pins and the J-8001 indicator to the axle housing.

Note: Preload the dial of the J-8001-3 indicator approximately $\frac{3}{4}$ of a turn and zero the gauge.
