Service Bulletin

Bulletin No.: 17-NA-384

Subject: Squeak, Rattle or Creak Coming from Second Row/Rear Seat Area

Brand:	Model:	Model Year:		VIN:		Engine:	Transmission:
		from	to	from	to		
Cadillac	XT5	2017	2018	SOP 2017	July 17, 2017	All	All
GMC	Acadia (VIN N)

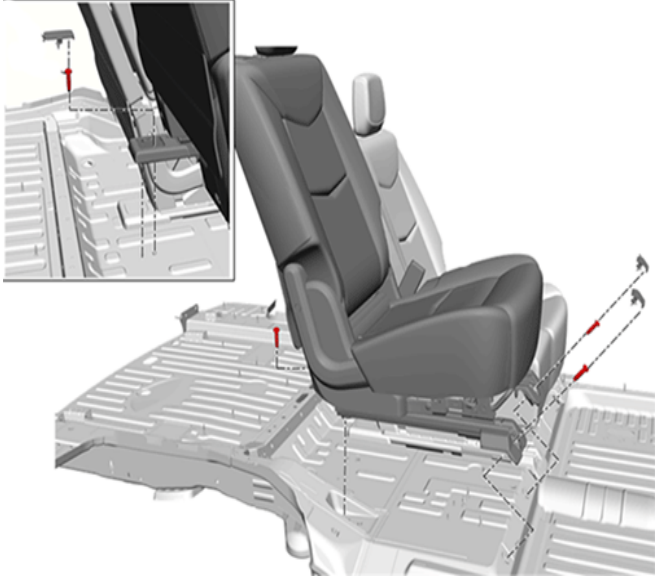
4911776

1. Remove the right rear seat. Refer to *Rear Seat Removal and Installation (40%)*, in SI, and also follow the seat attachment bolts removal sequence detailed below:
 - 1.1. Adjust the seat to full rearward position.
 - 1.2. Loosen the outboard front attachment bolt, then the inboard bolt.
 - 1.3. Adjust the seat to full forward position.
- Note:** It is important that the tracks remain locked until both rear bolts are re-torqued.
- 1.4. Ensure that both seat tracks are locked.
 - 1.5. Loosen the outboard rear attachment bolt, then the inboard bolt.
2. For vehicles built **prior to May 15, 2017**, inspect
