## SERVICE BULLETIN

**APPLICABILITY:** 2013-14MY Legacy and Outback Models with 2.5L FB Engines  
 2011-14MY Forester Models with 2.5L FB Engines  
 2015 MY Forester (Manual Transmissions Only) with 2.5L FB Engines  
 2012-13 MY Impreza and XV Crosstrek Models with 2.0 FB Engines  
 2014-15 MY Impreza and XV Crosstrek Models (Manual Transmissions Only) with 2.0 FB Engines

**NUMBER:** 02-157-14R

**SUBJECT:** Engine Oil Consumption

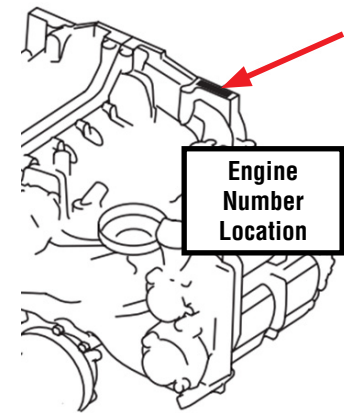
**\* NOTE:** When determining the engine number, use the **LAST 8** characters of the number stamped into the boss on top of the block adjacent to the starter and shown in the illustration. The engine number range for the FA1 assembly line is 800000 to 930025 and the FB2 range is 000000 to 652640.

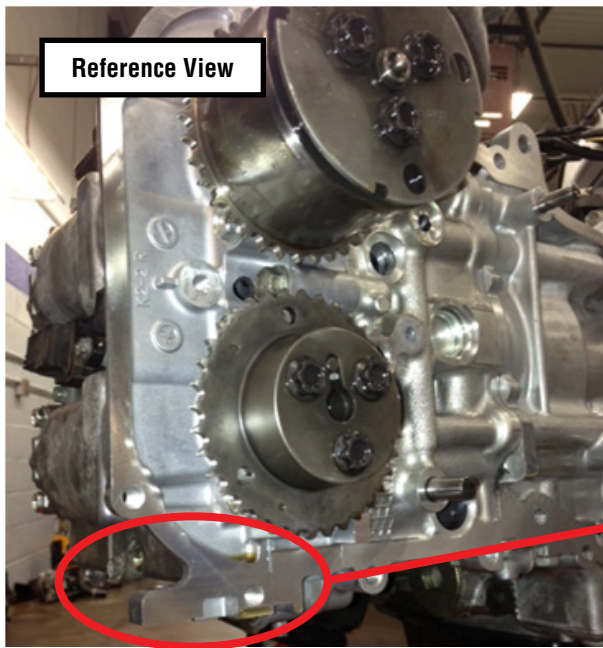
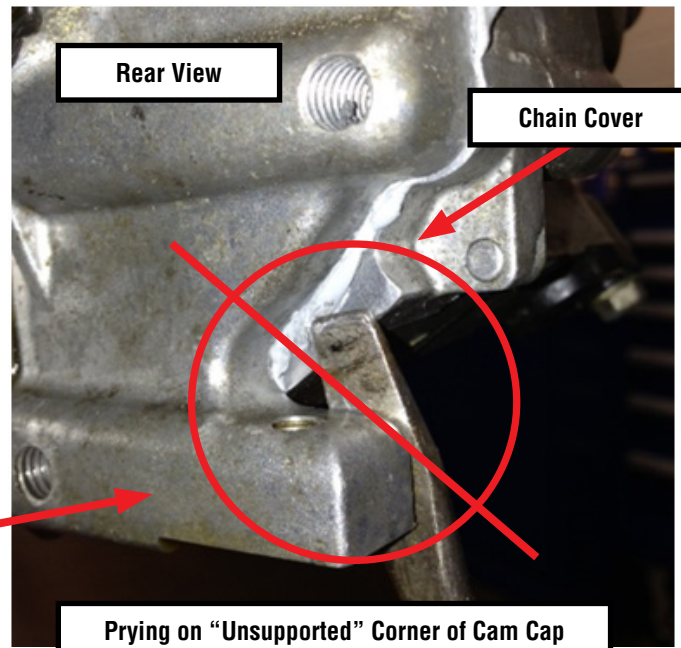
Reference View

- IMPORTANT:** After all 32 bolts securing the chain cover are removed, be **EXTREMELY** careful where you pry and what you pry on to break the silicone sealant's bond. The photos below show an example of where **NOT** to pry. In this case, the cam cap became cracked requiring a complete cam carrier replacement. *Patience is the key!*
