# Service Bulletin

Bulletin No.: PI1354I

**Subject:** Information on Vibration Analysis and Diagnostic

**Models:** 2014 Chevrolet Silverado 1500  
2015-2018 Chevrolet Silverado 1500  
2019 Chevrolet Silverado LD \*  
2014 GMC Sierra 1500  
2015-2018 GMC Sierra 1500  
2019 GMC Sierra Limited \*  
EXCLUDES HD Trucks

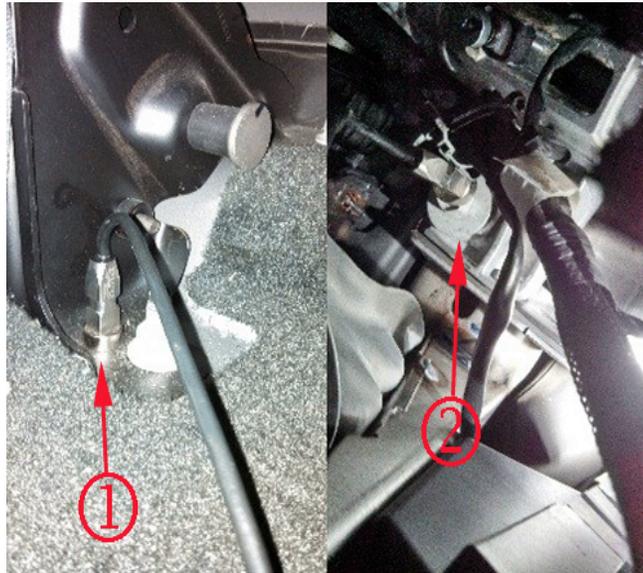
4002206

3. Using a Pico Oscilloscope Diagnostic Kit, mount the PicoScope vibration sensor on one of the two locations shown above.

- Seat Vibration – mount the sensor to the front right corner of the driver's seat bracket (1).
- Steering Wheel Vibration – mount the sensor to the steering wheel bracket (2) under dash.

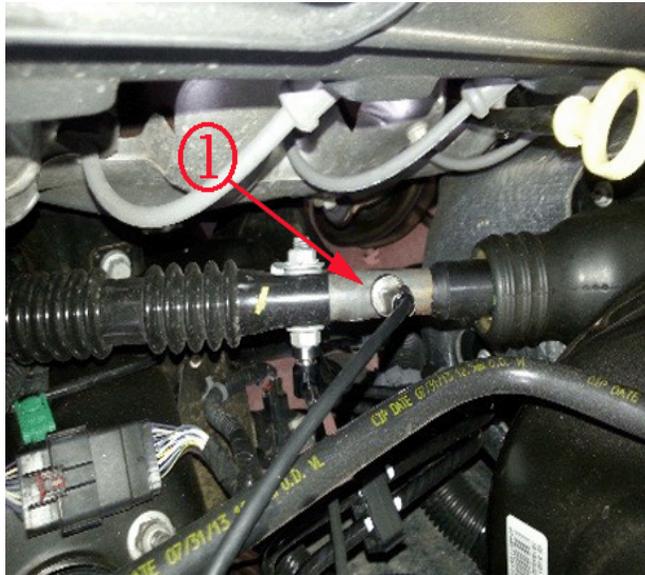
4002212

4. This step should be only be used if the vibration can be felt while running the vehicle on the rack. Mount the sensor on the steering shaft (1), under the hood as illustrated above.
5. Measure the vibration. Typically trucks should be driven in M5 for 6 speed applications and M7 for 8 speed applications to keep the engine from switching in and out of active fuel management (AFM).

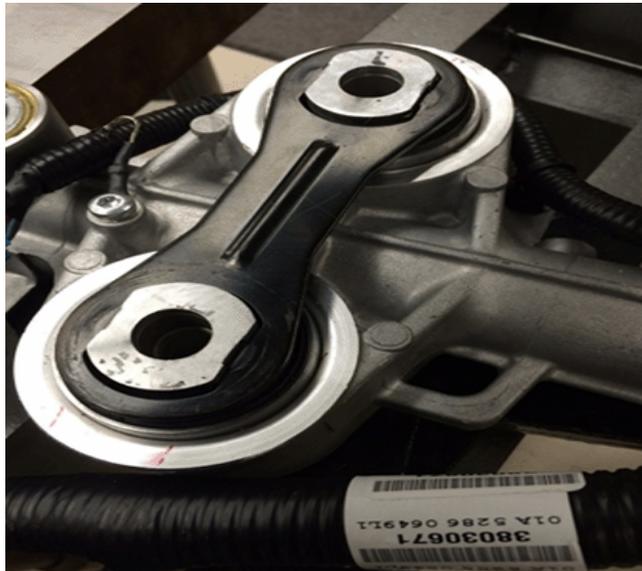
4728689

*A revised steering bushing (2) has been released to address customer vibration concerns. After various testing and measurement of the T1 vibration, a vibration path from the tie rods =>steering rack=>steering bushings=>frame=>Body Mount=>Cabin Floor=>Seat has been identified. To help isolate the steering rack (1), a revised hydraulic bushing has been released and tuned to the T1 frequency. The new steering bushing dampens minor T1 vibrations. This is the reason that the causal part (normally the Tire/Wheel Assembly) must be corrected first. If the T1 vibration is over 20-25m/g's, the bushings will have little to no effect.*

*For vehicles with T1 vibrations under 20-25m/g's, replace steering bushing per parts catalogue. Utilize SI procedure "Steering Gear Mount Bushing Replacement" for replacement of the steering bushings.*

**Warning:** Care must be taken to not damage the EPS Motor electrical connectors or gear replacement may be required.

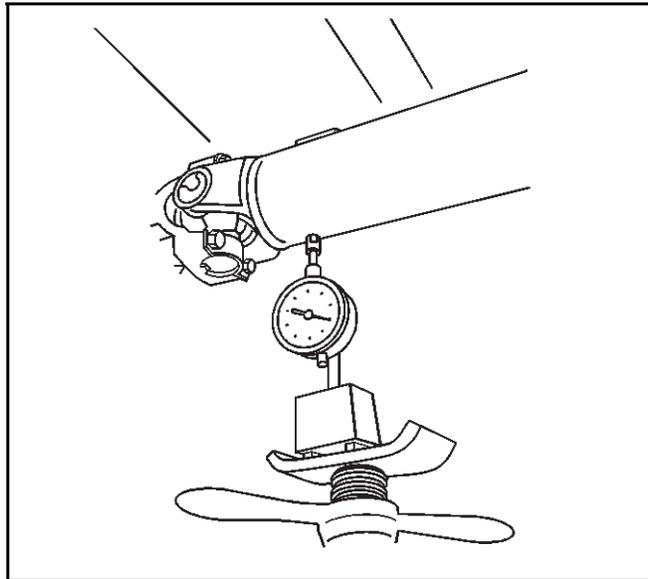
734521

5. Mount the GE-7872 Magnetic Base Dial Indicator Set, or equivalent, or the GE-8001 Dial Indicator Set, or equivalent, to the vehicle underbody or to a service stand positioned just clear of the U-joint yoke weld on the prop shaft.

9. Perform step six again.
10. If the high spot of the propeller shaft is in the same location as marked in the previous step and the measurement exceeds the maximum prop shaft runout specified, the prop shaft requires replacement before proceeding.

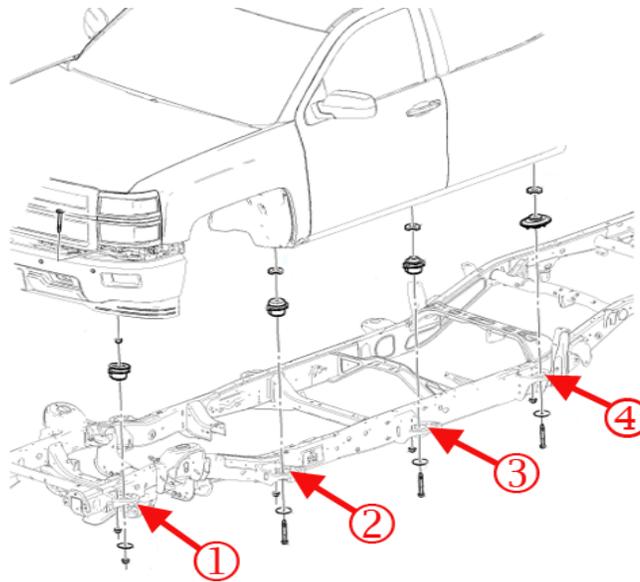
3996982

The numbers in the picture below indicate the specific mount position. The mounts on the passenger side of the vehicle are identified the same way. This will assist the technician to identify the correct location of each mount so they can be torque to the proper specification.

- 1 = body mount cushion front
  - 2 = body mount cushion position number 1
  - 3 = body mount cushion position number 2
  - 4 = body mount cushion position number 3
3. Pitchline runout – Pitchline runout will normally show as a 1st order tire vibration on the PicoScope. If after correcting tire(s) with excessive Road Force, a vibration exists, remove differential cover and check ring gear backlash. Every tooth should be checked for excessive backlash. If there is more than 0.0762 mm (0.003 in) of variation, the ring gear and/or differential should be replaced to correct the condition (SI Document ID# 3269088, 3620298) (PIP4148).

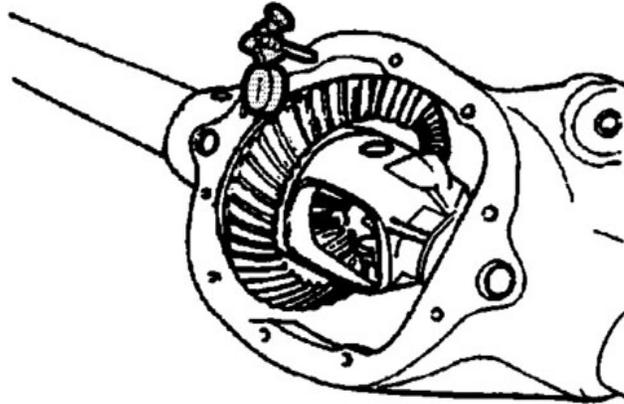
4002891

2. Install the J-25025 pins and the J-8001 indicator to the axle housing.

**Note:** Preload the dial of the J-8001-3 indicator approximately  $\frac{3}{4}$  of a turn and zero the gauge.

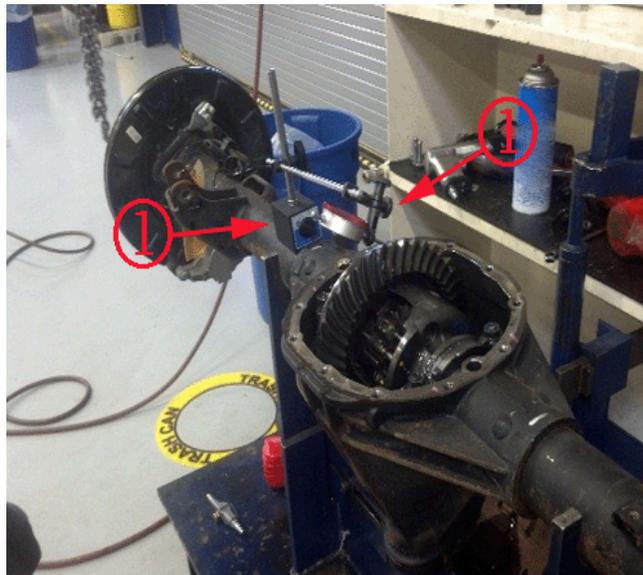
4002895

**Note:** The illustration above is for reference only. The differential does NOT need to be removed from the vehicle.

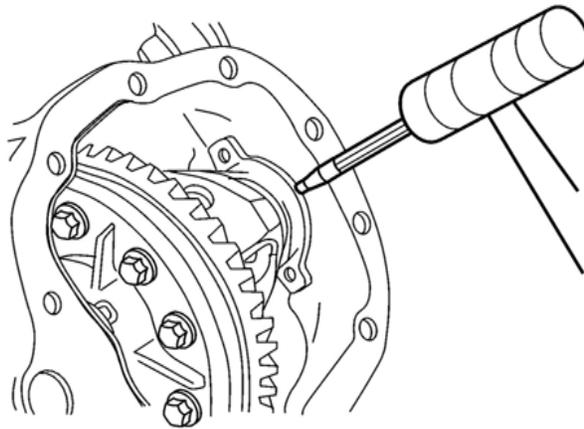
4002981

13. Install the left side service shims between the axle housing and the differential case.

14. Install the right side service shims between the axle housing and the differential case.

**Note:** The service spacers must be installed between the service shim(s) and the axle housing.
