TECHNICAL SERVICE BULLETIN

Technical Service Bulletin: 225-0970

Forest River is alerting you to an issue involving certain 2018 through 2019 – Crossfit – CFB22CF, CFB22CFEB, CFB22CFEBCA, CFB22DF, CFB22DFEB Class B motorhome recreational vehicles. Please see the information below which describes the issue and provides you with details on the steps you should take to have your vehicle repaired.

CORRECT INSTALLATION VALIDATION PROCEDURE • 02/19/2019

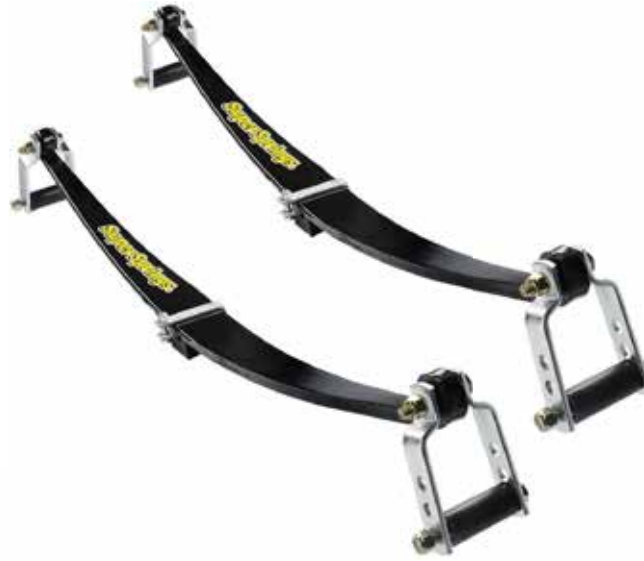
It has been reported that the SuperSprings may interfere with the Ford Transit 350 vehicle chassis rear factory spring hanger when incorrectly installed. This interference can result in a mechanical noise when fully loaded and hitting a severe pothole or speed bump.

To ensure proper positioning, the measurement of space between the front of the SuperSprings and the rear of the vehicle front spring eye is necessary. This dimension should be no less than 3.00" and must not exceed 3.5" (SEE IMAGE 1). If the measurement is within this range, then no further action is required. If this measurement is outside of this range then corrective action is required – refer to:

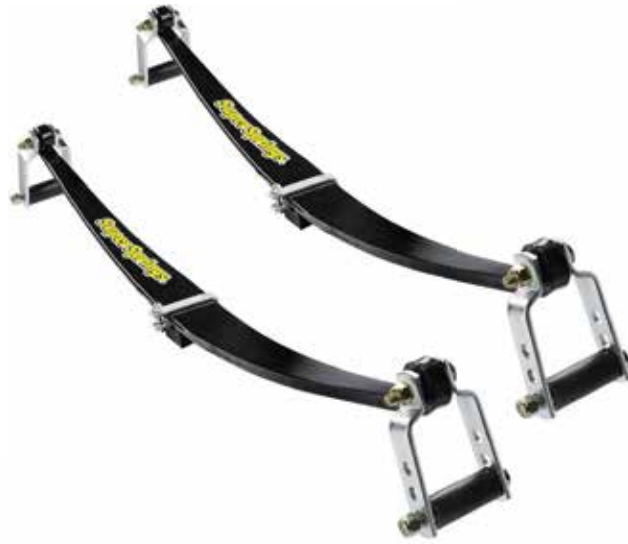
INSTALLATION CORRECTIVE PROCEDURE • 02/19/2019

If the SuperSprings are not positioned correctly, this corrective procedure is required. To confirm the installation is correct or needs correction – refer to:

- A. Using a ½" wrench and socket loosen the attaching bolt on the poly spring pad lock down clamp located at the center of the SuperSprings. Do not remove hardware. (SEE IMAGE A)
- B. Place a pry bar behind the rear of the SuperSprings with the end against the cross member. (SEE IMAGE B)

- C. Push the SuperSprings forward with the pry bar to obtain a measurement of 3" to 3.5" between the front of the SuperSprings and the rear of the vehicle front spring eye. (SEE IMAGE C1 AND C2)
 - D. Using a ½" wrench and socket retighten the attaching bolt on the poly spring pad lock down clamp located at the center of the SuperSprings originally loosened during step 3-A.
4. Repeat the same process on the other side if necessary.
 5. **LOWER THE VEHICLE**
Jack up the vehicle, remove the jack stands, and then lower the vehicle to the ground. Remove the blocks from front and rear of the front wheels.
