Service Bulletin

Bulletin No.: 00-06-01-012H

Date: September, 2017

Subject: Use of "Surface Conditioning Disks" When Cleaning Gasket Sealing Surfaces and/or Reused Parts

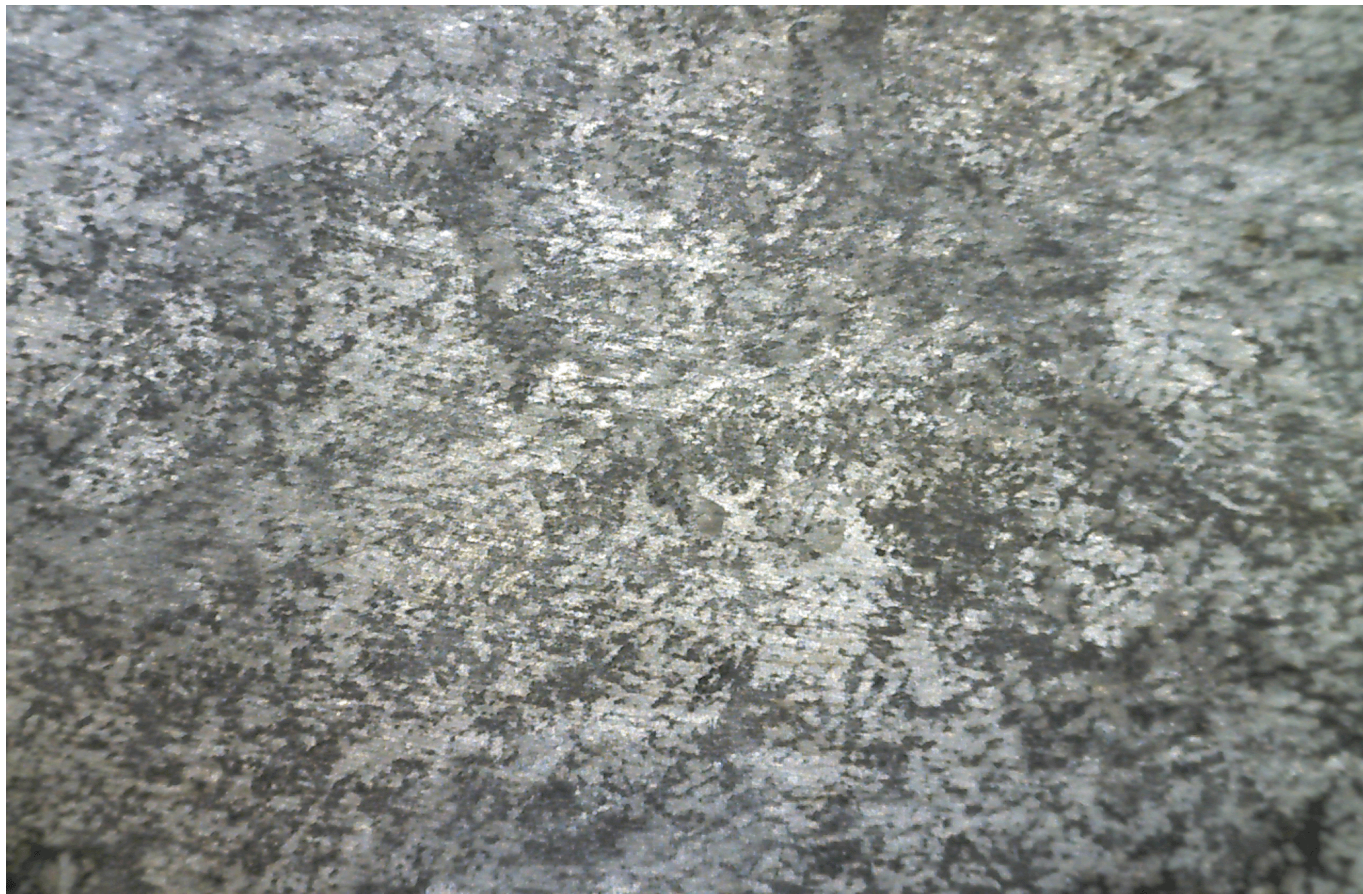
4791153

A close up of the sealing surface after cleaned with GM Low VOC Cleaner and plastic scraper.

To properly clean the sealing surface prior to reassembly, GM Low VOC Cleaner, P/N♦19287401 (in Canada, P/N 88901247), should be sprayed on the mating surface. Use care to avoid getting solvent in any area other than the mating surface to be cleaned. Allow it to soak in for several minutes to loosen the old RTV sealer/gasket material. GM strongly recommends using a plastic razor blade or non-metallic scraper to remove all loose sealer/gasket material.
