Service Bulletin

Bulletin No.: 12-08-51-002G

Subject: Spray-in Bed Liner General Information and Repair Procedures

Models: 2013-2014 Chevrolet Silverado HD 2500/3500 Series

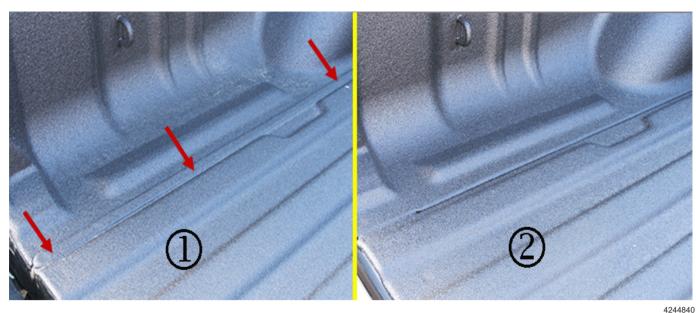
The photos below show the areas that are covered by the spray-in bed liner. These should be used as a guideline when making any repairs or answering customer questions concerning bed liner coverage areas.
