ARTICLES CONTAINED IN THIS ISSUE

07 2019MY FORESTER, DRIVER MONITORING SYSTEM (DMS) INOPERATIVE B2632 B2642

11 SECONDARY AIR INJECTION DIAGNOSTIC TROUBLE CODES P2441 AND P2442

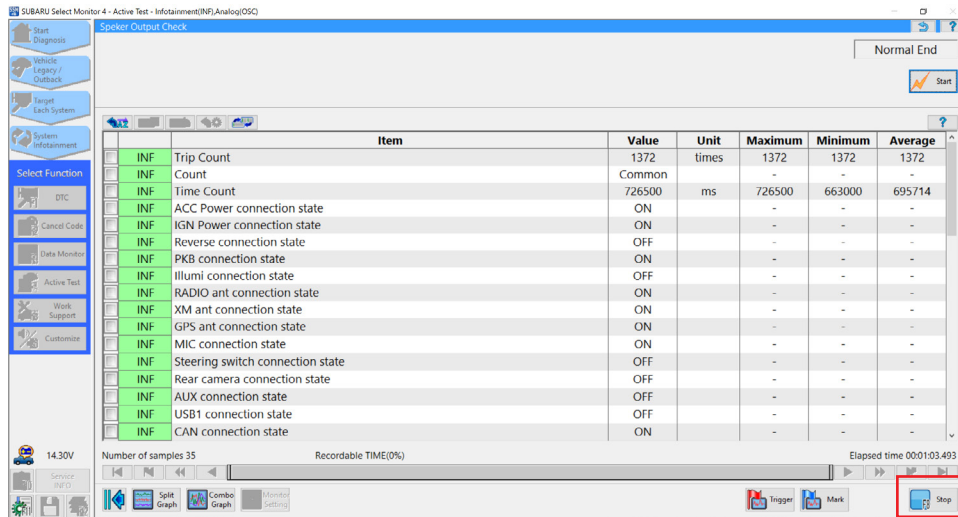
When performing the Speaker Output Check Active Test with SSM, there is possibility the SSM cannot stop the test. If you encounter this scenario follow the directions below to end the test.

1. Press the “Stop” Button in the right lower part on the Active test screen. (If this procedure isn’t performed, you may not perform step 2 since the volume screen continues to be displayed on the Head Unit display)
