PRODUCT CAMPAIGN BULLETIN

<p>APPLICABILITY: 2010-2014 model year Legacy 2010-2014 model year Outback 2010-2013 model year Forester 2010-2014 model year Tribeca 2010-2011 model year Impreza 2010-2014 model year WRX and STI</p> <p>SUBJECT: Takata Front Passenger Airbag Inflator Replacement (2019 Calendar year expansion)</p>	<p>NUMBERS: TKA-19 TKB-19 TKC-19</p> <p>DATE: 01/14/19</p> <p>REVISED: 03/19/19</p> <p>NHTSA ID: 19V-007 19V-008 19V-009</p>
-------------------------------------------------------------------------------------------------------------------------------------------------------------------------------------------------------------------------------------------------------------------------------------------------------------------------------------------------------------------------------------------------------	--------------------------------------------------------------------------------------------------------------------------------------------------------------------------------------------------------------

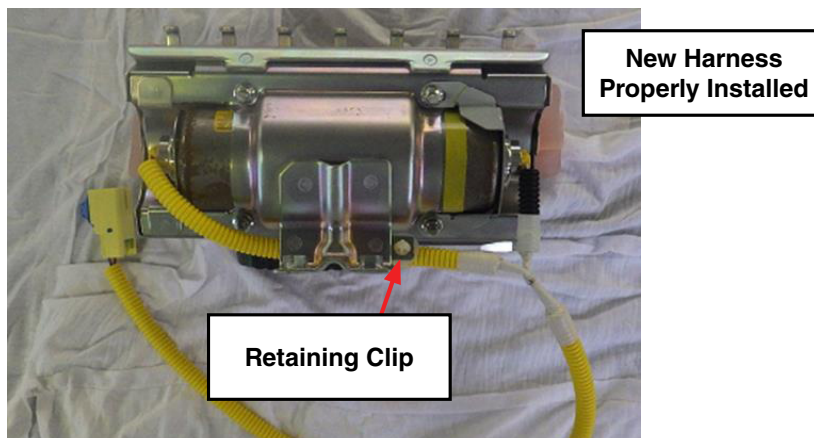
VERY IMPORTANT: When connecting the new harness to the inflator, both sides MUST be routed and the retaining clip installed as shown in the "New Harness Properly Installed" photo below.

CAREFULLY align the pins of the inflator with the female terminals of the harness connector (red / yellow wires) as shown in the photos below. Once pin alignment is confirmed, push down firmly to engage the connector's 3 locking tangs into the locking groove inside the connector boss. Confirm the connector is locked by prying up **LIGHTLY** with a small flat-blade screwdriver. Repeat the procedure on the opposite "short" side with the blue / white wires.
