Technical Journal

Panoramic roof hard to open/close

REF NO: TJ 34477.1.0	ISSUING DEPARTMENT: Technical Service	CAR MARKET: United States and Canada	
PARTNER: 3 US 7510 Volvo Car USA		ISSUE DATE: 2019-05-15	STATUS DATE: 2019-05-28
FUNC GROUP: 8360	FUNC DESC: Roof hatch	Page 1 of 8

TJ Instruction VCC-516847-1

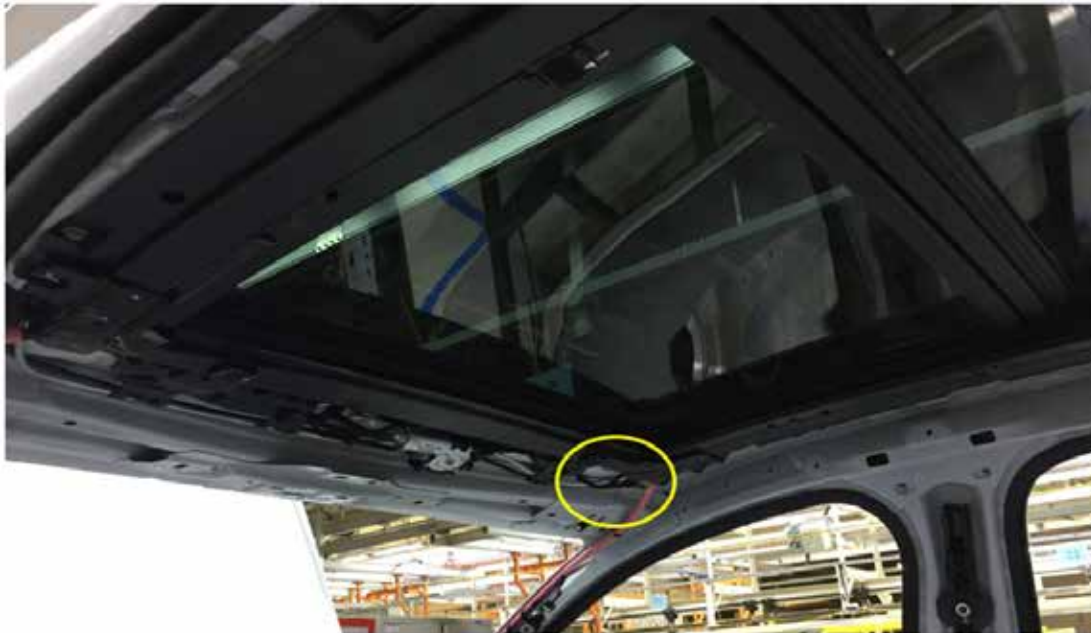
TJ 34477

B) Check the routing of the sunroof harness located in the right front corner [Harness I.PNG](#), if it's routed according to [Harness II.PNG](#), check if the harness is damaged as shown in [Damaged Harness.PNG](#). The damaged harness should be repaired with spare parts according to VIDA (VCC-389589-2). After the wiring repair, reroute the harness correctly [Harness III.PNG](#).
