SERVICE BULLETIN

APPLICABILITY: 2015-2017MY Legacy and Outback
2015-2017MY WRX

NUMBER: 04-17-17R

SUBJECT: Rattling Sound from EPS Gear Box

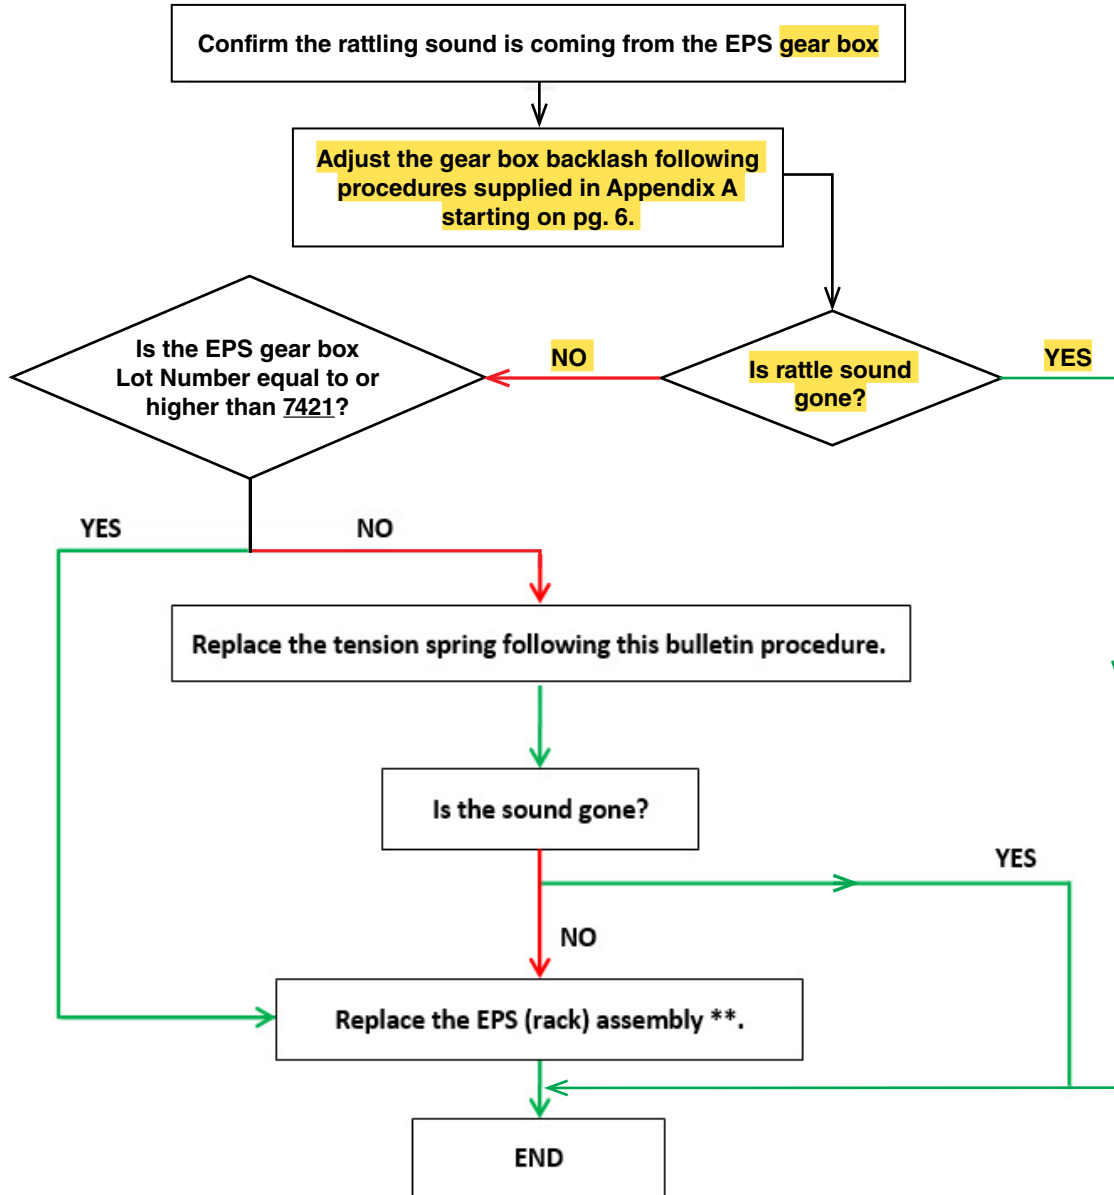
Use the following flow chart when diagnosing a steering rattle sound concern on the applicable vehicles specified above:
