Service Bulletin

Bulletin No.: 18-NA-217

Subject: Cruise Control Inoperative, Malfunction Indicator Lamp (MIL) Illuminated - DTCs P0097, P00F4, P0102 and/or P2199 Set

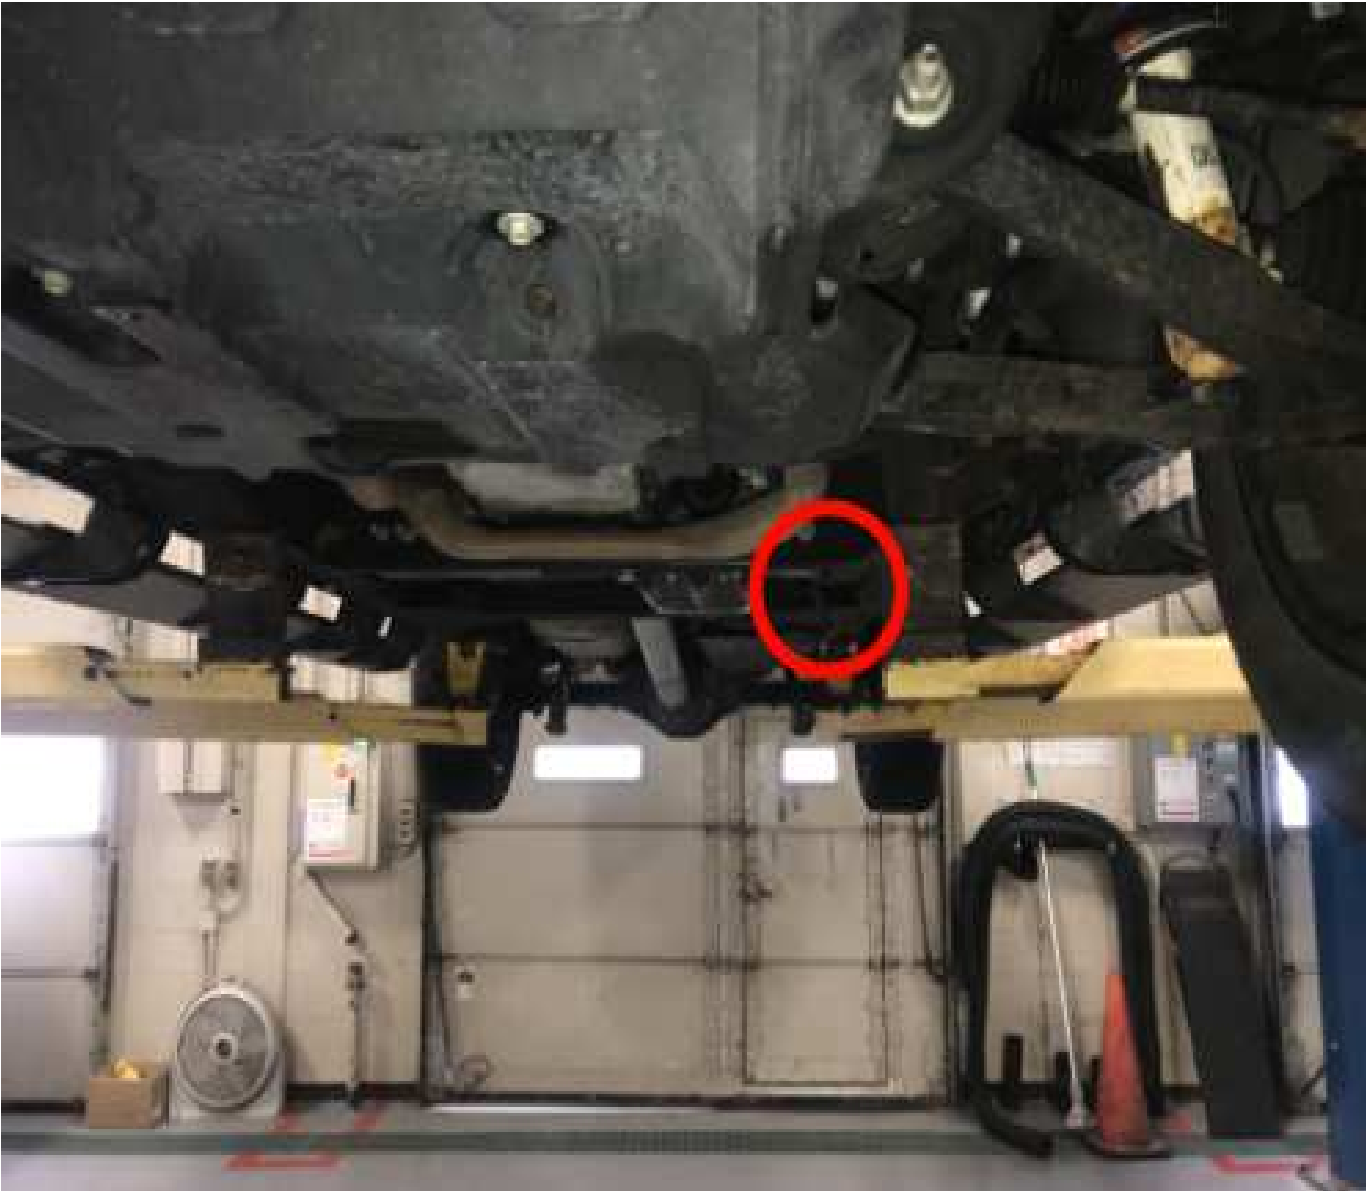
1. Raise the vehicle.
2. With a suitable light, inspect the wiring harness.
Located along driver's side frame rail near electronic brake control module.
