Service Alert

2019 MAZDA3 SERVICE CAUTIONS FOR NEW AND REVISED FEATURES

Service Alert No.: SA-010/19

Last Issued: 06/13/2019

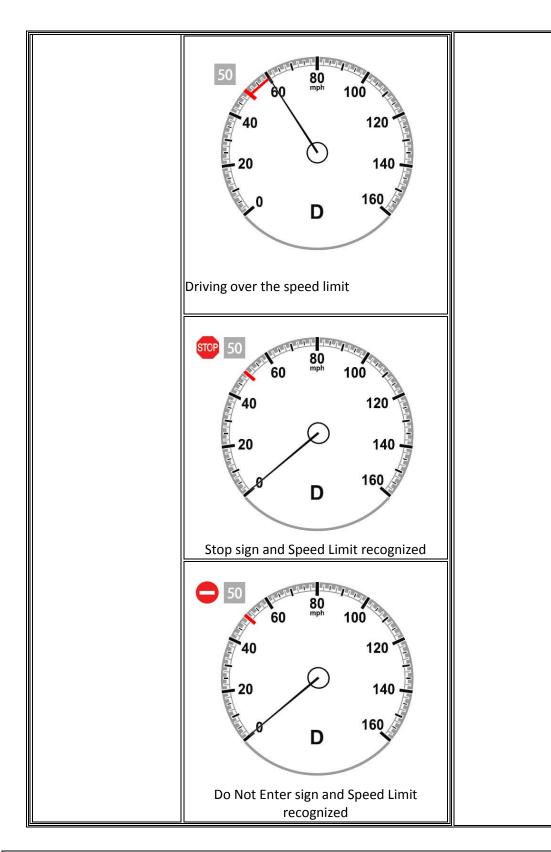
Traffic Sign Recognition (TSR) *

- 1. TSR function is only available with a dealer installed in-vehicle navigation system accessory.
- 2. TSR function requires Forward Sensing Camera (FSC) recognition or navigation SD card map data when the vehicle is driven.**
- 3. TSR function is not displayed in the Active Driving Display.
- TSR function is disabled when Apple CarPlay[™] or Android Auto[™] is connected.

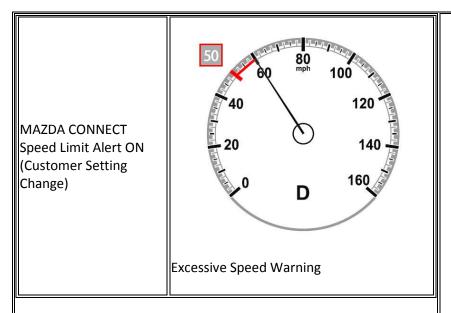
MAZDA CONNECT Speed Limit Alert Customer Settings

- 1. Speed Limit Alert Settings
 - 1. OFF
 - 2. Visual
 - 3. Visual + Audible
- 2. Speed Limit Alert Threshold
 - 1. 0 mph
 - 2. +5 mph
 - 3. +10 mph
- ** SD Card maps may contain information about the speed limits of the roads. The navigation system is able to warn driver if they exceed the current limit. This information may not be available in some areas or may not be fully correct for all roads on the map.
