SERVICE BULLETIN

APPLICABILITY: 2015-2018MY Legacy and Outback

"Popping" or "Snapping" Sound When

NUMBER: 12-246-18R

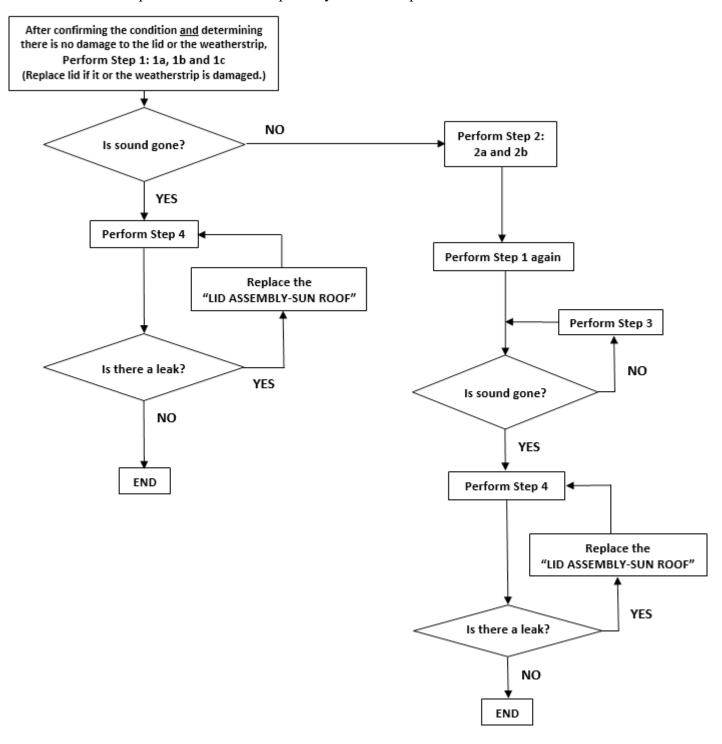
This bulletin provides a procedure for diagnosing and repairing customer concerns of a "popping" or "snapping" -type sound heard when opening the sunroof. The sound may occur when the rear portion of the glass lid weatherstrip contacts or catches the roof frame when the sunroof is opened.

A flow chart is provided below to help clarify the service procedure.

Step 1: Adjust the lid forward to reduce chances of the weatherstrip sticking or catching the edge of the sunroof opening in the roof panel or the sunroof frame. This can cause the snapping sound and / or damage to the weatherstrip / seal..

Step 3: If the condition persists, remove the lid and check the operation of the cable guides. If inspection reveals any uneven movement, adjust or if necessary, replace the affected "CABLE-GUIDE ASSEMBLY RIGHT/LEFT" following the procedure outlined in the applicable Service Manual.

Step 4: Leak testing
