Service Bulletin

Bulletin No.: 17-NA-258

Subject: Excessive Wind Noise from Front Side Door Glass Area

Brand:	Model:	Model Year:		VIN:		Engine:	Transmission:
		from	to	from	to		
Chevrolet GMC	Silverado 1500 Sierra 1500	2014	2014			All	All
	Chevrolet GMC	Silverado Sierra	2015

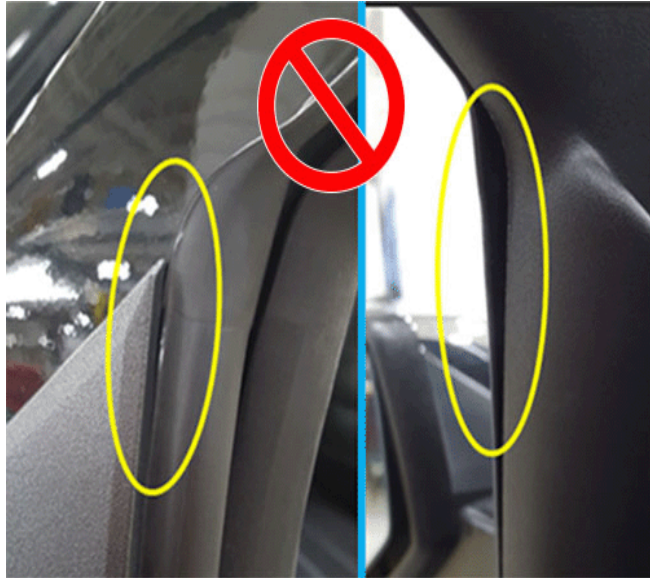
4846275

- Improper front side door fit to roof.

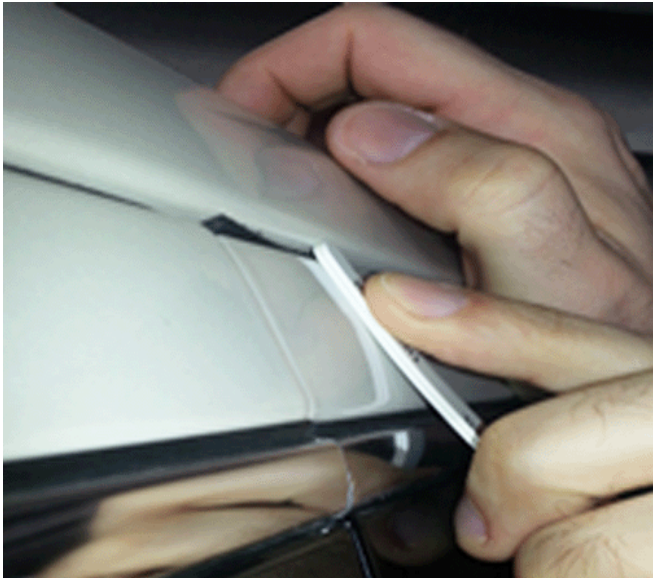
3806384

Note: These vehicle models use an inlay door construction, with the door fitting sub-flush to the body header by 1-2 mm (0.040–0.080 in).

1. At the two locations (1) shown in the illustration above, inspect the front door fit as to meeting the suggested 1-2 mm (0.40–0.80 in) sub-flush dimension.
 - If the door fit meets the sub-flush specification, no door adjustment is necessary and you can jump ahead to step #4.
 - If the door fit DOES NOT meet the sub-flush specification, continue to step #2 to start the door adjustment.

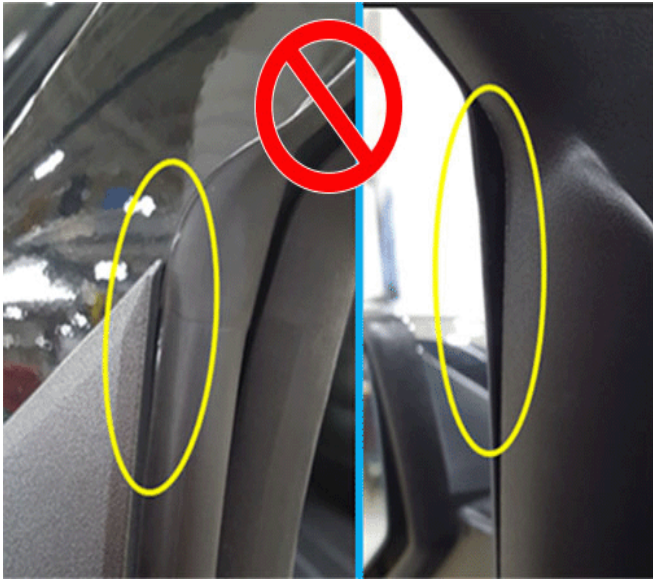
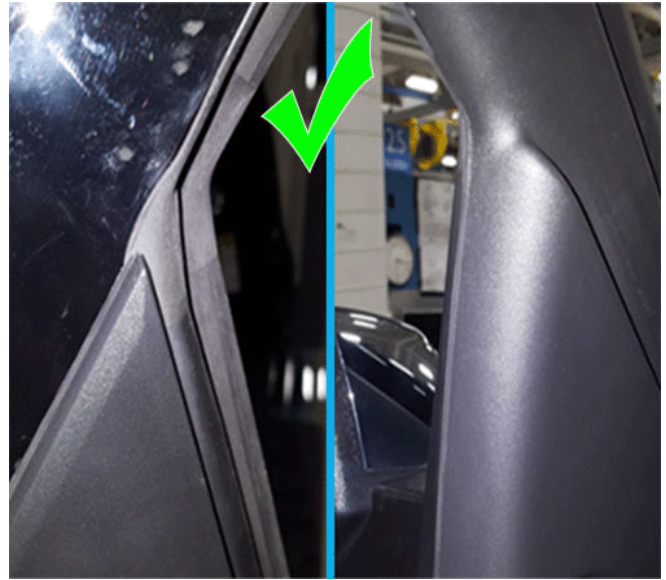
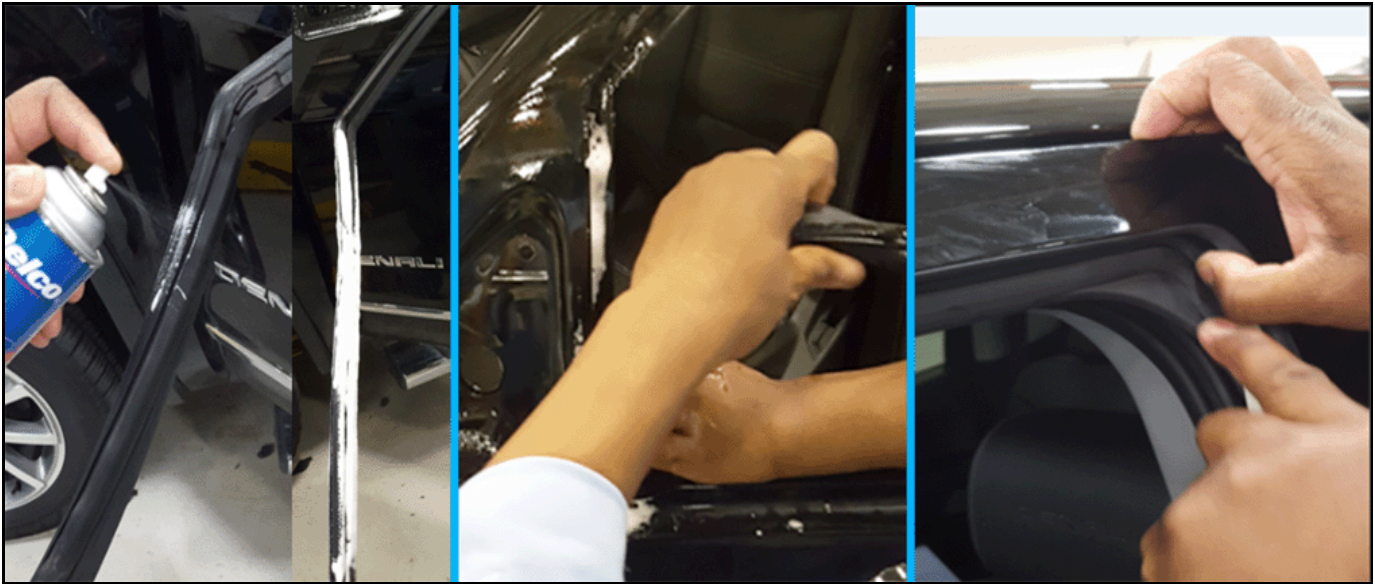
Note: The graphics below are “before and after” examples which help show the proper positioning of the front door window weatherstrip.

Important: The last example above shows the front, upper corner of the weatherstrip installed too high and well out of position. The feature line (shown circled) should be located down at the center-line of the metal notch.
