SERVICE BULLETIN

APPLICABILITY: 2019-20MY Ascent
SUBJECT: Hood Panel Vibration

NUMBER: 12-281-20
DATE: 02/19/20

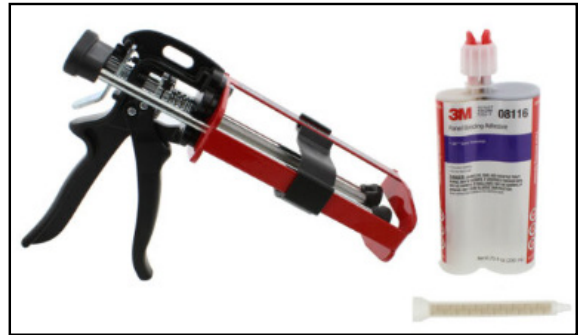
This bulletin provides a repair procedure to address a small number of customer concerns of the hood panel surface vibrating while driving. This condition can result if the mastic (adhesive) used to bond the inner hood reinforcing panel to the outer panel (skin) begins to separate.

- 3M Panel Bonding Adhesive #08116 (200ml tube)
- 3M Mixing Nozzles #08193
- 3M Applicator #08571
- A 25 x 50 x 5mm (1" x 2" x .200 thick) non-metallic (plastic or wood) spacer with rounded edges
- Alcohol wipes (or isopropyl alcohol)
- Clean Shop Cloths
- Qty. 8: 90814FC001 Hood Insulation clips
