Service Bulletin

Bulletin No.: 20-NA-071

Subject: Service Engine Soon Lamp Illuminated and/or Service Power Brake Assist Message Displayed, with DTCs P0557 or P0558 Stored

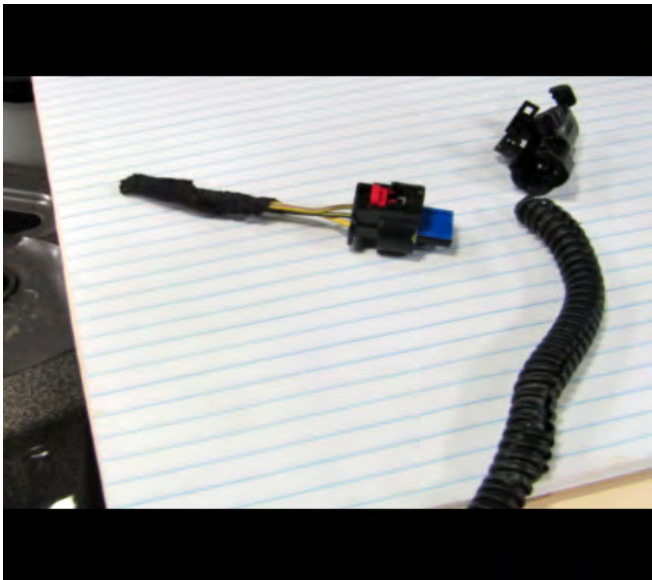
5549619

Note: The top graphic shows the LGX connector intact; the bottom one shows the LFY wiring already cut.

2. Locate the power brake booster vacuum sensor electrical connector. Fold conduit back and cut off connector, leaving approximately 5.0 cm (2.0 in) of wiring on the engine harness side.
3. Tape the cut wiring end to the engine harness. These wires will no longer be used.

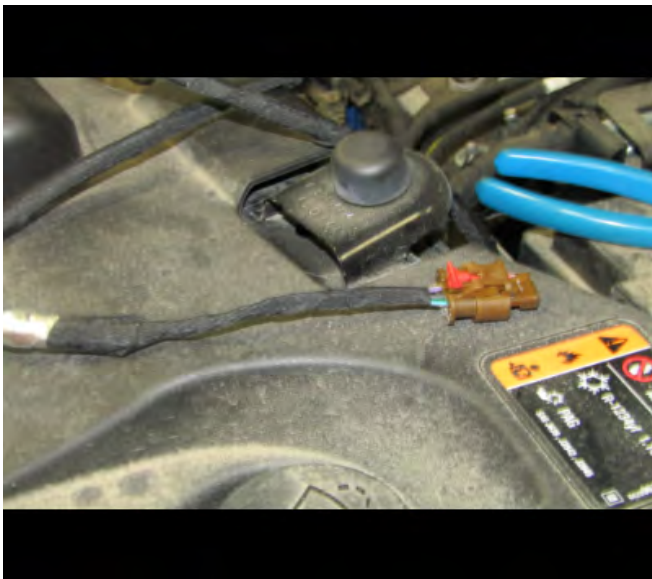
5549620

Note: Not all applications will have a cover on the connector.

4. Remove conduit and cover from the old connector.

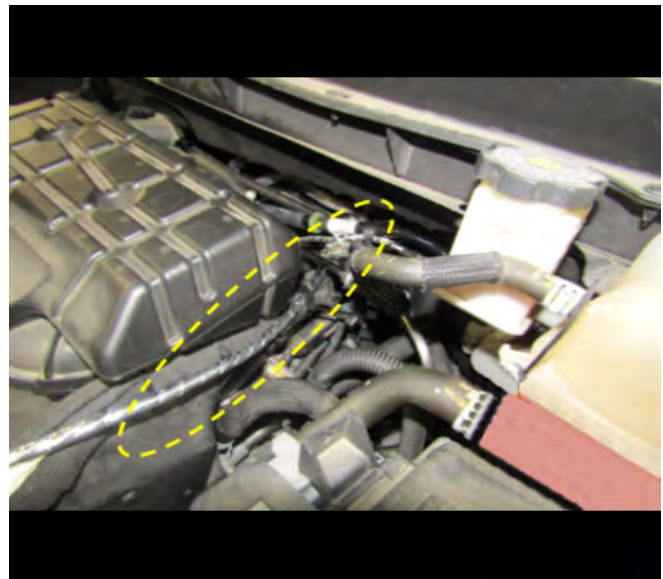
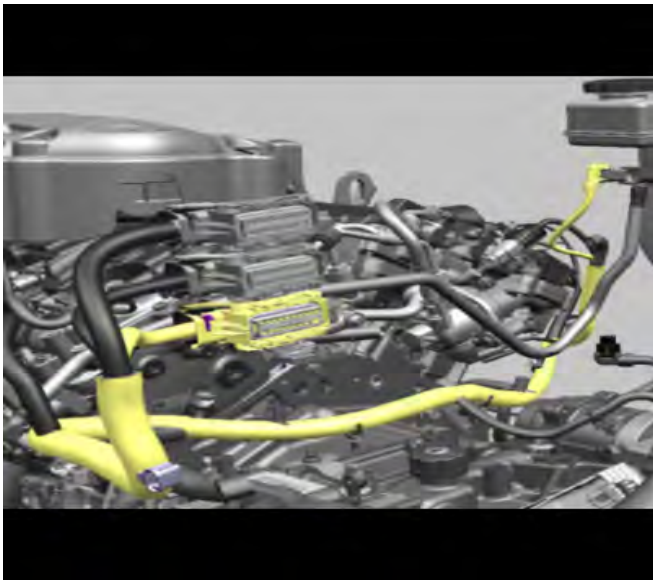
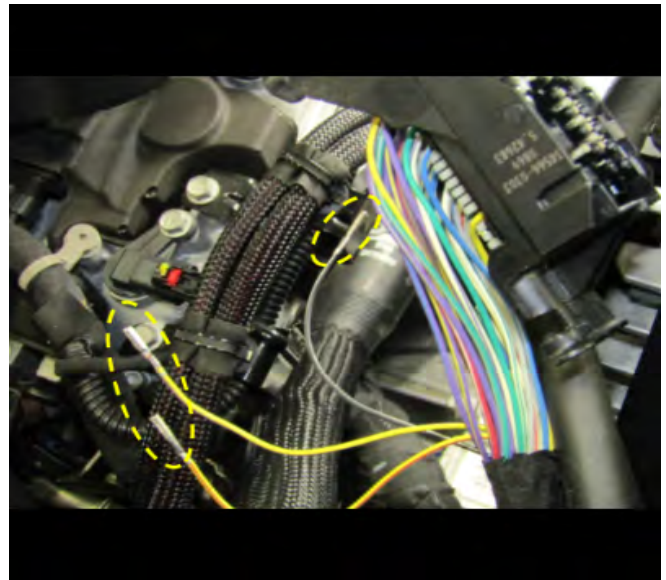
Note: The LFY harness routing is shown in the top graphic, the LGX routing is shown in the bottom math file. The routing for LCV is similar to the routing of the LGX.

9. Remove the mounting bolt and reposition the radiator surge tank away from the cowl. Refer to *Radiator Surge Tank Replacement*, in SI.

10. Start routing the new harness alongside the engine harness.

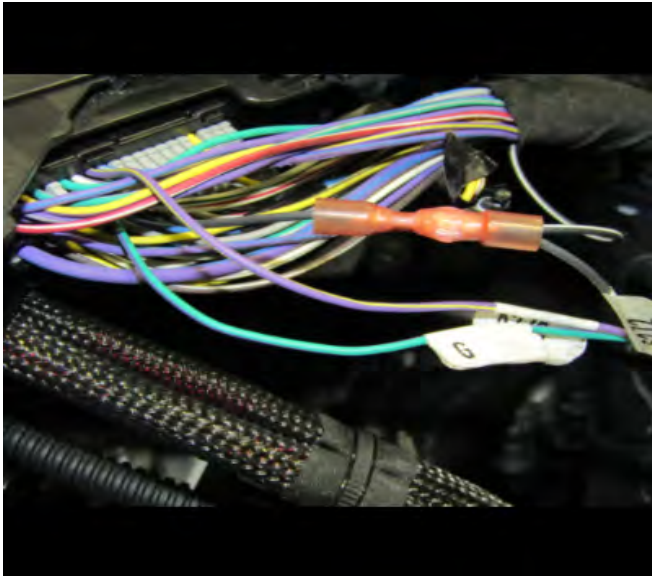
5549631

Important: There are multiple ground circuits tied to ECM ground circuit #2151 and the existing vehicle harness wire **MUST** be spliced into the new harness.

16. Locate the wire labeled #6270 on the new harness and install that terminated lead into the location in connector X1, where circuit #6030 was located.
17. Locate the wire labeled #6271 on the new harness and install that terminated lead into the location in connector X1, where circuit #6031 was located.
18. Locate the wire labeled #6272 on the new harness and install that terminated lead into the location in connector X1 where circuit #2151 was located.
