Preliminary Information

PIC5650H Diagnostic Tip - Security Light on Intermittently / No Crank/No Start or Start Stall / Keyless Access Vehicles May Display No Remote/Fob Detected / Poor or No RKE Range / Service TPM

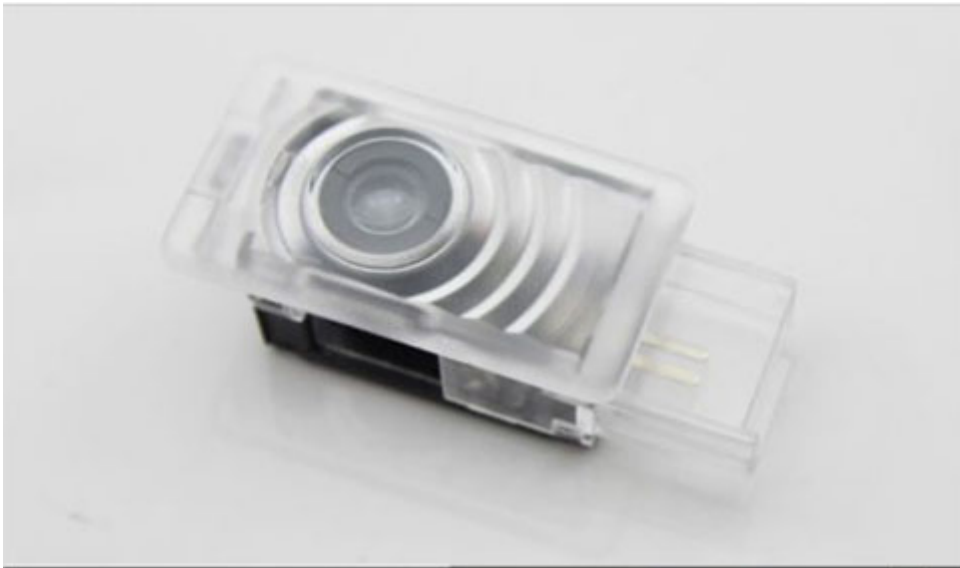
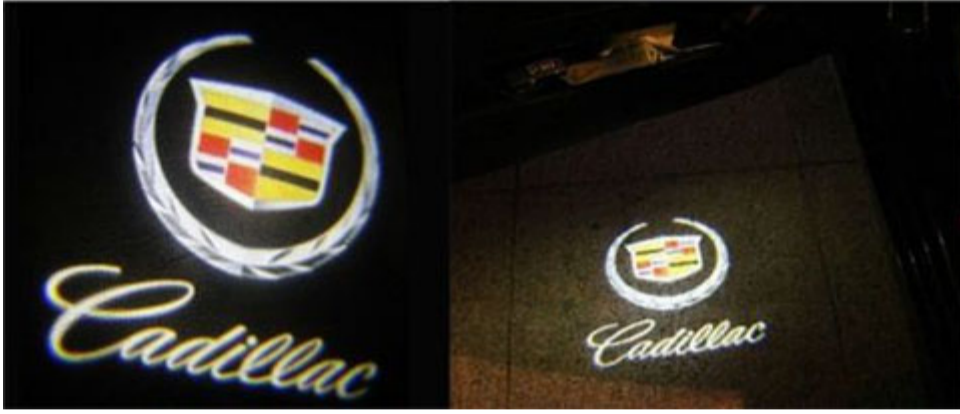
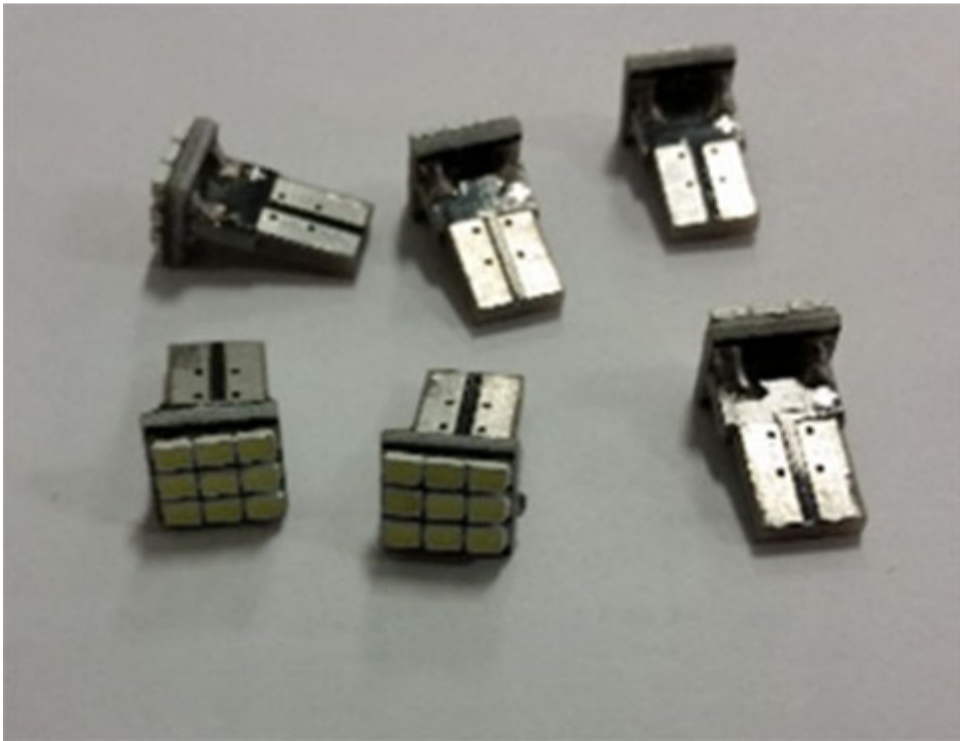
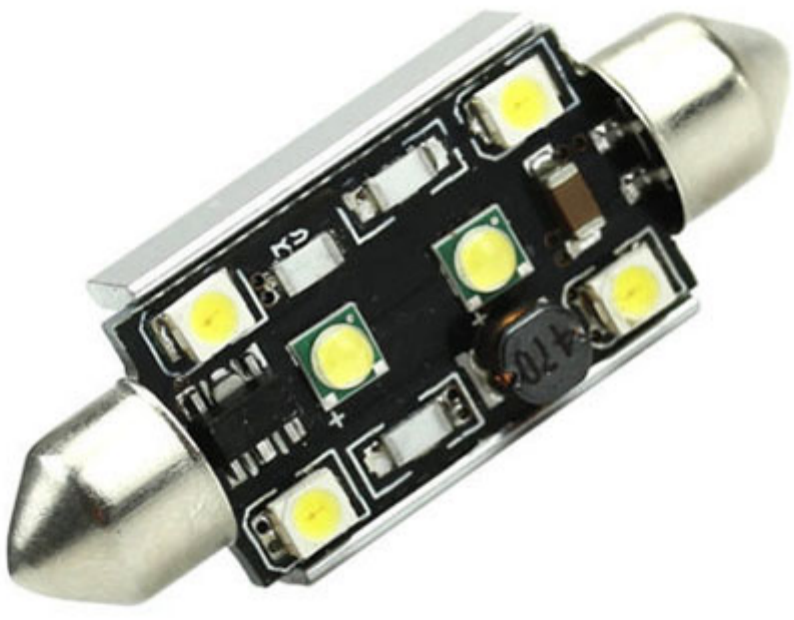
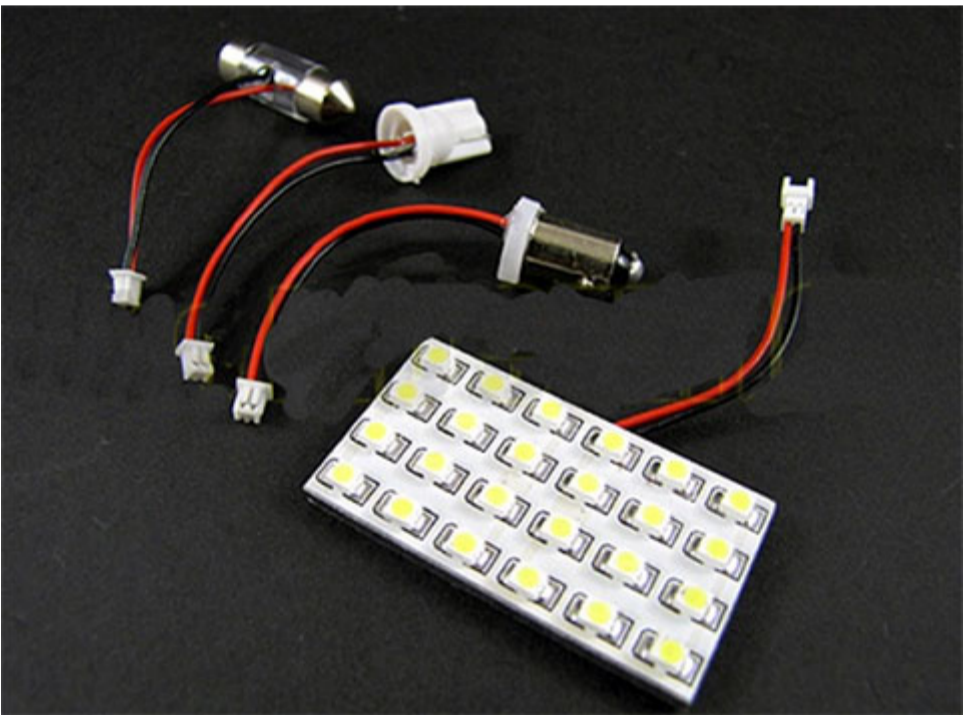
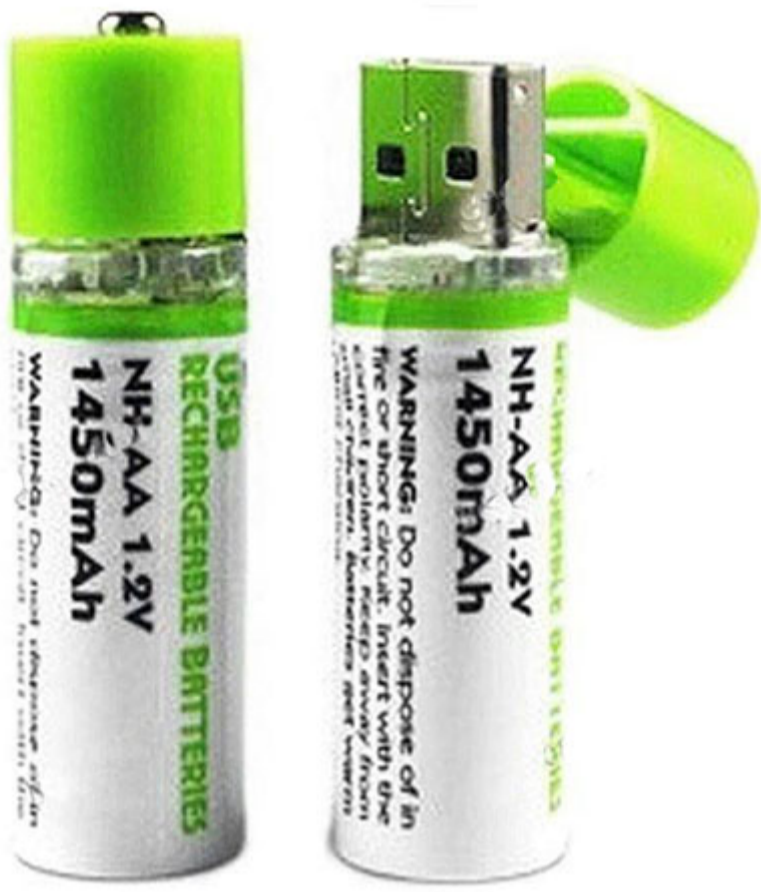
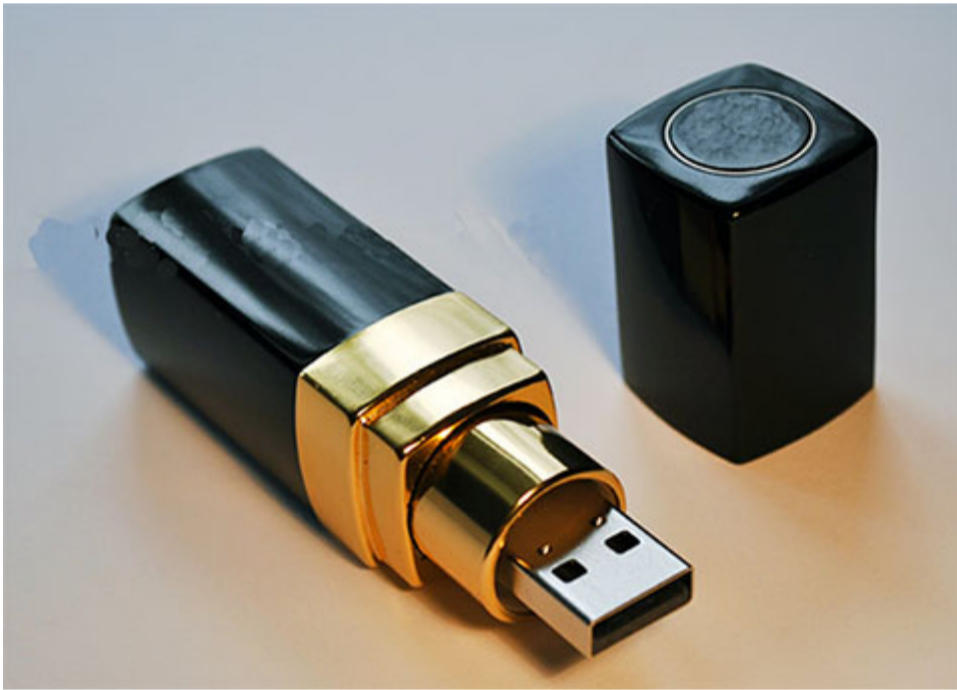
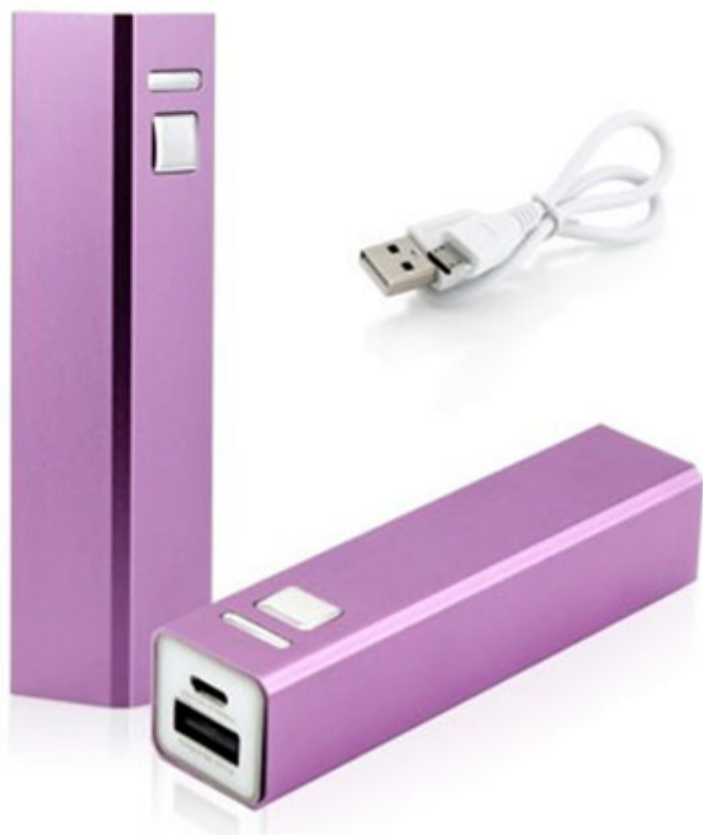
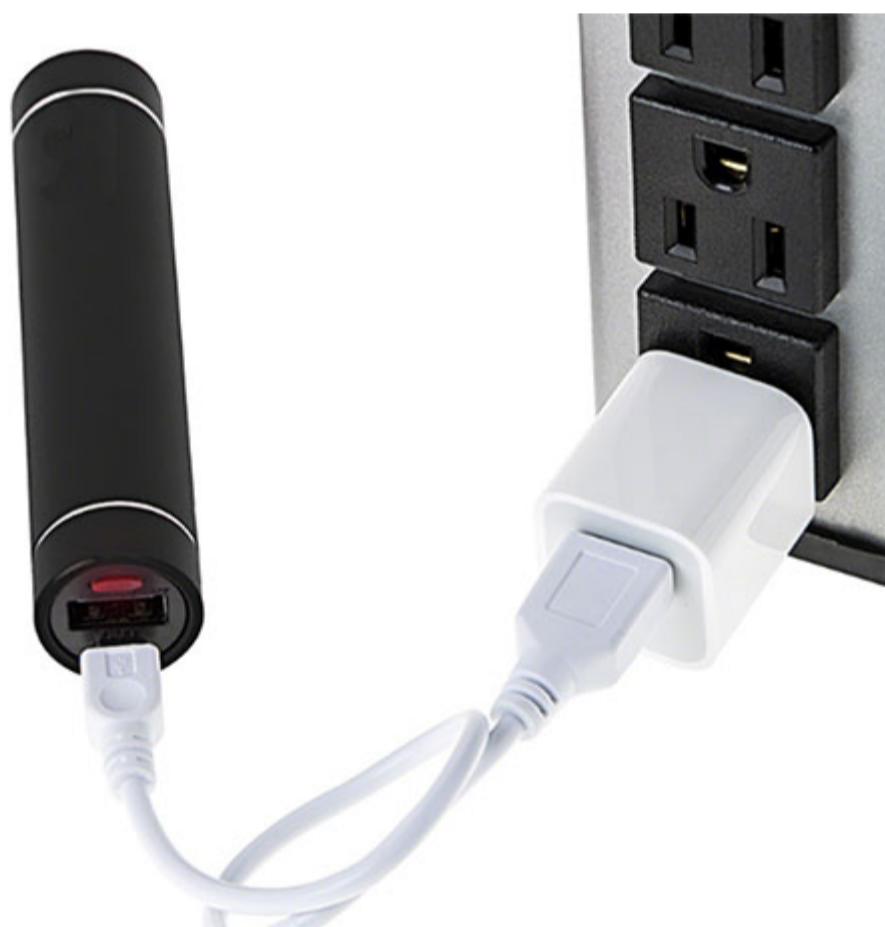
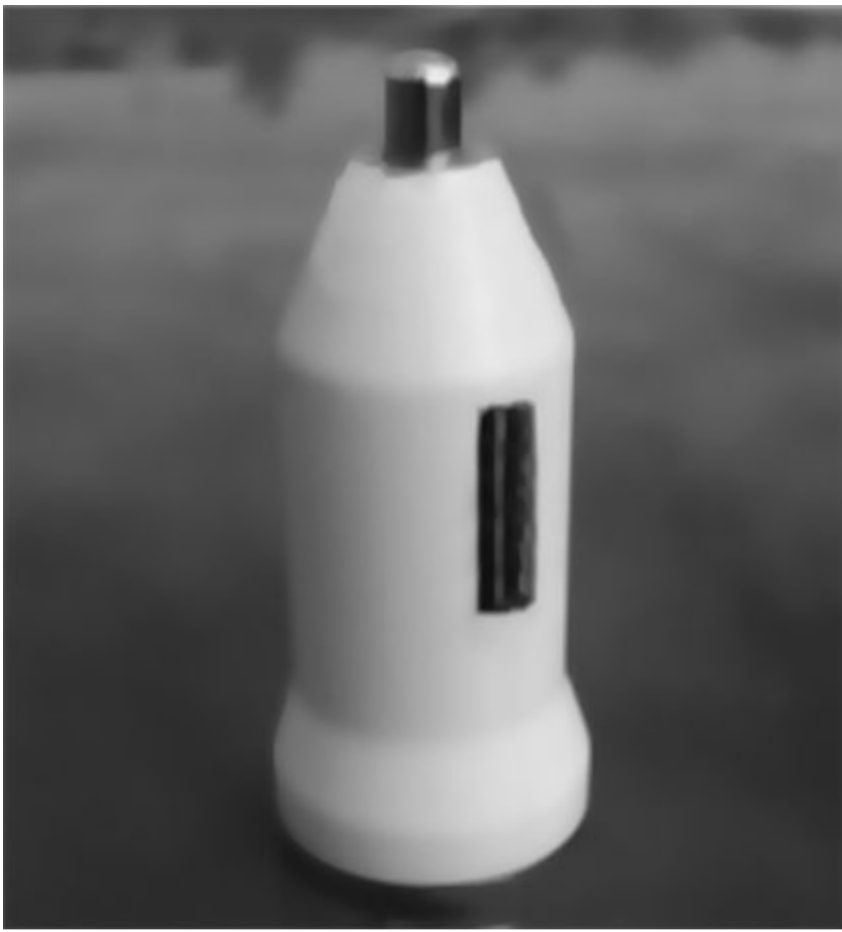
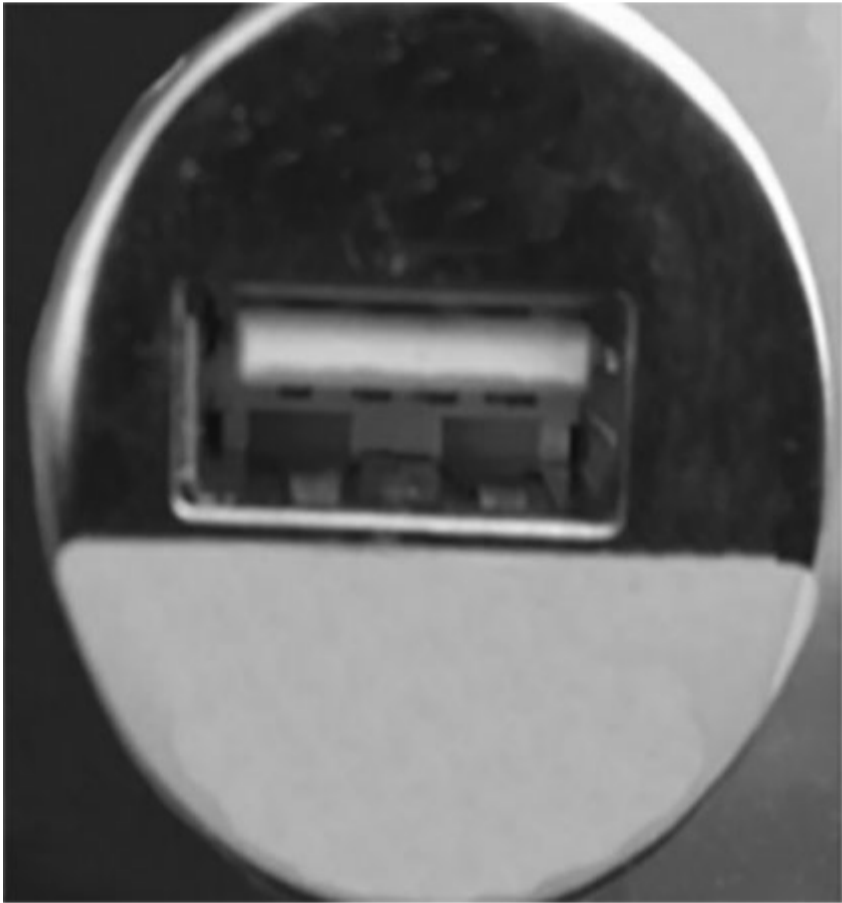
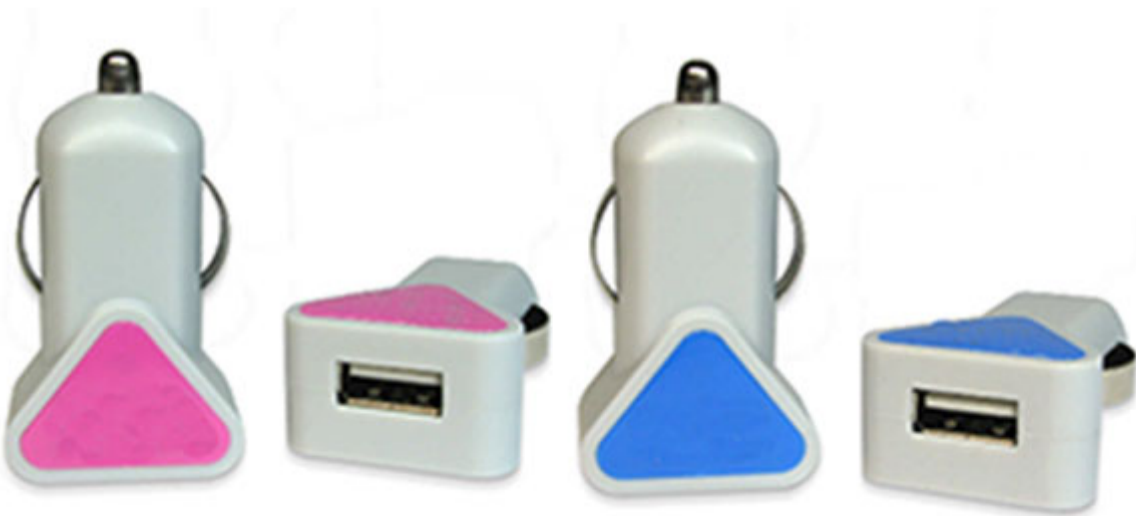
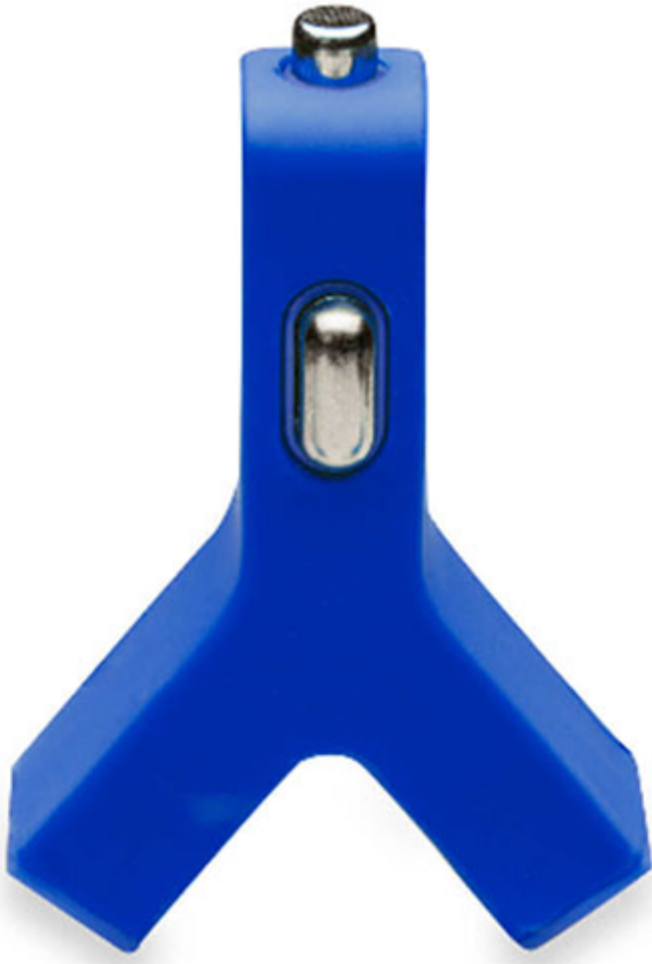
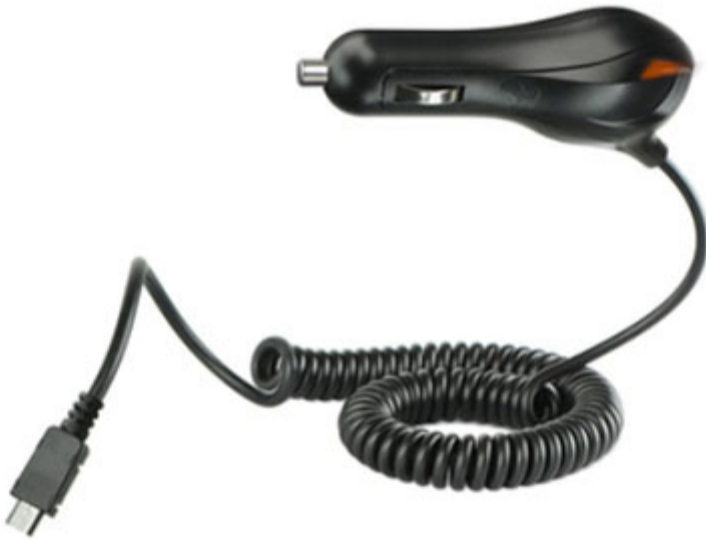
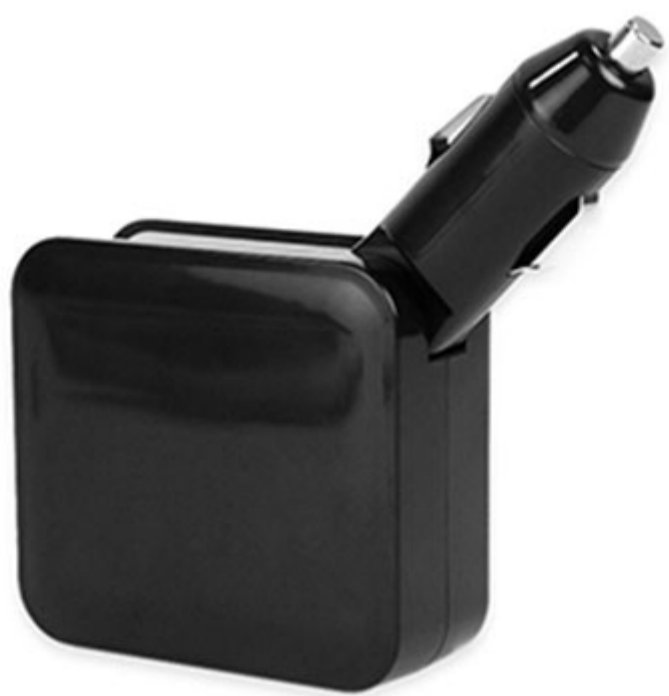
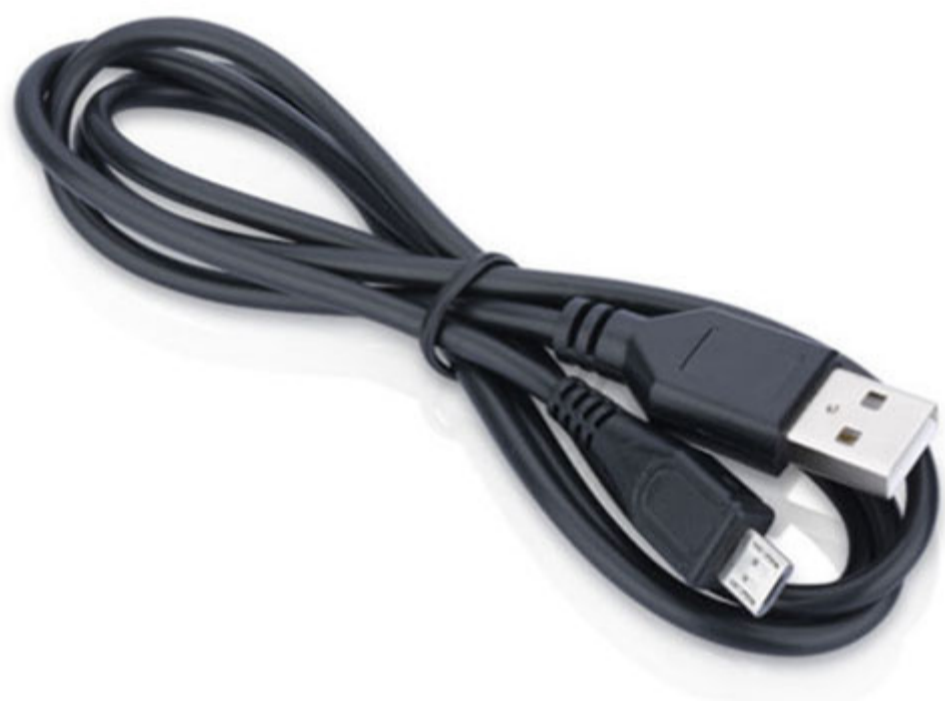
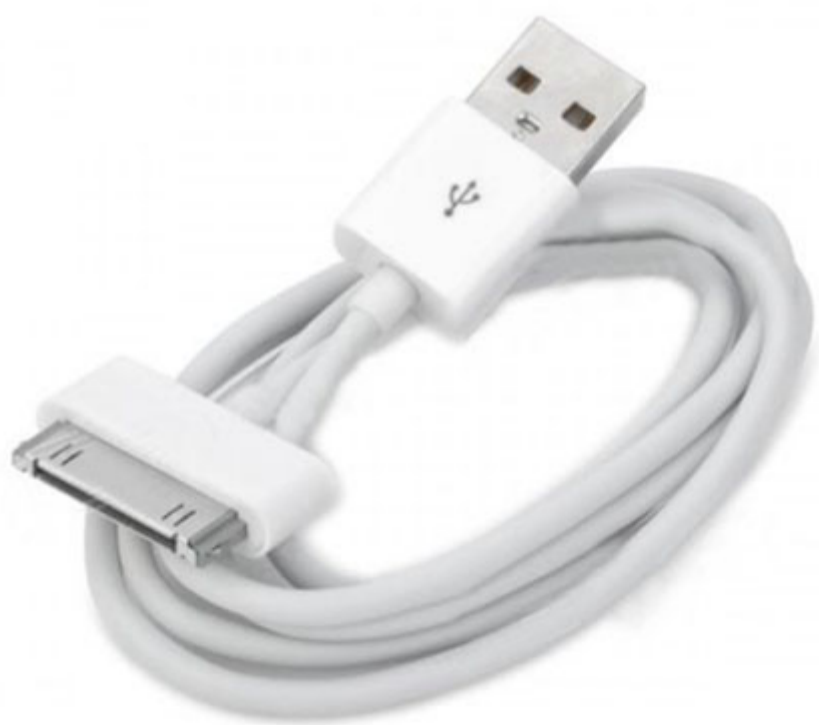
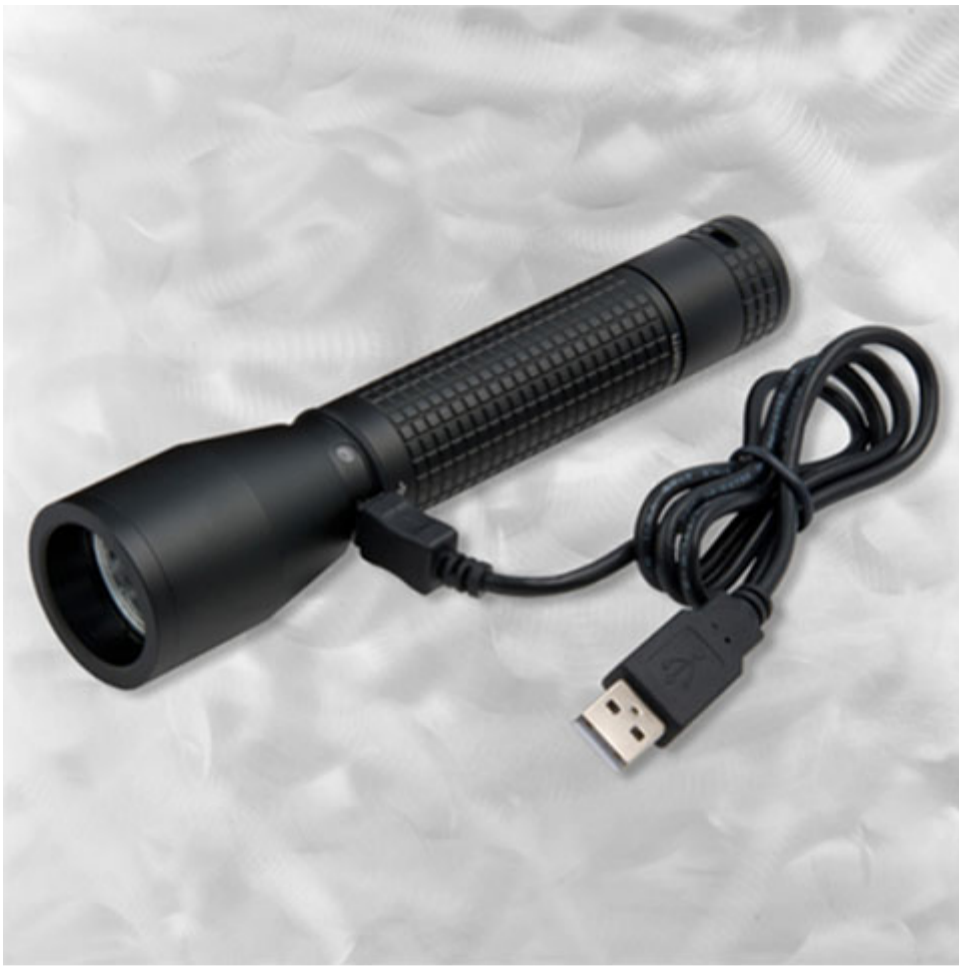
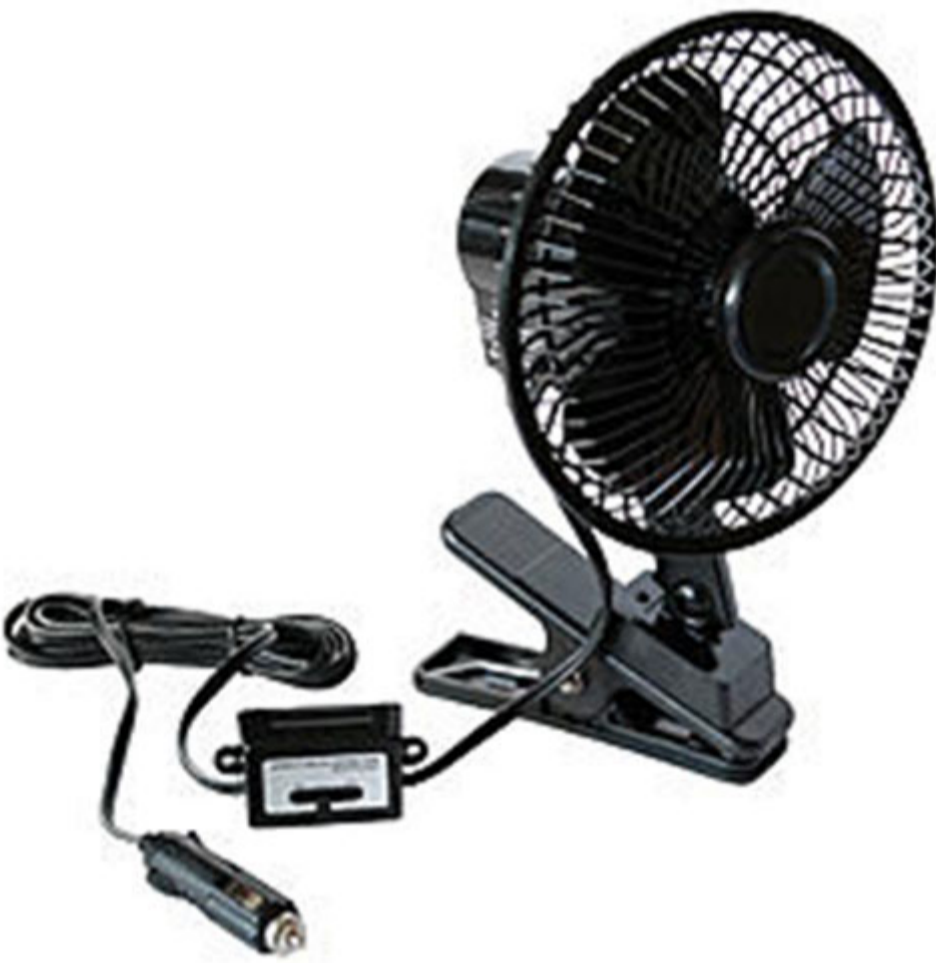
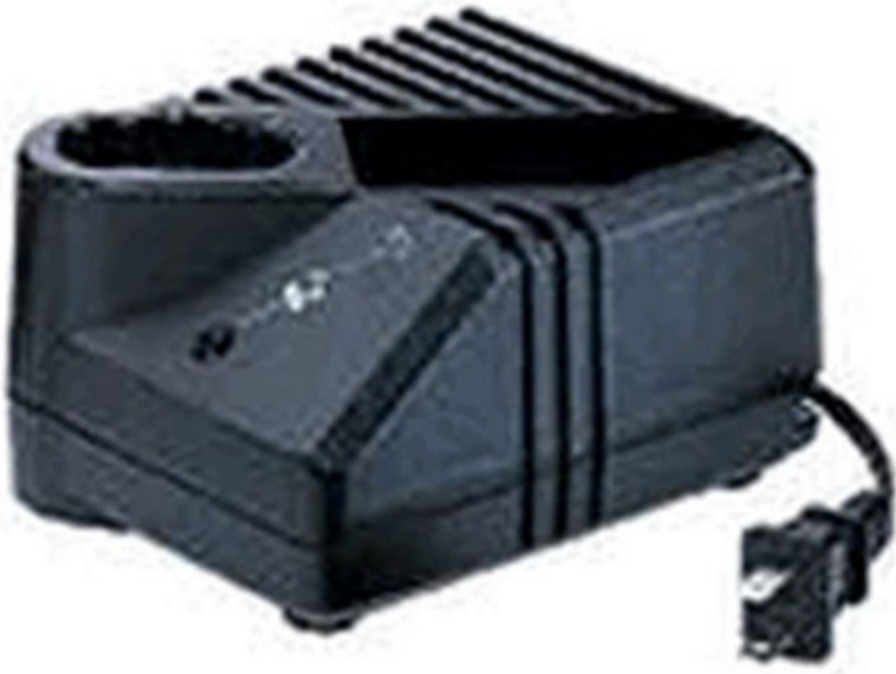
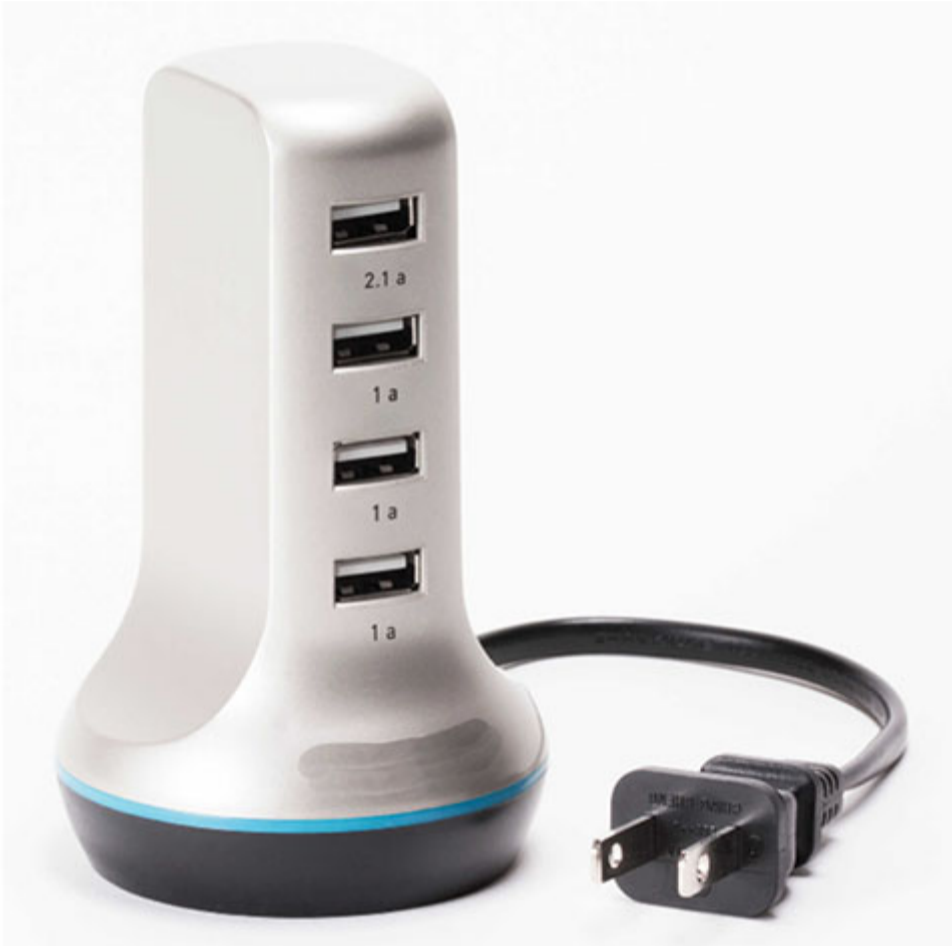
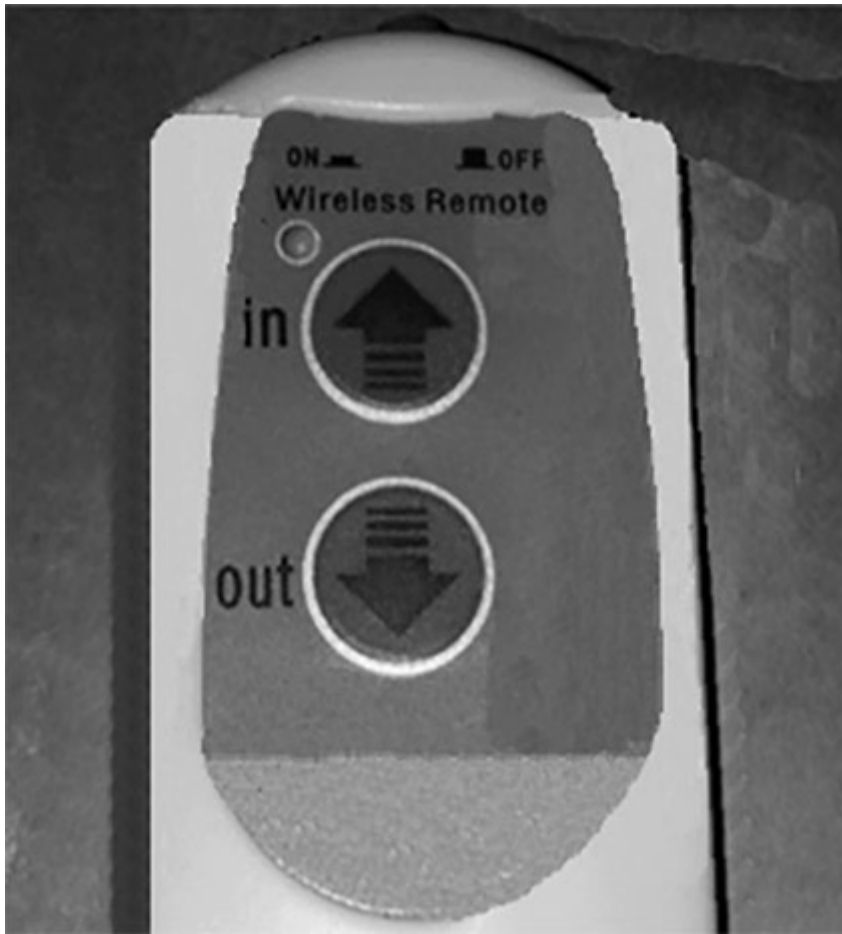
Listed below are a number of aftermarket devices that can cause RFI. In many cases, these types of devices will be attached to the customer's key ring and could be removed from the key ring or from inside the vehicle when the customer drops the vehicle off for service.

- Aftermarket LED dome, tail, turn, stop, strip, floor, door, Logo, head lights
- In many cases, when the LED lighting is turned on it can interfere with a RF signal. Example, RKE inoperative after the first fob button press. When the RKE fob button is pressed the dome lights may turn on, which if equipped with an aftermarket LED dome light, it can interfere with any additional fob button presses.
- Certain cell phone chargers
 - USB power banks
 - USB flash lights
 - Fans (12 volt or 110 volt)
 - Any type of USB, 12 volt or 110 volt chargers
 - "Bedazzle Trim Ring" surrounding ignition lock cylinder, shown below (1)

Before any in depth diagnosis is performed, question the customer or inspect the vehicle for any types of aftermarket equipment, like shown above, which could cause RFI. These items need to be removed and/or disconnected from the vehicle.
