SERVICE BULLETIN

APPLICABILITY: 2020 Outback & Legacy **NUMBER:** 15-270-20
SUBJECT: FOTA (Firmware Over-The-Air) Reprogramming for **DATE:** 8/19/2020
DENSO Gen 4 Audio / Navigation Infotainment Systems

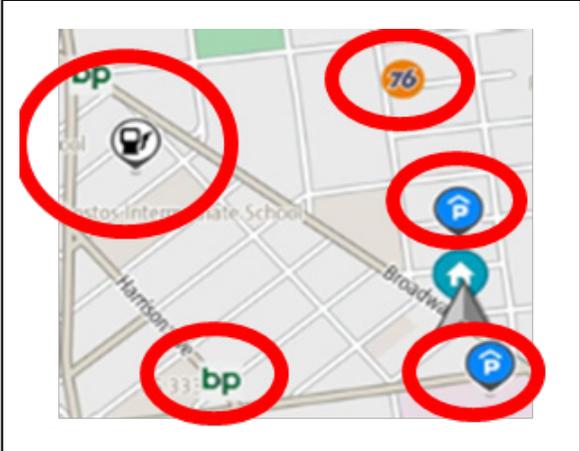
2	<p>Pin display of POI is available.</p>

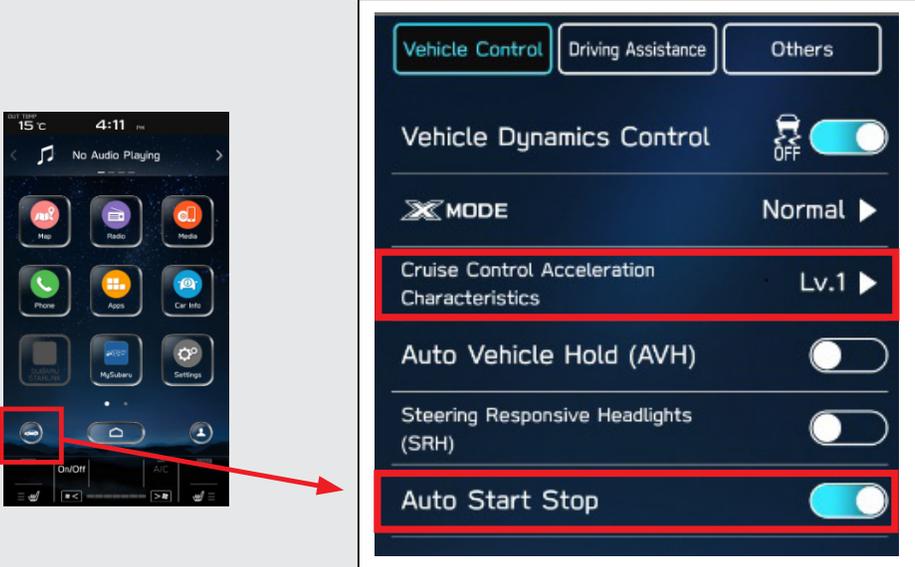
Yes
3	<p>In the 2D and 3D HU display mode, the own vehicle position icon on the Navigation map is easier to be recognized.</p> <p>Icon size: 9mm(0.35in) <instead of 7mm(0.28in)> Icon color: Dark blue <instead of Blue> Icon position (with route guidance): The icon stays at the same position as that without route guidance. The position is located 9mm(0.35in) higher than that of previous version. Icon position (without route guidance): The icon stays at the same position as that with route guidance whereas the previous version icon was displayed lower position than that with route guidance.</p>	Yes
4	<p>ISS (Auto start stop) button is moved to upper layer in the Car Setting menu. By touching the “Car Setting” icon, Auto Start Stop setting menu and the Cruise Control Acceleration Characteristics selection menu can be accessed immediately, whereas the previous version needed to select “Others” in the Car Setting screen to access these menus.</p>

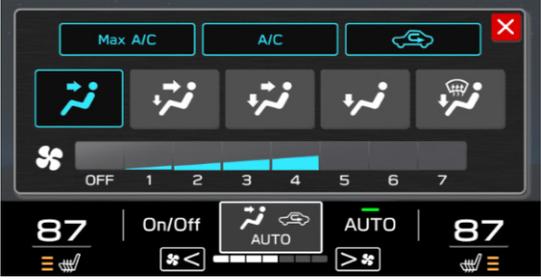
5	<p>HVAC control buttons of base grade are displayed larger and easy to see.</p>

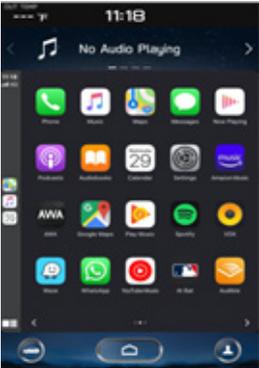
USB ONLY
6	<p>Time zone and Summertime are automatically selected. Default setting of clock setting is Auto (Time zone is changed according to the vehicle location, and the Summertime is automatically set according to the calendar)</p>	Yes
No. New functions and improvement		FOTA
7	<p>Direct selection of clock setting. Clock setting can be selected by touching the clock display in the status bar.</p>	Yes
8	<p>Hold displaying Album Art even with vehicle in motion. The Album Art that is displayed whenever music is played on the audio system keeps displaying even after the vehicle is in motion (the speed signal is inputted.)</p>	Yes
9	<p>CarPlay screen is extended to full screen. CarPlay screen is expanded from half size (horizontal) to full screen (vertical.)</p>

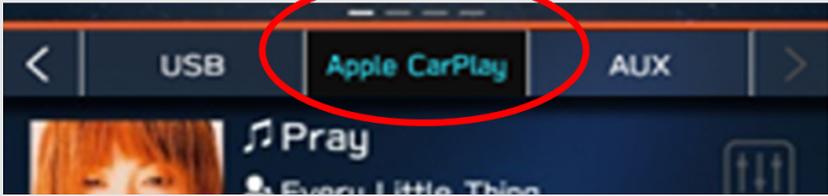
Yes
10	<p>Add new CarPlay or Android Auto tab to Music screen When using CarPlay or Android Auto, “CarPlay” or “Android Auto” tab will appear on the Media tab bar. By selecting this tab, music data and metadata can be browsed.</p>

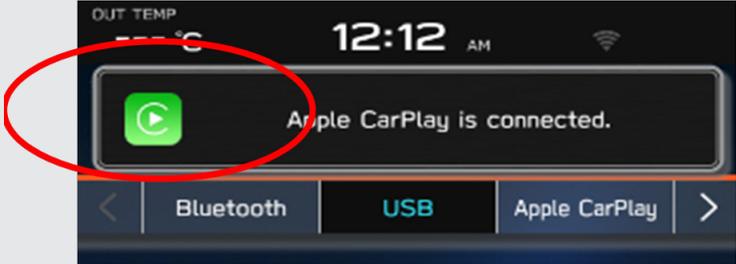
11	<p><Turn by Turn> is added to information and meter. When using route guidance with CarPlay navigation, <Turn by Turn> descriptions will be displayed both in the Information bar of CID and in the MID located in the center of the combination meters.</p>	Yes
12	<p>Direct select CarPlay button is available in the Information bar. Buy touching the CarPlay button located in the upper part of CID, the CarPlay menu can be accessed easily.</p>

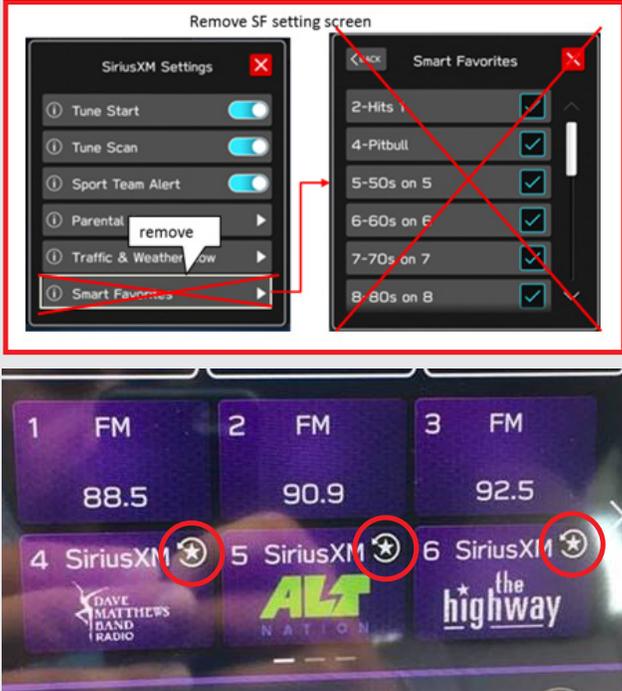
Yes
13	<p>CarPlay connection status can be retained even after Ignition off/on. In case the system was shut down with the CarPlay being connected previously, the system automatically resumes the connection at the next start up.</p>	Yes
14	<p>Improvement in the <Siri> Voice Recognition The starting of <Siri> Voice Recognition function can be ready faster.</p>	USB ONLY
15	<p>Gracenote database update Up to Nov 2019 database</p>	USB ONLY
16	<p>1. Sirius XM Smart Favorites menu has been removed from SiriusXM Settings</p>

<p>2. Going forward, the first 10 set Sirius XM presets are now smart favorites by default 3. Smart favorite channel has “star” added to the preset button</p>	USB ONLY
