TECHNICAL SERVICE BULLETIN High Roof Bus/Passenger Wagon - Headliner Loose Or Unseated At The C And/Or C 1/2 Pillar(s)

20-2341
29 September 2020

| Ford 2015-2020 Transit |

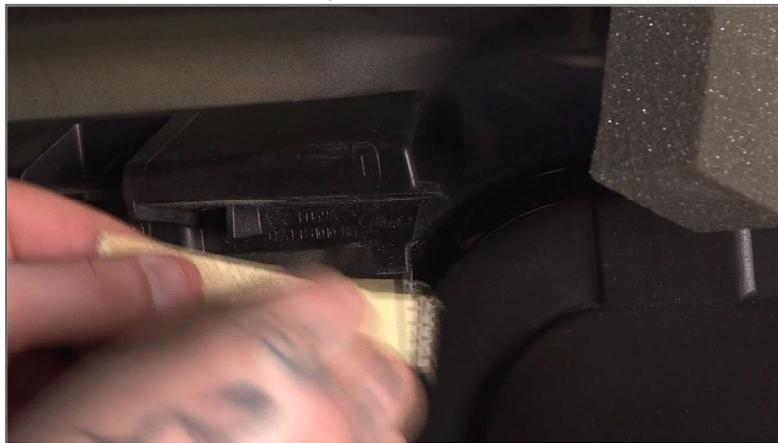
Figure 1

1. Does this vehicle have a high roof with a loose or unseated headliner causing a visible gap at the C and/or C 1/2 pillar(s), misalignment between headliner locator tab and pillar block pins? (Figures 1-3)
