SERVICE BULLETIN

APPLICABILITY: 2020MY Legacy and Outback
SUBJECT: Denso Gen 4 Cockpit One (CP1) Infotainment System Operating TIPS

NUMBER: 15-259-20R
DATE: 02/19/20
REVISED: 12/01/20

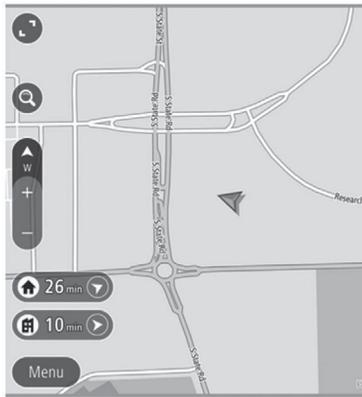
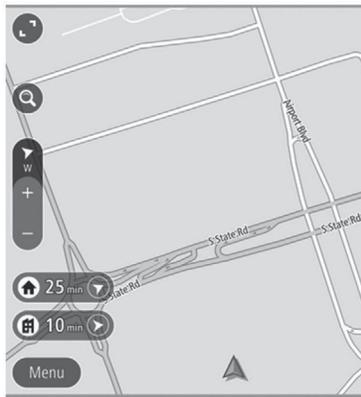
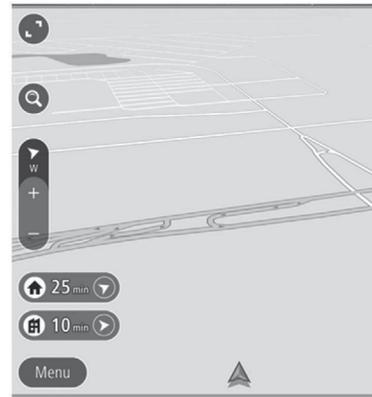
CONDITION #1: During Navigation operation, the map orientation can be changed between 2D north-up, 2D heading-up and 3D.

The map orientation defaults to 2D north-up, 2 mile scale whenever the ignition is cycled off-on.

This is a normal operating characteristic.

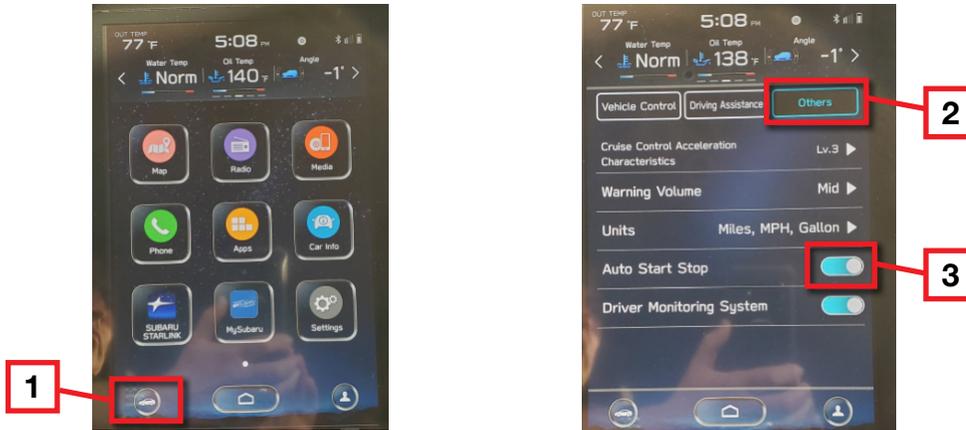
CONDITION #4: Engine Auto Start-Stop operation defaults to “ON” following the ignition cycle off-on.

The Auto Start-Stop feature operates automatically to save gasoline and reduce emissions when the vehicle is stopped. By design, the Auto Start-Stop feature always defaults to ON whenever the ignition is cycled off-on.

1. Touch the Vehicle Icon on the Home screen
2. Touch the Others tab on top
3. Move the Auto Start-Stop slider to OFF.

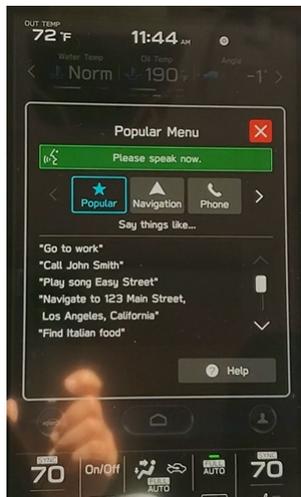
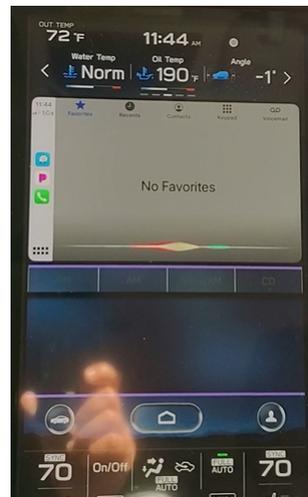
CONDITION #6: Voice Recognition (VR) operation is inconsistent when using Apple CarPlay or Android Auto applications.

REMINDER: To start Siri / Google Assistant, while using CarPlay / Android Auto press and HOLD (**long** press) the Talk switch on the steering wheel.

The same is true when using the voice to text function. To start Siri/ Google Assistant, press and HOLD the Talk switch on the steering wheel. This will initiate change-over from the native on-board VR system to Siri / Google Assistant.

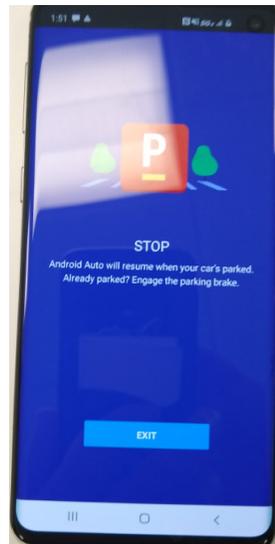
Android Phone

CONDITION #8: Android Auto does not launch.

CAUSE / NOTE: The vehicle must be stopped and the electric parking brake (EPB) must be ON to complete the initial pairing process between the CP1 / Gen 4 Infotainment system and the phone using the Android Auto application. When connecting a phone to the USB port, follow the messages on both the CP1 display and the phone screen. See below an example.

This is a normal operating characteristic. It is a good practice to confirm an undamaged, genuine cable is used to connect the phone as well as the making sure the phone is set to accept connection with a new vehicle.

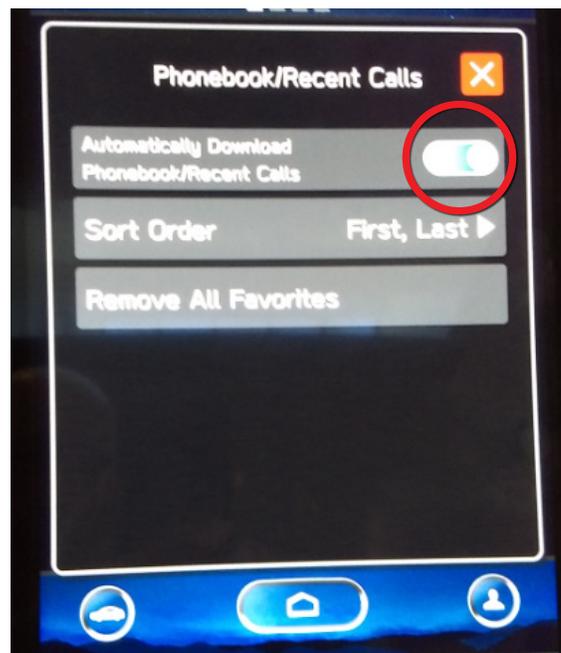
Home > Settings > Phone > Phonebook/Recent Calls

CONDITION #10: User is unable to download Phonebook Contacts.

When assisting with questions about the phonebook download process, start by verifying the option is enabled in the CP1 / Gen 4 Infotainment system using the following screen shot as a guide.

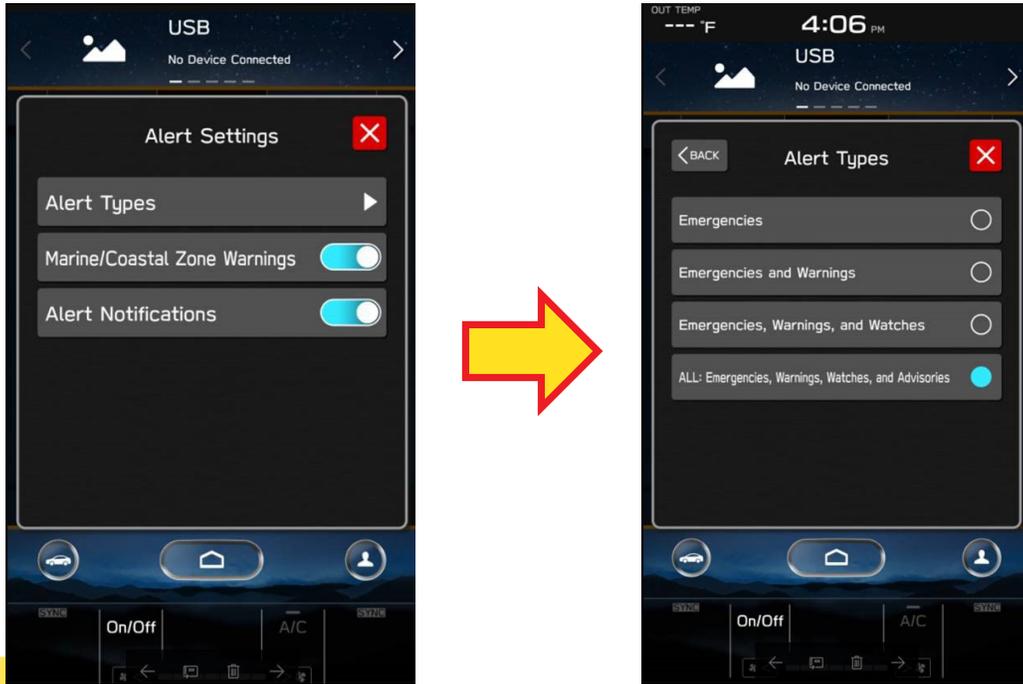
CONDITION #16: Weather Alert message

Denso implemented SXM Weather Alert settings within the Gen 4 CP1 controls. These settings control all alert types as well as the ability to completely turn the alerts off. Unlike Gen 3 Harman, the settings for Weather Alert in Gen 4 Denso are in the SiriusXM Travel Link menu (Applications). See the Gen 4 screenshots below.

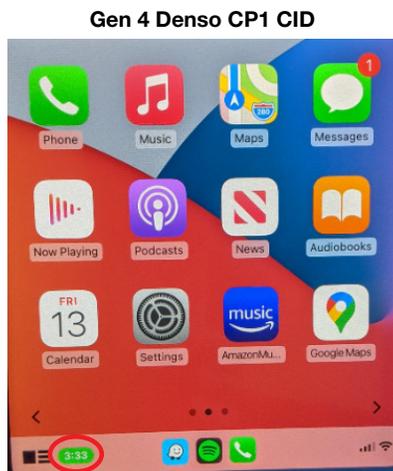
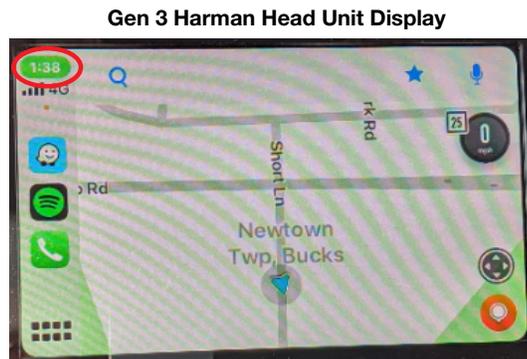
- *Handsfree call in progress (clock with green background)*

NOTE: This information may be beneficial if the customer asks about the clock background color changing at random or, how to confirm a handsfree call was in progress when the condition occurred. Diagnostic hint: Check the phone screen when the condition occurs to see what is active on it or if any error messages are displayed.

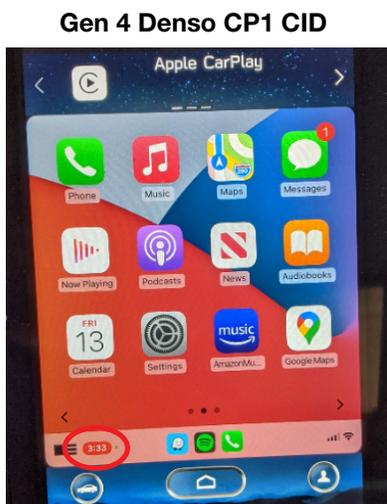
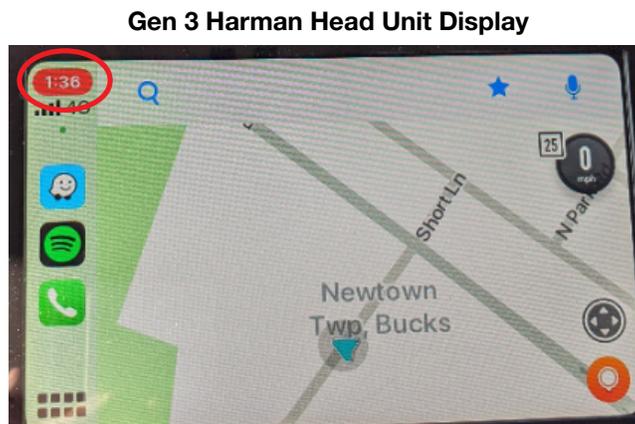
- *iPhone MIC is enabled by another application (clock with red background)*

NOTE: A report was received with a customer concern of the audio streaming app stopping at random. It turned out, the Camera application (video) has been accidentally started on the iPhone and was interfering with the audio streaming application. It was determined by using clock background attribute showing the MIC was enabled each time the streaming stopped. Replacing the hardware in the vehicle would not have had any effect or resolved this case but, helping the customer to understand how the phone works will likely prevent future concerns.

HINT: Always check the phone screen when the condition occurs to see what app is active and if any error messages may be displayed.

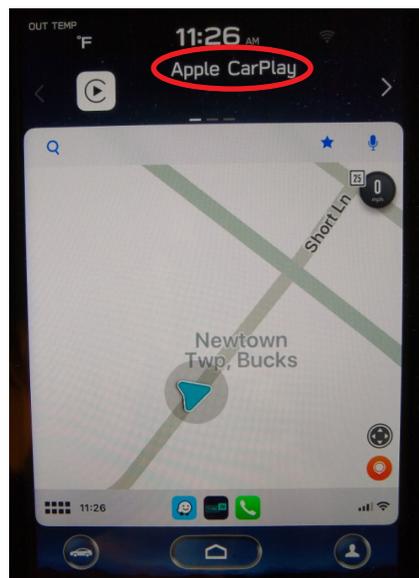
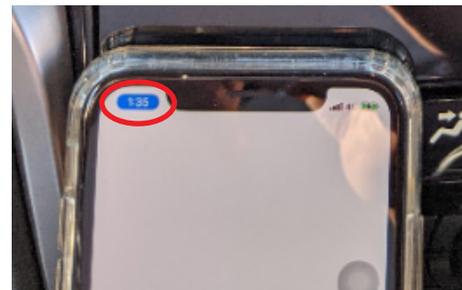
- **WAZE application has started on iPhone (iPhone clock with blue background to indicate enabled notification mode with the vehicle audio source forced to switch to Apple CarPlay):**

NOTE This information will be helpful when explaining why the radio or CD stop playing when the Waze app was started. The head unit projects what the iPhone is pushing to it. Hardware replacement will NOT fix the concern of a crashing phone app. In cases like this, frequent iPhone reboots or restarts (especially after recent iOS update) or updating or reinstalling the application on the phone were suggested. Check the comments in iTunes store as this may be a known concern with the app.

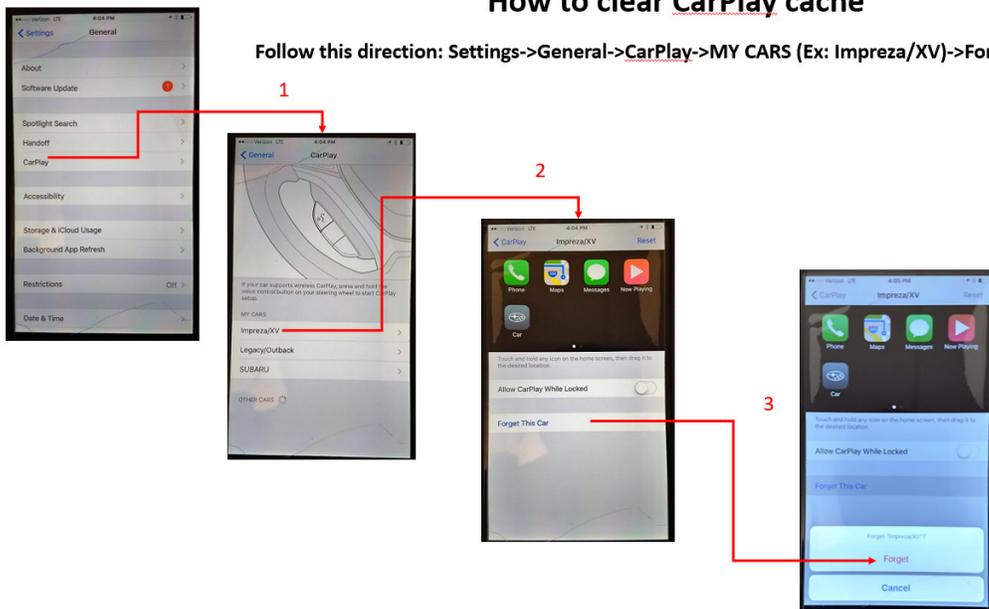
How to clear CarPlay cache

CONDITION #18: No Audio during CarPlay

Follow this direction: Settings->General->CarPlay->MY CARS (Ex: Impreza/XV)->Forget This Car

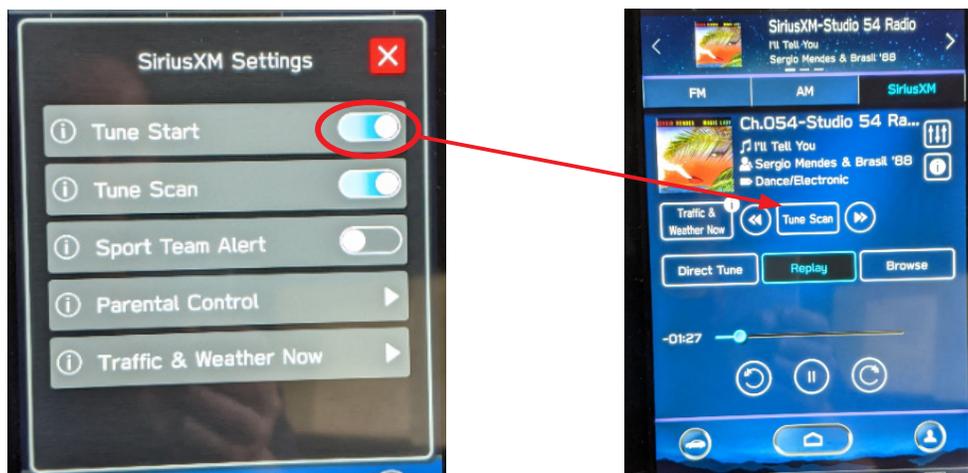
Tune Start: When this function is on, channels registered as Smart Favorites will be cached and when the channel is changed, the song on that channel can be listened to from the beginning. Reports have been received where the customer is not sure how to bring back the display of the preset buttons once the cache / song replay screen has popped up. Touching the "Replay" soft button will remove the cache / song replay screen.

NOTE: This playback option automatically appears for Smart Favorites when the “Tune Start” setting is ON and based on when the smart favorite channel is selected. Tune Start causes the module to start playing from the start of the most recent buffered song with each station selection change. This operation is a normal operating characteristic. Do NOT replace hardware to stop getting the replay screen following Smart Favorite channel selection. If the customer wants to stop the playback option from automatically appearing for Smart Favorites, turn “Tune Start” setting to OFF using SiriusXM Setting options.
