SERVICE BULLETIN

APPLICABILITY: 2013-14MY Legacy and Outback Models with 2.5L FB Engines 2011-14MY Forester Models with 2.5L FB Engines 2015 MY Forester (Manual Transmissions Only) with 2.5L FB Engines 2012-13 MY Impreza and XV Crosstrek Models with 2.0 FB Engines 2014-15 MY Impreza and XV Crosstrek Models (Manual Transmissions Only) with 2.0 FB Engines

SUBJECT: Engine Oil Consumption

NUMBER: 02-157-14R **DATE:** 08/28/14 **REVISED:** 01/26/21

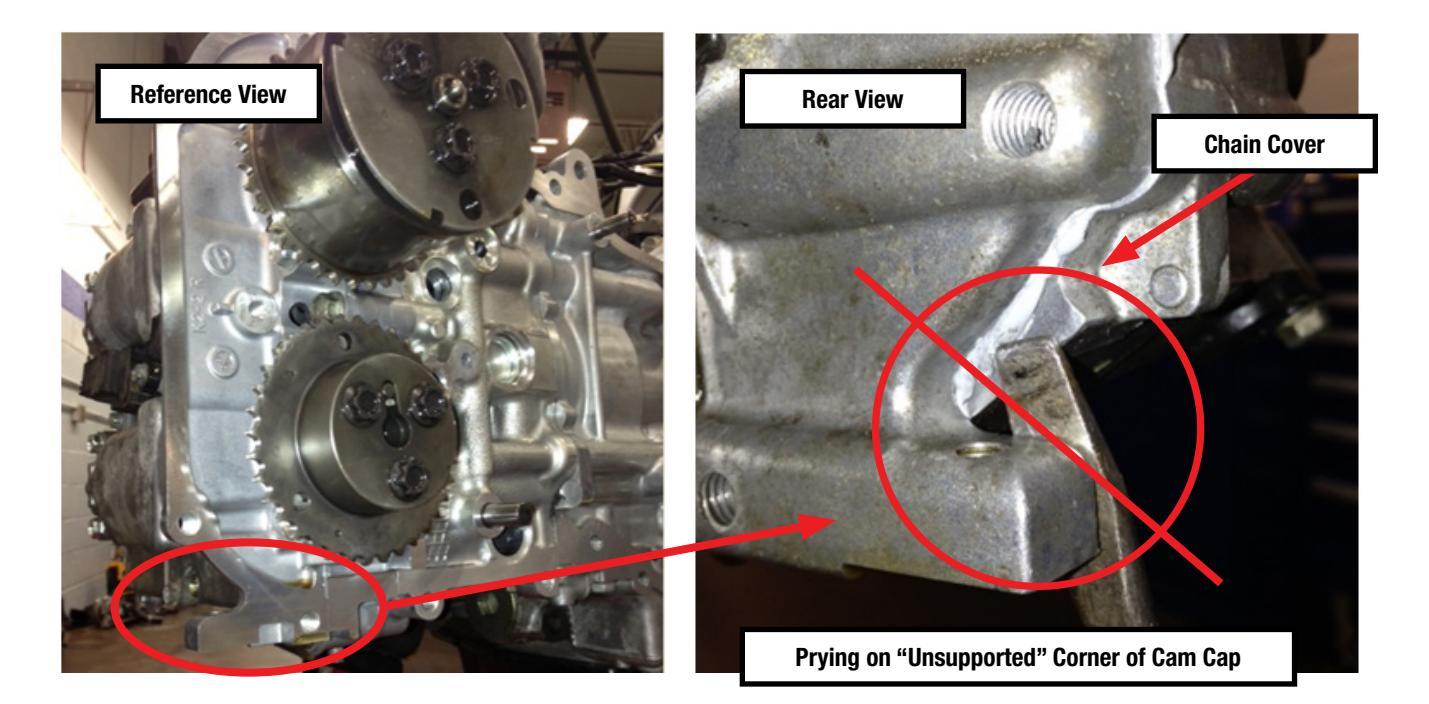
• **IMPORTANT:** After all 32 bolts securing the chain cover are removed, be <u>EXTREMELY</u> careful where you pry and what you pry on to break the silicone sealant's bond. The photos below show an example of where <u>NOT</u> to pry. In this case, the cam cap became cracked requiring a complete cam carrier replacement. *Patience is the key!*

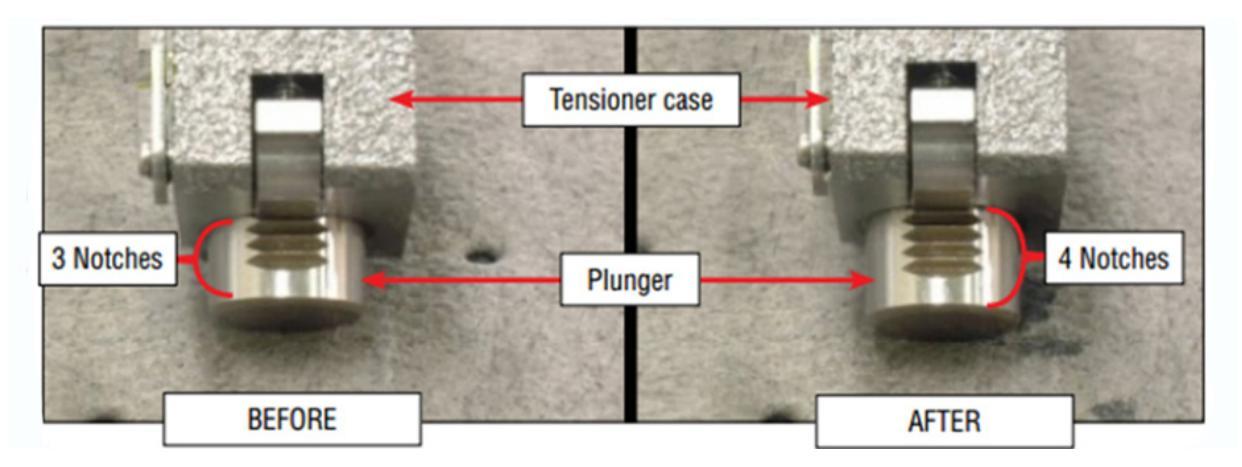
• If you have 3 notches showing, you want to get one more "click" so that 4 notches are visible as shown in the photos below. If you have 4 showing, you want to end up with 5. Whether you start with 3 or 4 will depend on the amount of wear present on the chains and guides. The number of clicks listed here is simply a guide. The point is to ensure proper initial chain tension is applied to avoid creating a brief rattle sound at engine start.

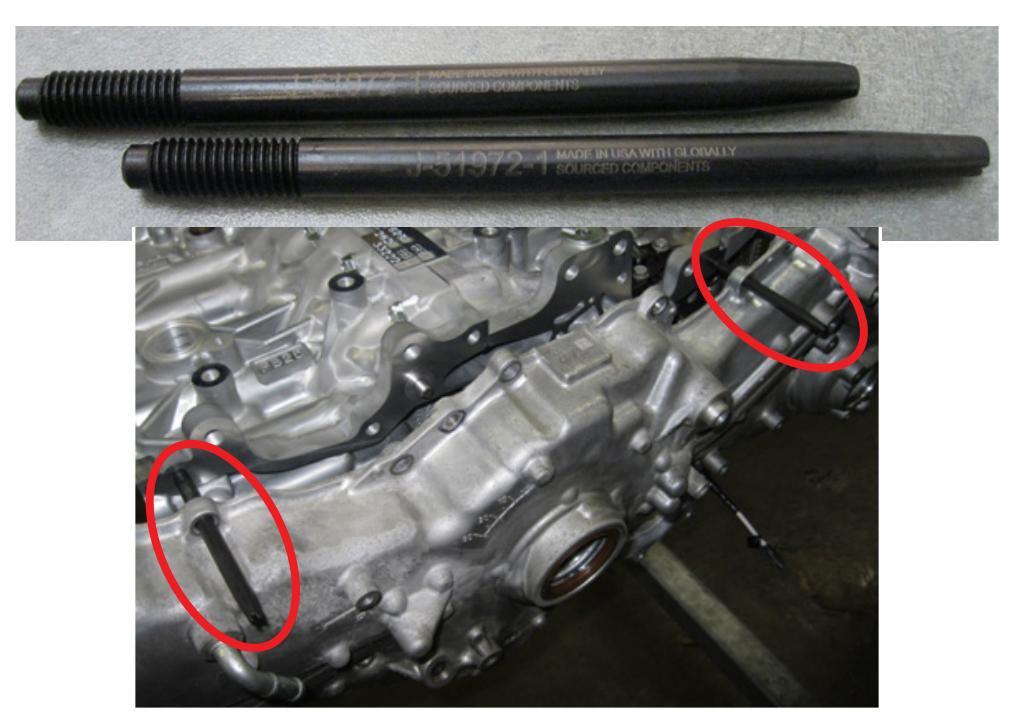
IMPORTANT: When re-installing the front cover assembly, be very careful to not allow it to contact any of the timing sprockets. If contact does occur, it will most likely be with the exhaust sprockets and it is almost a guarantee the fresh silicone sealer beads applied to the cover will be disturbed. To minimize the possibility of this happening, alignment pins as shown in the photos below have been developed to "guide" the cover into its proper position without disturbing the fresh sealer. The Subaru Special Tool number for the alignment pin kit is J-51972. Each kit includes 2 pins.

- If alignment pins are not used and the sealer gets disturbed during the cover installation, unless properly addressed, the affected area(s) will most likely be the source of an oil leak after reassembly. Don't hesitate to use a helper for the cover installation to prevent this from happening.
