SERVICE BULLETIN

NUMBER: 16-132-20R

SUBJECT: Diagnostic Information for Alleged Chain Slip Condition
 on TR580 / TR690 Transmissions

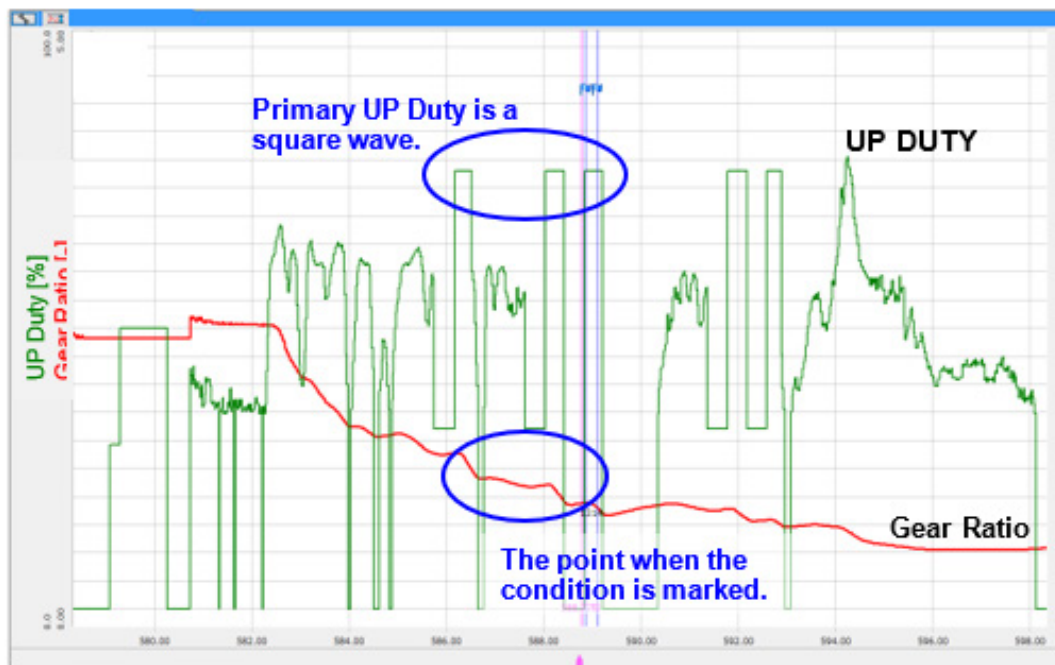
FIG. 6

STEP 2-3: Troubleshooting Flow Chart Symptom Other Than Chain Slip -3 (Lock-up)
