SERVICE BULLETIN

APPLICABILITY: 2013-14MY Legacy and Outback Models
 with 2.5L FB Engines
 2011-14MY Forester Models with 2.5L FB Engines
 2015 MY Forester (Manual Transmissions Only)
 with 2.5L FB Engines
 2012-13 MY Impreza and XV Crosstrek Models
 with 2.0 FB Engines
 2014-15 MY Impreza and XV Crosstrek Models
 (Manual Transmissions Only) with 2.0 FB Engines

NUMBER: 02-157-14R

SUBJECT: Engine Oil Consumption

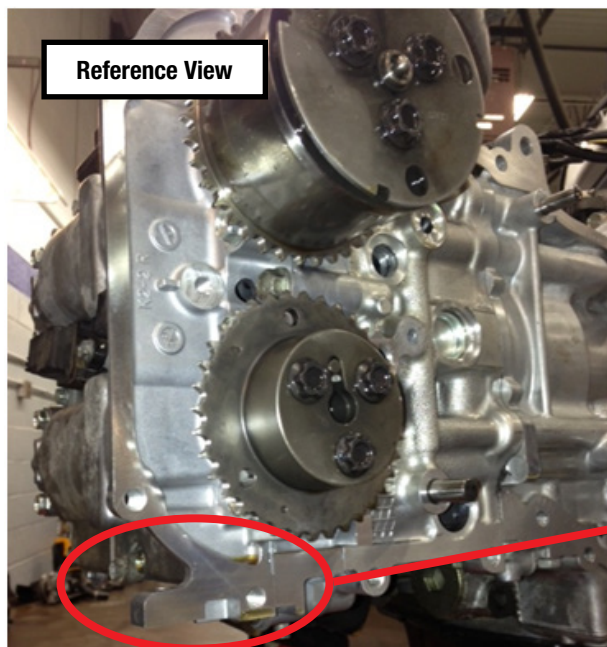
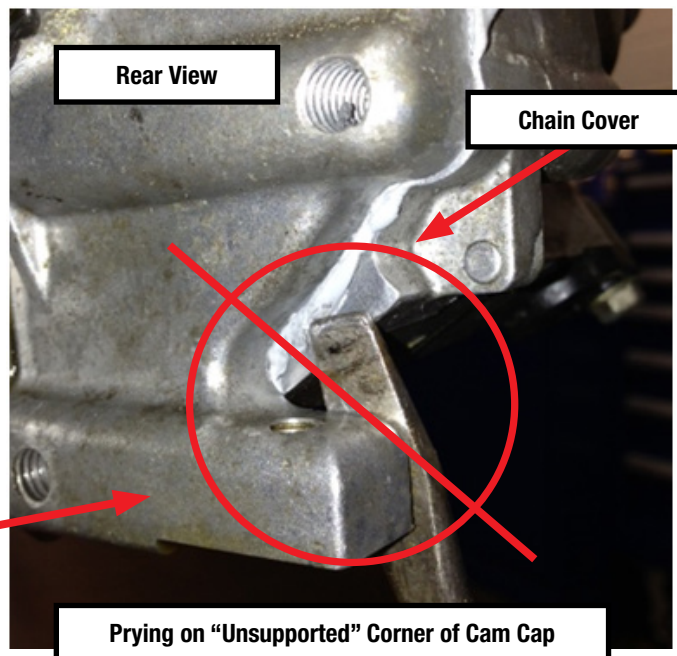
- IMPORTANT:** After all 32 bolts securing the chain cover are removed, be **EXTREMELY** careful where you pry and what you pry on to break the silicone sealant's bond. The photos below show an example of where **NOT** to pry. In this case, the cam cap became cracked requiring a complete cam carrier replacement. *Patience is the key!*
