June 17, 2021

Version 7

Popping/Crackling from the Speakers; Display Blank

Year	Model	Trim Level	VIN Range
2021	RDX	ALL	ALL

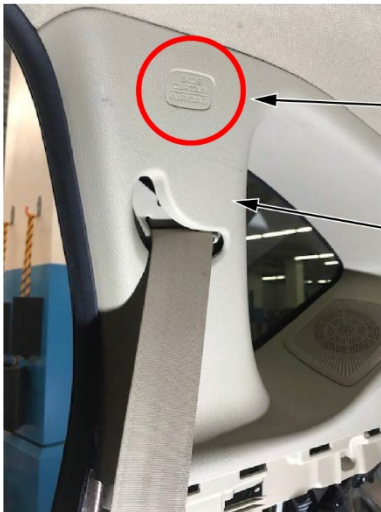
**QUARTER
PILLAR TRIM**

Lightly tap this area
with a rubber mallet.

17. Using a rubber mallet, apply a light blow to disengage the quarter pillar trim clip (a must-replace part). Then, remove the quarter pillar trim. Once it is removed, install a new quarter pillar trim clip.
