SERVICE BULLETIN

APPLICABILITY: 2020MY Legacy and Outback

SUBJECT: Denso Gen 4 Cockpit One (CP1)
Infotainment System Operating TIPS

NUMBER: 15-259-20R

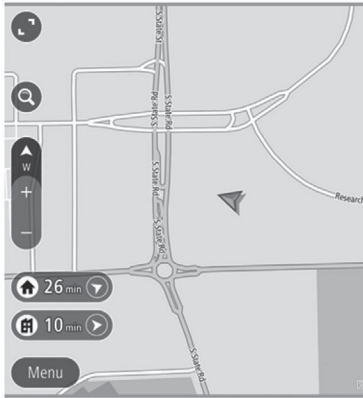
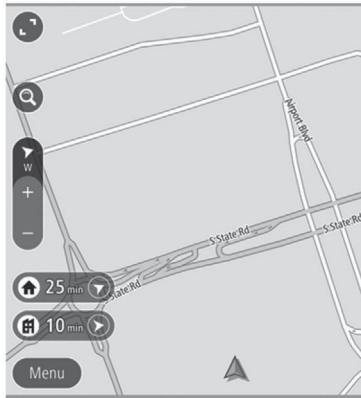
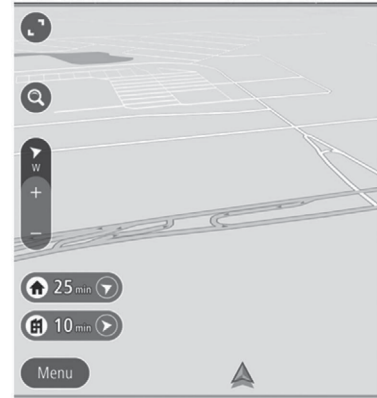
CONDITION #1a: During Navigation operation, the map orientation can be changed between 2D north-up, 2D heading-up and 3D.

The map orientation defaults to 2D north-up, 2 mile scale whenever the ignition is cycled off-on.

This is a normal operating characteristic.

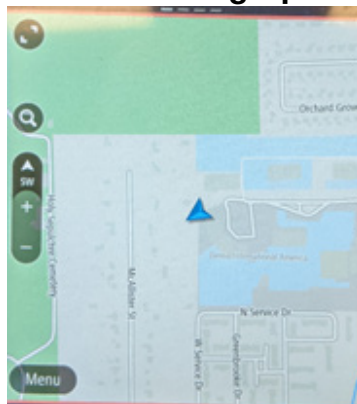
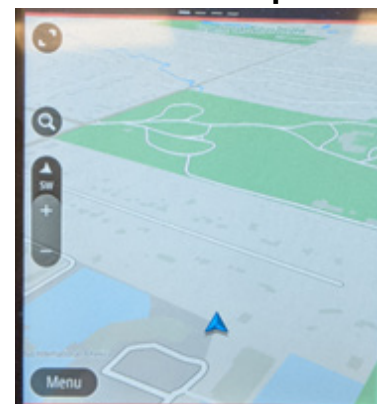
CONDITION #1b: Navigation issues due to street names not shown.

Street names are not shown.

Please note street names only appear in 2D north-up and 2D heading-up. **Street names are not shown in 3D heading-up map orientation mode.** This is TomTom User Interface constraint for CP1.0 system. So this operation is characteristic.

Just a reminder there are three map orientation modes: 2D north-up, 2D heading-up and 3D heading-up.

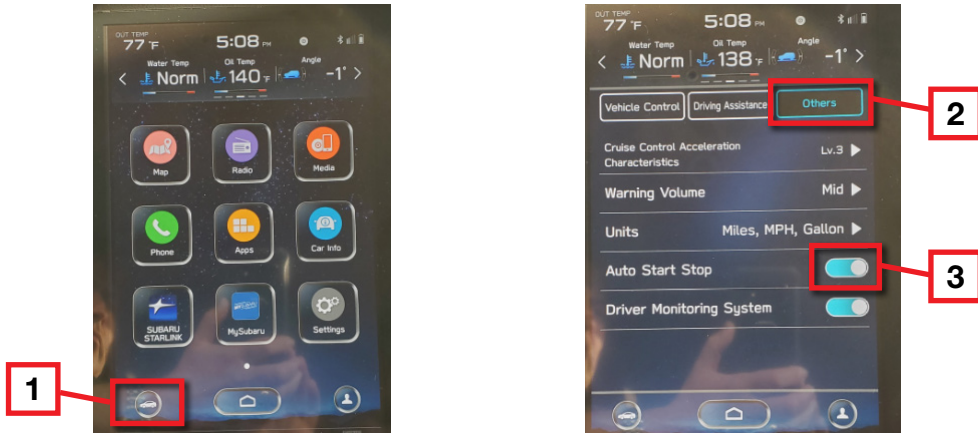
CONDITION #4: Engine Auto Start-Stop operation defaults to “ON” following the ignition cycle off-on.

There may be times when this feature needs to be deactivated. Follow the sequence provided below to deactivate Auto Start-Stop:

1. Touch the Vehicle Icon on the Home screen
2. Touch the Others tab on top
3. Move the Auto Start-Stop slider to OFF.

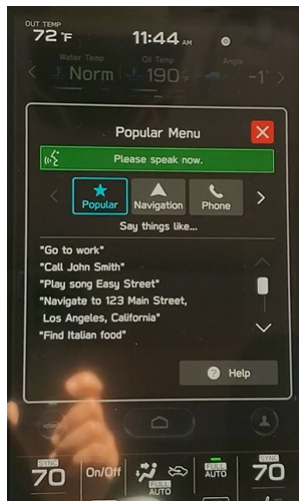
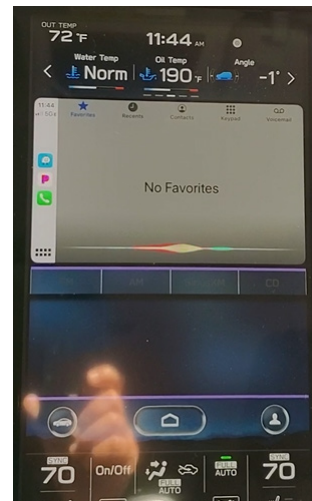
CONDITION #6: Voice Recognition (VR) operation is inconsistent when using Apple CarPlay or Android Auto applications.

REMINDER: To start Siri / Google Assistant, while using CarPlay / Android Auto press and HOLD (long press) the Talk switch on the steering wheel.

The same is true when using the voice to text function. To start Siri/ Google Assistant, press and HOLD the Talk switch on the steering wheel. This will initiate change-over from the native on-board VR system to Siri / Google Assistant.

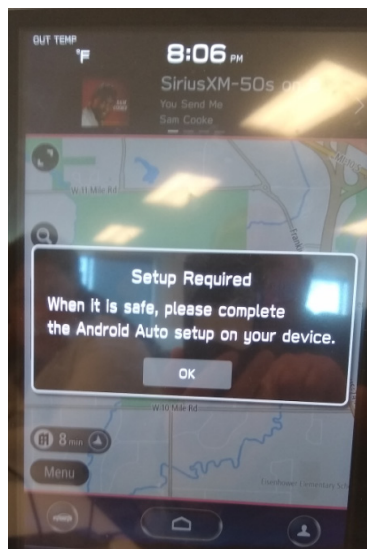
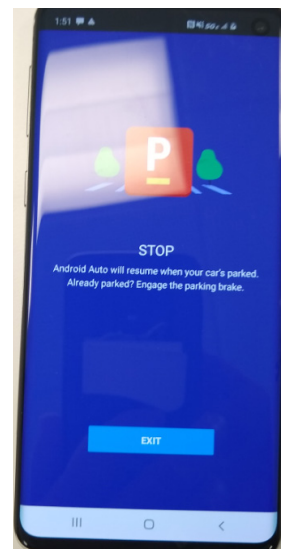
CONDITION #8: Android Auto does not launch.

CAUSE / NOTE: The vehicle must be stopped and the electric parking brake (EPB) must be ON to complete the initial pairing process between the CP1 / Gen 4 Infotainment system and the phone using the Android Auto application. When connecting a phone to the USB port, follow the messages on both the CP1 display and the phone screen. See below an example.

This is a normal operating characteristic. It is a good practice to confirm an undamaged, genuine cable is used to connect the phone as well as the making sure the phone is set to accept connection with a new vehicle.

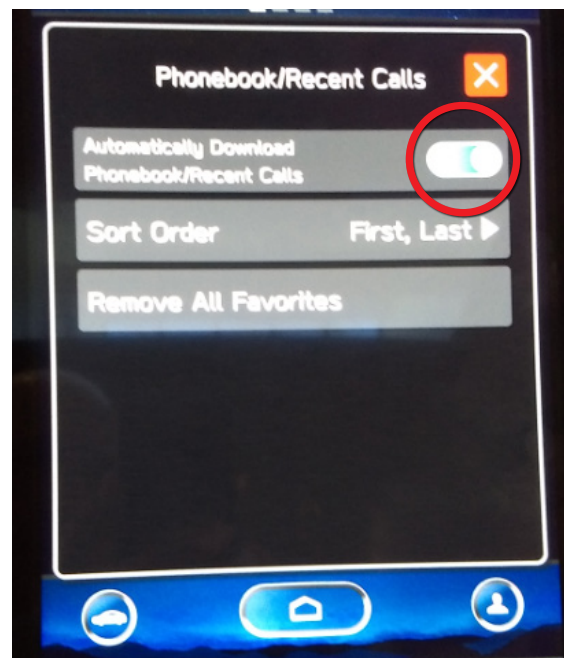
Home > Settings > Phone > Phonebook/Recent Calls

CONDITION #10: User is unable to download Phonebook Contacts.

When assisting with questions about the phonebook download process, start by verifying the option is enabled in the CP1 / Gen 4 Infotainment system using the following screen shot as a guide.

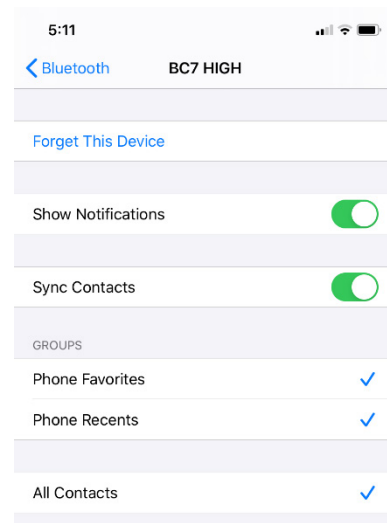
If the customer still cannot access the phonebook or messages, check the phone's Bluetooth settings to ensure all related sharing settings are enabled.

Select the gear icon next to your vehicle device name. Ensure all settings are enabled.

Select Bluetooth setting, then under “MY DEVICES”, click on the “i” symbol next to connected device to confirm “Sync Contacts” and “Show Notifications” options are enabled as shown below. It is strongly recommended to restart the vehicle to finalize the pairing process and ensure all devices are properly synchronized.

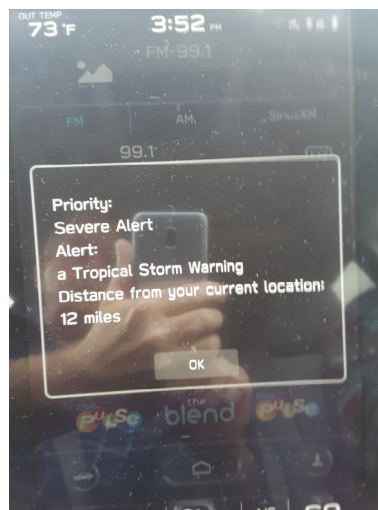
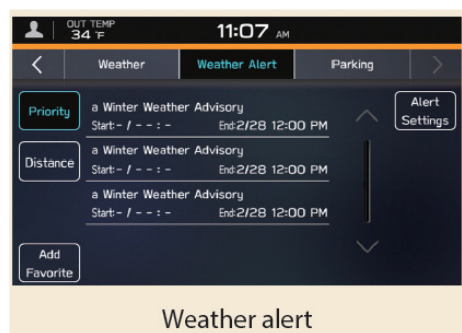
Weather alert

CONDITION #16: Weather Alert message

The Denso CP1 system is designed to receive severe weather alert information from Sirius XM (SXM) and display a pop-up window with the alert message as shown below.

Denso implemented SXM Weather Alert settings within the Gen 4 CP1 controls. These settings control all alert types as well as the ability to completely turn the alerts off. Unlike Gen 3 Harman, the settings for Weather Alert in Gen 4 Denso are in the SiriusXM Travel Link menu (Applications). See the Gen 4 screenshots below.

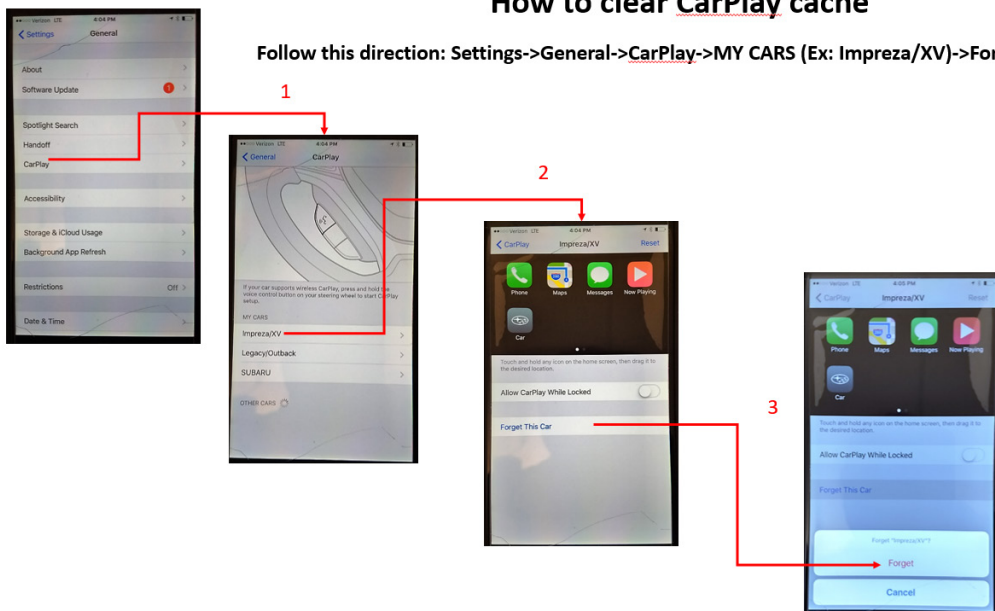
How to clear CarPlay cache

CONDITION #18: No Audio during CarPlay

Follow this direction: Settings->General->CarPlay->MY CARS (Ex: Impreza/XV)->Forget This Car

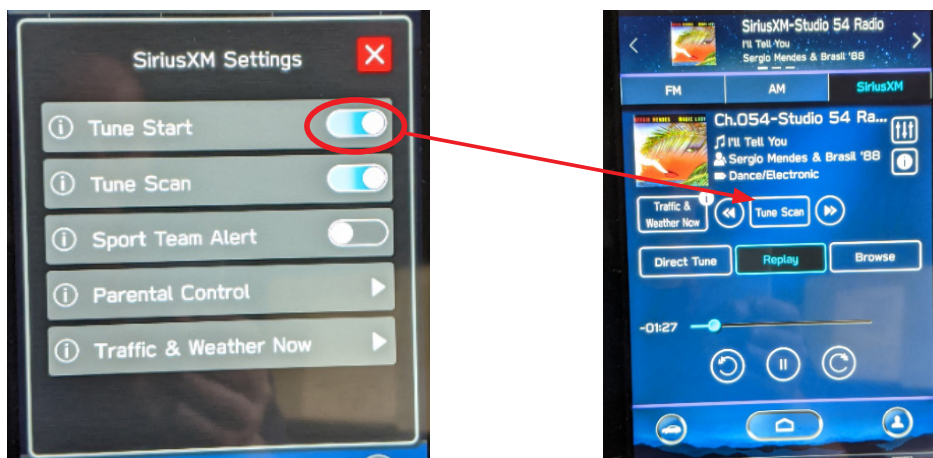
Tune Start: When this function is on, channels registered as Smart Favorites will be cached and when the channel is changed, the song on that channel can be listened to from the beginning. Reports have been received where the customer is not sure how to bring back the display of the preset buttons once the cache / song replay screen has popped up. Touching the “Replay” soft button will remove the cache / song replay screen.

NOTE: This playback option automatically appears for Smart Favorites when the “Tune Start” setting is ON and based on when the smart favorite channel is selected. Tune Start causes the module to start playing from the start of the most recent buffered song with each station selection change. This operation is a normal operating characteristic. Do NOT replace hardware to stop getting the replay screen following Smart Favorite channel selection. If the customer wants to stop the playback option from automatically appearing for Smart Favorites, turn “Tune Start” setting to OFF using SiriusXM Setting options.
