## SERVICE BULLETIN

**APPLICABILITY:** 2019-21MY Impreza  
 2019-21MY Crosstrek (Including Hybrid Model)  
 2019-21MY Forester  
 2019MY Legacy/ Outback  
 2019-21MY WRX  
 2019-20MY BRZ- Navigation -equipped ONLY  
 2019-21MY Ascent

**NUMBER:** 15-236-18R

**SUBJECT:** Reprogramming File Availability for Optimization of Harman Gen 3.1 and Gen 3.1α Audio and Navigation Head Units

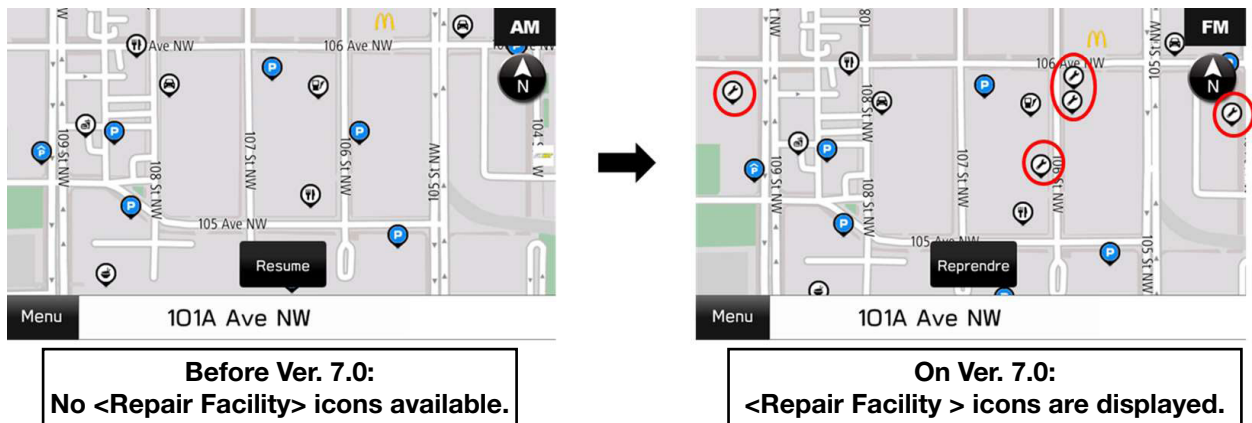
**NOTE 4:** Displaying Repair Facility POI icons:

<Repair Facility> Icons can be displayed in the NAVI Map.

<Repair Facility> Icons can be turned On or OFF by going to: Settings > Navigation > POI Icons.

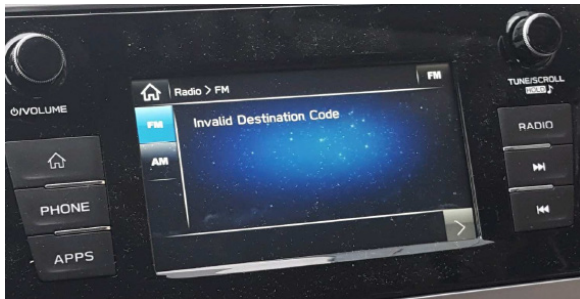
- 3) US State names corrected when using voice guidance.
- 4) Correction made for Pop / Crackling-type sound when using AM radio.
- 5) Navigation system freezes during loading / start-up.
- 6) Music skips/cuts out while using Apple CarPlay.
- 7) Hands-free feature freezes intermittently while loading.
- 8) Navigation system freezes after entering a particular address using Voice Recognition.  
**NOTE:** All other functions are not affected.
- 9) The voice guidance volume no longer changes After Ignition Off/On. Once the Voice Guidance has been muted, the system retains that setting even after switching the ignition Off/On.
- 10) Invalid Destination Code message appears on the display while listening to the radio.

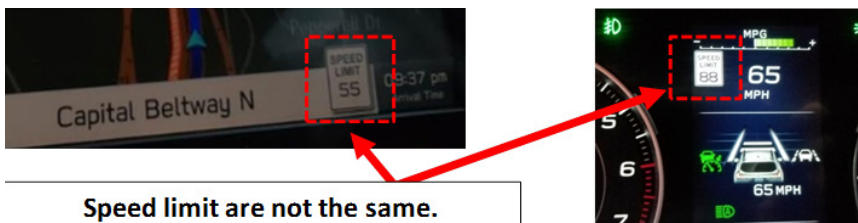
- 11) Spanish version FOTA (Firmware Over The Air) translation corrected.
- 12) Mismatch of Speed Limit between Navigation display and the Speed Limit displayed in the Combination Meter Multi-Function Display (MFD).
