# Service Bulletin

Bulletin No.: 20-NA-121

**Subject:** Water Leak at Roof Area, Various Electrical Issues, No Start, Stall, Brake Lamp Not Off, Radio Inoperative, Remote Key Inoperative, TPM Light Illuminated, Malfunction Indicator Lamp (MIL) Illuminated with Possible DTCs C0750 SYM29, C0755 SYM29, C0760 SYM29, C0765 SYM29

Brand:	Model:	Model Year:		VIN:		Engine:	Transmission:
		from	to	from	to		
Buick	Encore GX	2020	2021	—	—	All	All
Chevrolet	Trailblazer (VIN M)	2021	2021			All	All

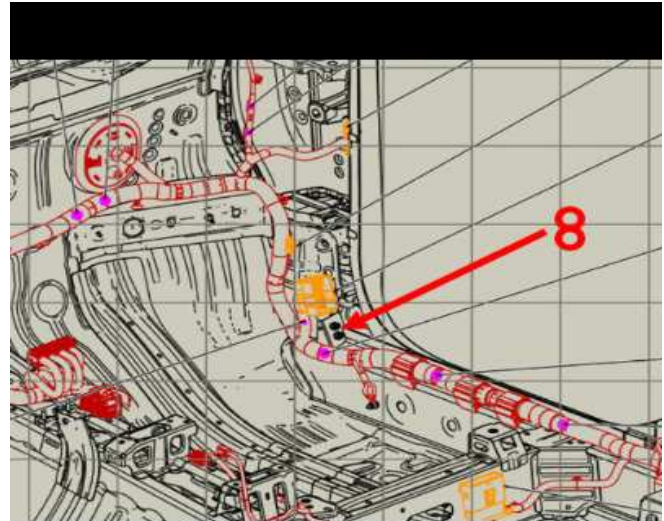
5752326

## Inspect and Clean Body-IP Inline Connectors and Seat Belt Retractor Pretensioners

1. With vehicle off, disconnect the battery.
2. To access the connectors, remove the left and right garnish trim. Refer to *Front Side Door Sill Garnish Molding Replacement* and *Center Pillar Lower Trim Panel Replacement* in SI.
3. Inspect the connectors for any moisture. If needed, clean using a clean nylon bristle brush and dry connector using compressed air.
4. Preparing NYOGEL 760G (electrical grease) and flatting tool, apply on IP harness inline connector surface. Make sure all terminal pins are covered enough by grease.
5. Reattach the connectors. Make sure the 2nd locking tab is closed.
6. Reinstall the garnish trim. Refer to *Front Side Door Sill Garnish Molding Replacement* and *Center Pillar Lower Trim Panel Replacement* in SI.
