**SERVICE BULLETIN**

**APPLICABILITY:** 2020-21MY Legacy and Outback Models      **NUMBER:** 15-261-20R  
**SUBJECT:** Reprogramming File Availability for Optimization of Gen 4 Denso CP1 Infotainment Systems      **DATE:** 03/10/20  
**REVISED:** 07/19/21

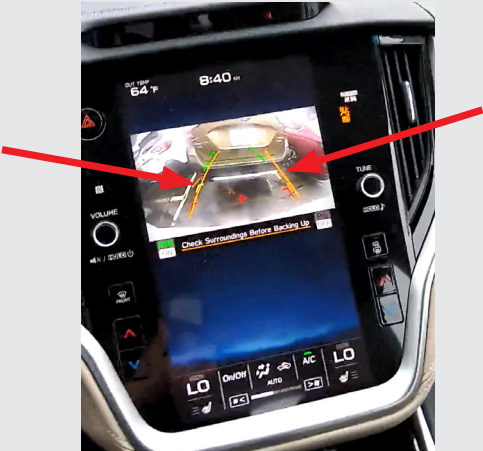
<p><b>**NOTE:</b> After switching the ignition off and leaving the driver’s door open more than 70 seconds, the system <i>may</i> recover after switching the ignition back on.</p>
2	<p>Delayed response of rear view camera guide lines. When the rear view camera is activated and the steering wheel is turned, there is a delay before the steering-responsive guide lines respond to the steering wheel input.</p>

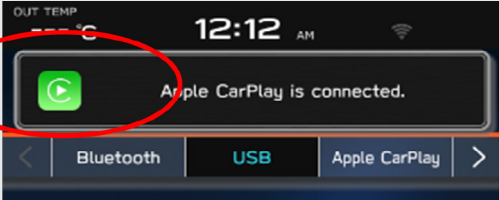
11	<p>When using route guidance with CarPlay navigation, &lt;Turn by Turn&gt; descriptions will be displayed both in the Information bar of CID and in the MID located in the center of the combination meter.</p>
12	<p>By touching the new CarPlay button located at the top of the CID, the CarPlay menu can be accessed easily.</p>

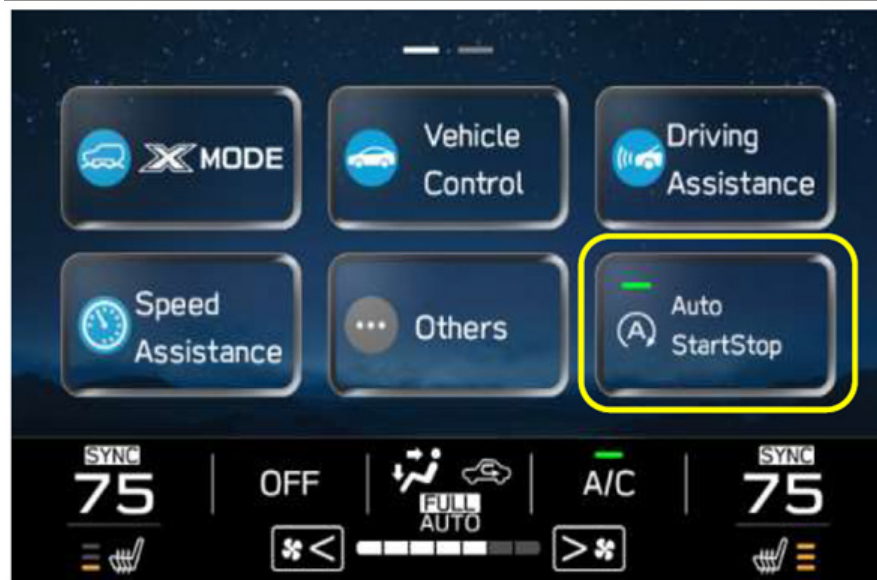
1

The Auto Stop-Start On/Off function is difficult to use (find) in SUBARU STARLINK® Multimedia. The function button has been moved from the bottom to top layer of the system for easier use.
