SERVICE BULLETIN

APPLICABILITY: 2019-21MY Impreza
 2019-21MY Crosstrek (Including Hybrid Model)
 2019-21MY Forester
 2019MY Legacy/ Outback
 2019-21MY WRX
 2019-20MY BRZ- Navigation -equipped ONLY
 2019-21MY Ascent

NUMBER: 15-236-18R

SUBJECT: Reprogramming File Availability for Optimization of Harman Gen 3.1 and Gen 3.1α Audio and Navigation Head Units

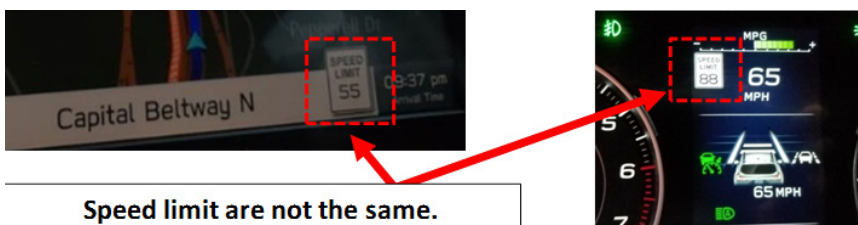
- 11) Spanish version FOTA (Firmware Over The Air) translation corrected.
- 12) Mismatch of Speed Limit between Navigation display and the Speed Limit displayed in the Combination Meter Multi-Function Display (MFD).
