SERVICE BULLETIN

APPLICABILITY: 2020 Outback & Legacy **NUMBER:** 15-270-20R

SUBJECT: FOTA (Firmware Over-The-Air) Reprogramming for DENSO Gen 4 Audio / Navigation Infotainment Systems **DATE:** 8/19/2020

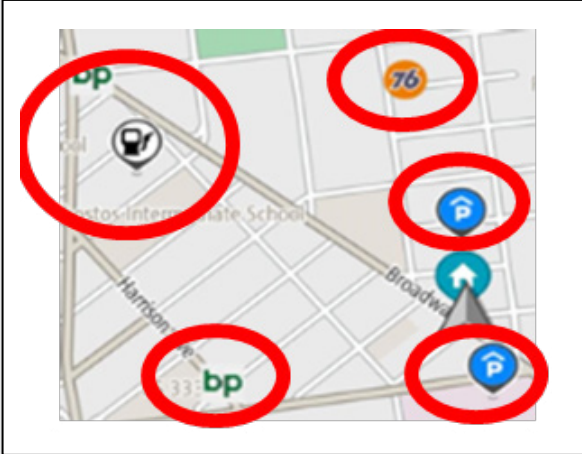
2	<p>Pin display of POI is available.</p>

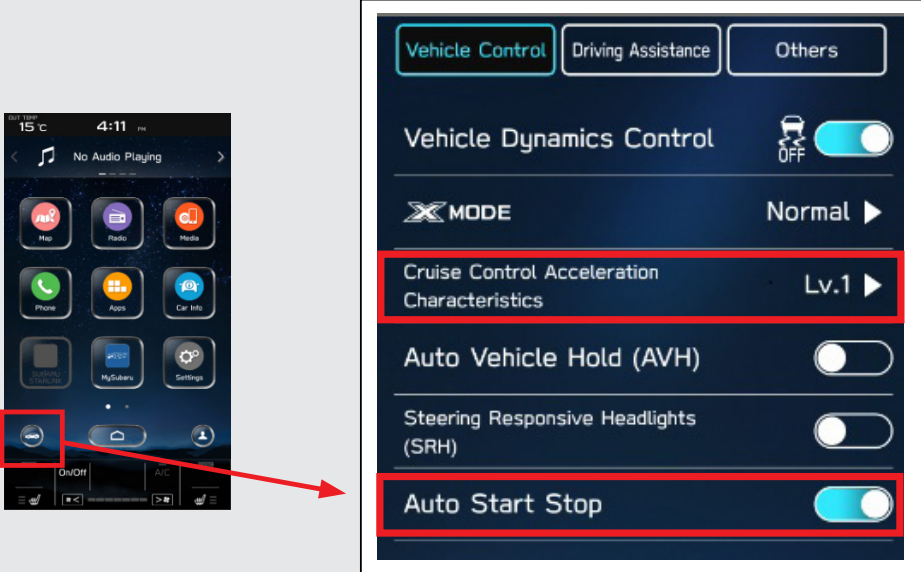
Yes
3	<p>In the 2D and 3D HU display mode, the own vehicle position icon on the Navigation map is easier to be recognized.</p> <p>Icon size: 9mm(0.35in) <instead of 7mm(0.28in)> Icon color: Dark blue <instead of Blue> Icon position (with route guidance): The icon stays at the same position as that without route guidance. The position is located 9mm(0.35in) higher than that of previous version. Icon position (without route guidance): The icon stays at the same position as that with route guidance whereas the previous version icon was displayed lower position than that with route guidance.</p>	Yes
4	<p>ISS (Auto start stop) button is moved to upper layer in the Car Setting menu. By touching the “Car Setting” icon, Auto Start Stop setting menu and the Cruise Control Acceleration Characteristics selection menu can be accessed immediately, whereas the previous version needed to select “Others” in the Car Setting screen to access these menus.</p>

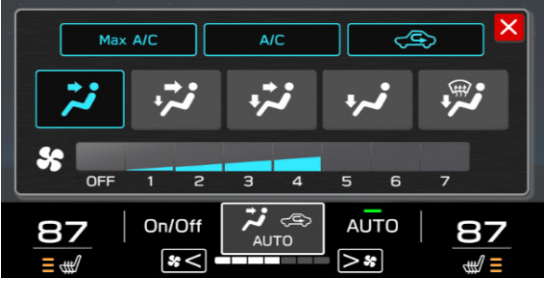
5	<p>HVAC control buttons of base grade are displayed larger and easy to see.</p>

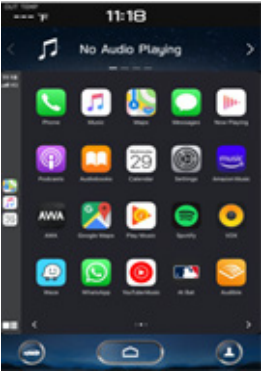
USB ONLY
6	<p>Time zone and Summertime are automatically selected. Default setting of clock setting is Auto (Time zone is changed according to the vehicle location, and the Summertime is automatically set according to the calendar)</p>	Yes
No. New functions and improvement		FOTA
7	<p>Direct selection of clock setting. Clock setting can be selected by touching the clock display in the status bar.</p>	Yes
8	<p>Hold displaying Album Art even with vehicle in motion. The Album Art that is displayed whenever music is played on the audio system keeps displaying even after the vehicle is in motion (the speed signal is inputted.)</p>	Yes
9	<p>CarPlay screen is extended to full screen. CarPlay screen is expanded from half size (horizontal) to full screen (vertical.)</p>

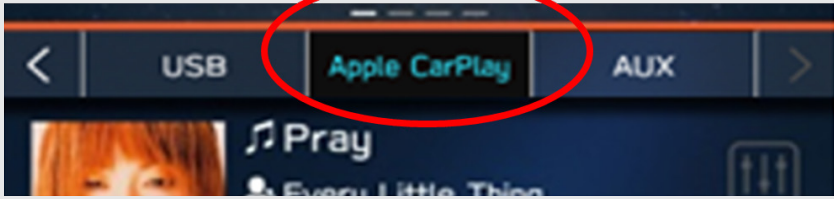
Yes
10	<p>Add new CarPlay or Android Auto tab to Music screen When using CarPlay or Android Auto, “CarPlay” or “Android Auto” tab will appear on the Media tab bar. By selecting this tab, music data and metadata can be browsed.</p>

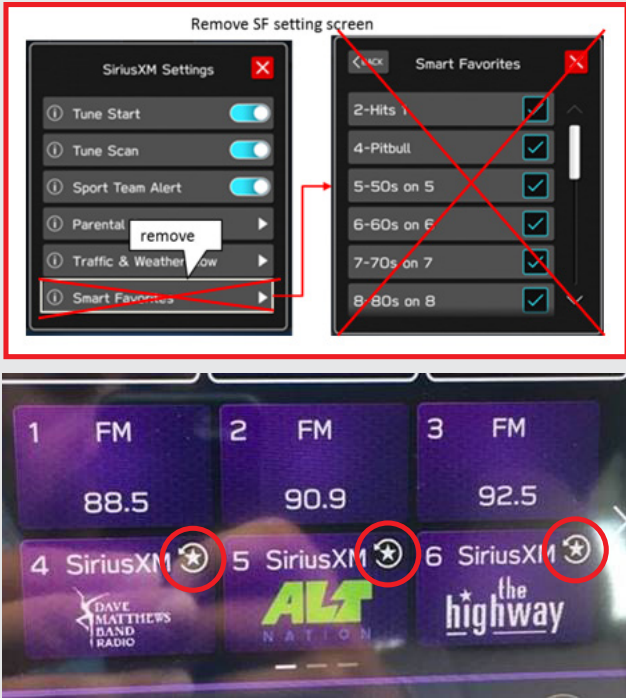
Yes
13	<p>CarPlay connection status can be retained even after Ignition off/on. In case the system was shut down with the CarPlay being connected previously, the system automatically resumes the connection at the next start up.</p>	Yes
14	<p>Improvement in the <Siri> Voice Recognition The starting of <Siri> Voice Recognition function can be ready faster.</p>	USB ONLY
15	<p>Gracenote database update Up to Nov 2019 database</p>	USB ONLY
16	<p>1. Sirius XM Smart Favorites menu has been removed from SiriusXM Settings</p>

<p>2. Going forward, the first 10 set Sirius XM presets are now smart favorites by default 3. Smart favorite channel has “star” added to the preset button</p>	USB ONLY
