Service Bulletin

Bulletin No.: 21-NA-209

Subject: Black Radio Display Screen (Triangle and Camera with the Slash Through it) with both DTCs U023C and B1A62 Setting Current in Video Processing Module (VPM)

Brand:	Model:	Model Year:		VIN:		Engine:	Transmission:
		from	to	from	to		
Cadillac	Escalade Escalade ESV	2021	2021

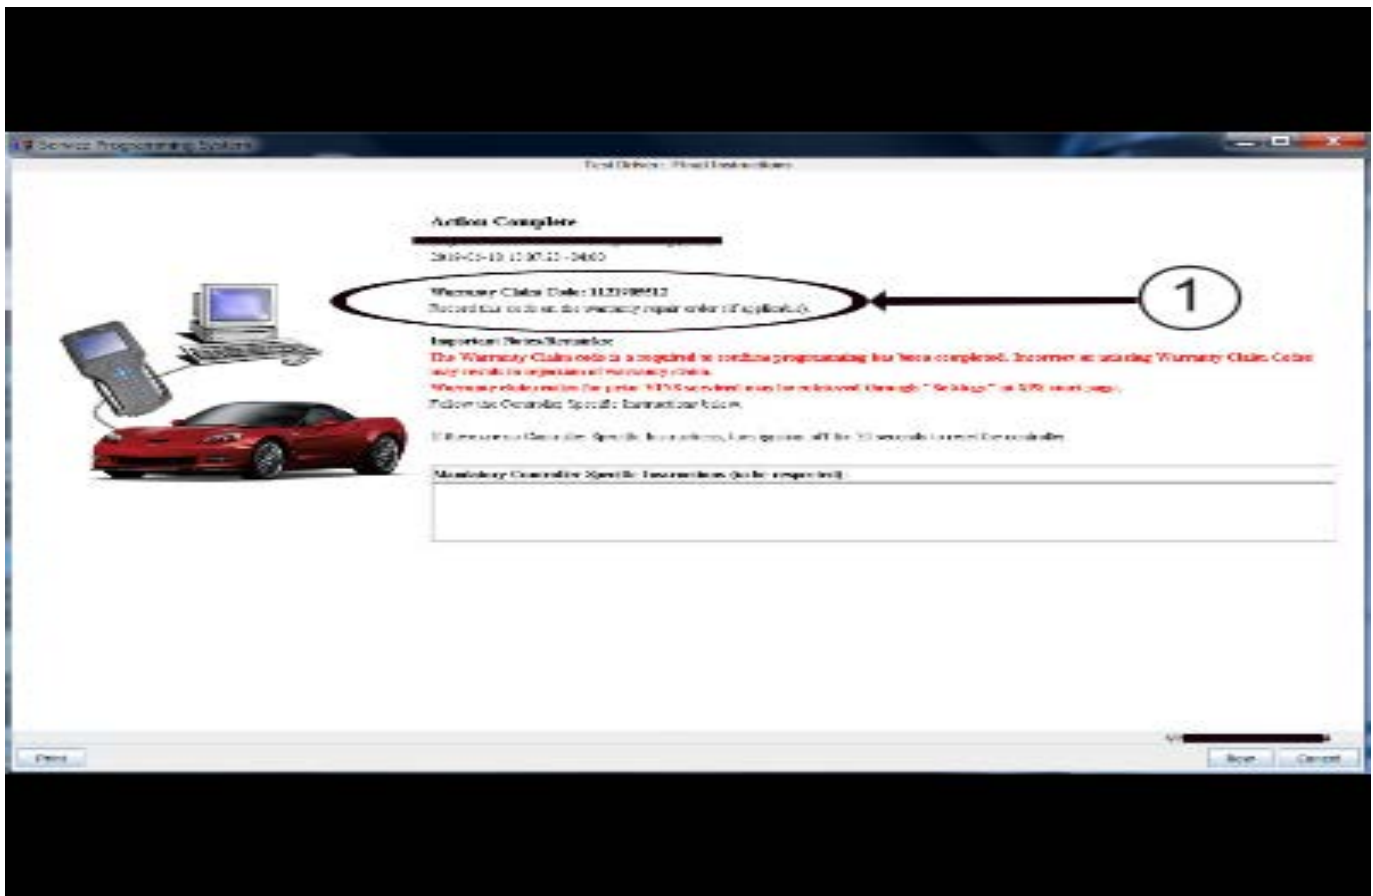
5431209

Note: The screenshots above are an example of module programming and may not be indicative of the specific module that is being programmed. Module selection and VIN information have been blacked out.
