**SERVICE BULLETIN**

**APPLICABILITY:** 2019-22MY Impreza  
 2019-22MY Crosstrek (Including Hybrid Model)  
 2019-22MY Forester  
 2019MY Legacy/ Outback  
 2019-22MY WRX  
 2019-22MY WRX STI  
 2019-22MY BRZ- Navigation -equipped ONLY  
 2019-22MY Ascent

**NUMBER:** 15-236-18R

**SUBJECT:** Reprogramming File Availability for Optimization of Harman Gen 3.1 and Gen 3.1α Audio and Navigation Head Units

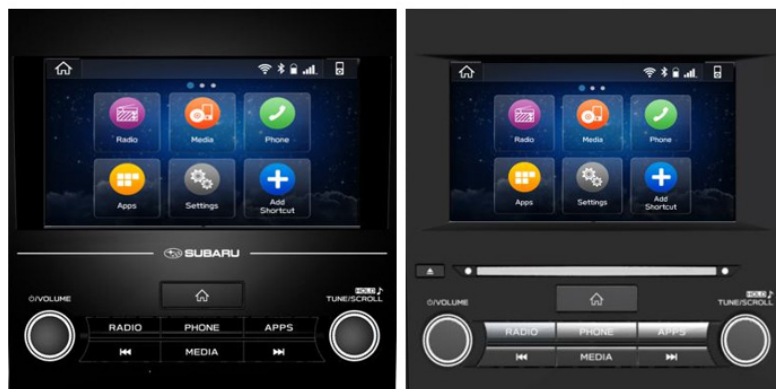
BASE

Multimedia System Type	Descriptive Features
6.5 Inch Display Audio System (Base)	No CD slot / Eject Button
6.5 Inch Display Audio System (Base +)	Equipped with CD Player and Eject Button
8.0 Inch Display Audio System (Mid)	Phone Button
8.0 Inch Audio / Navigation System (High)	Map Button but no Phone Button
