SERVICE BULLETIN

APPLICABILITY: 2017-18MY Impreza
 2018MY Crosstrek
 2018MY Legacy and Outback
 2018MY BRZ*

NUMBER: 15-211-17R
DATE: 06/13/17
REVISED: 04/26/22

SUBJECT: Reprogramming File Availability for Additional Optimization of Harman Gen 3 Audio and Navigation Head Units

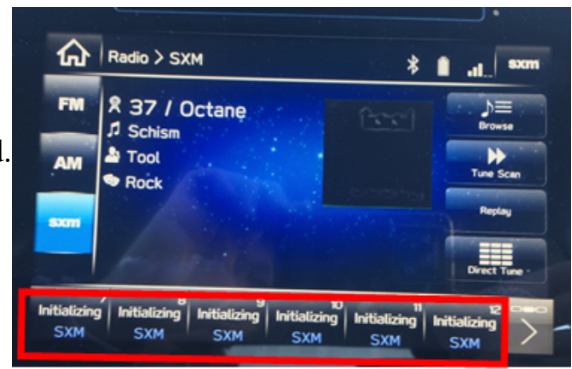
- On 2018MY Legacy / Outback models with Navigation (High) head units, the update corrects a condition where the head unit remains powered even after the ignition is OFF and the driver door is opened.
- Update for a condition where the SXM presets become lost and only “Initializing” appears as shown below.
- Update for condition where only the star field background is displayed (without icons) after the HOME button is pressed.

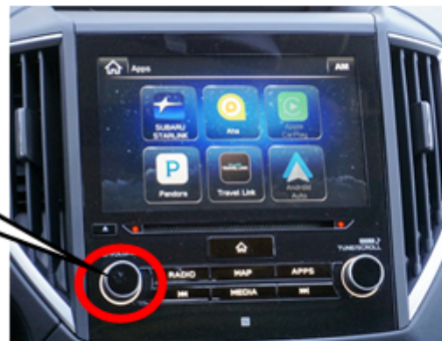
- The Mute function of the Power / Volume knob (a brief press and release of the Power / Volume knob to mute audio output) is unchanged.
 - A “system reboot” function is initiated by pressing and holding the Power / Volume button for 10 seconds. This feature was included as part of the previous (11/2017) software update.
