**SERVICE BULLETIN**

**APPLICABILITY:** 2020-22MY Legacy and Outback Models      **NUMBER:** 15-261-20R  
**SUBJECT:** Reprogramming File Availability for Optimization of Gen 4 Denso CP1 Infotainment Systems      **DATE:** 03/10/20  
**REVISED:** 05/02/22

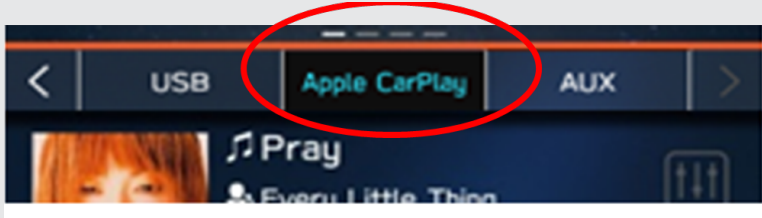
Number	New Functions and Improvements:
10	<p>When using CarPlay or Android Auto, a “CarPlay” or “Android Auto” tab will now appear on the Media tab bar. By selecting this tab, music data and metadata can be browsed.</p>

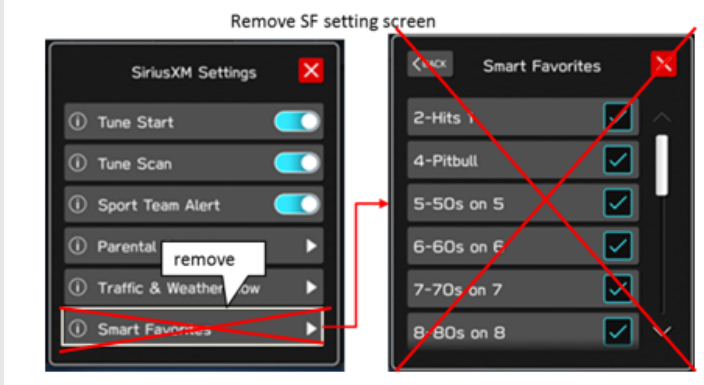
Number	New Functions and Improvements:
16	<p>1. Sirius XM Smart Favorites menu has been removed from SiriusXM Settings</p>

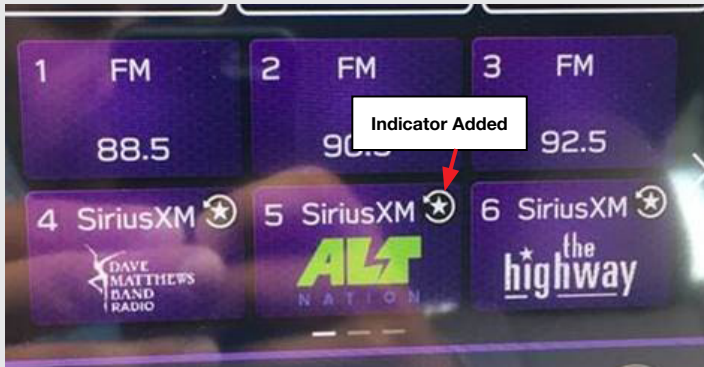
<p>2. Going forward first 10 set Sirius XM presets are now smart favorites by default</p> <p>3. Smart favorite channel has “star” added to the preset button</p>
